**River Babingley – River Restoration and Maintenance
Proposal**

**Prepared for King’s Lynn Internal Drainage Board by Emily long, MSc,
Norfolk Rivers Trust**

April 2015

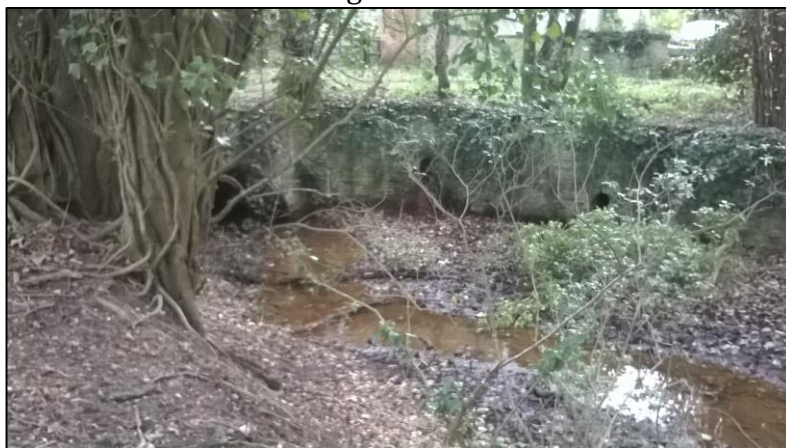
The channel is most modified at the most eastern and western ends of the reach with water mills present at both ends. The western mill at the end of the reach is now redundant with the old mill channel operating as a backwater habitat, Photo 1, BOX 8. These more modified areas display and over wide channel and disconnected floodplain. The western extend, just below the mill have an Environment Agency gauging station sited on the river causing a small impoundment and localised widening of the channel.

Photo 1 Old mill leat operating as backwater channel

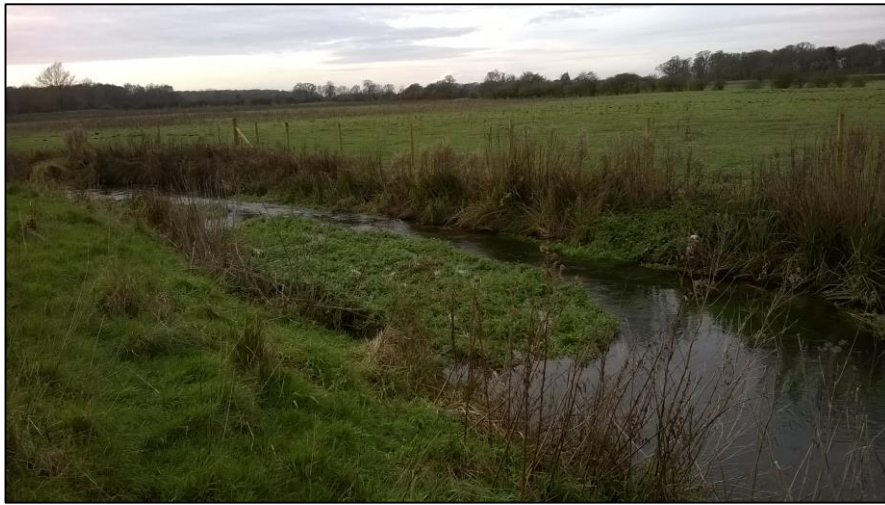
Photo 2 'Dig and dump' berm creation on near (left hand) bank. Now vegetated.

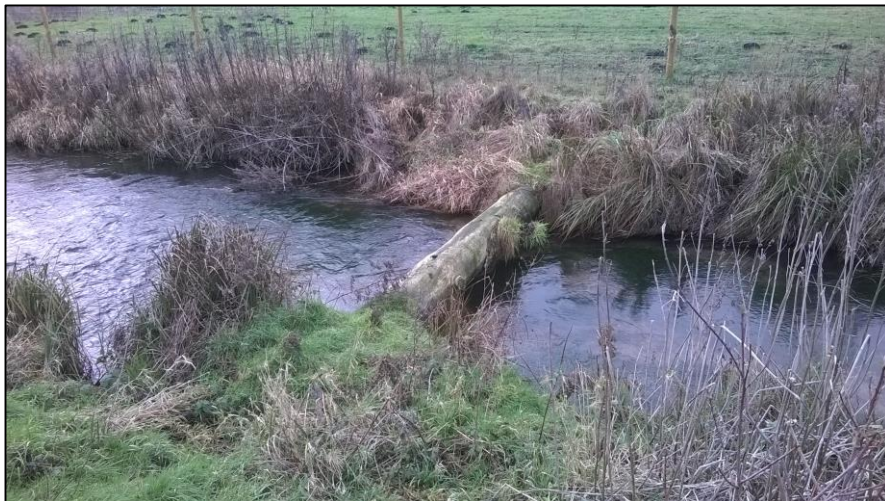
Photo 3 Restoration measure - log across channel

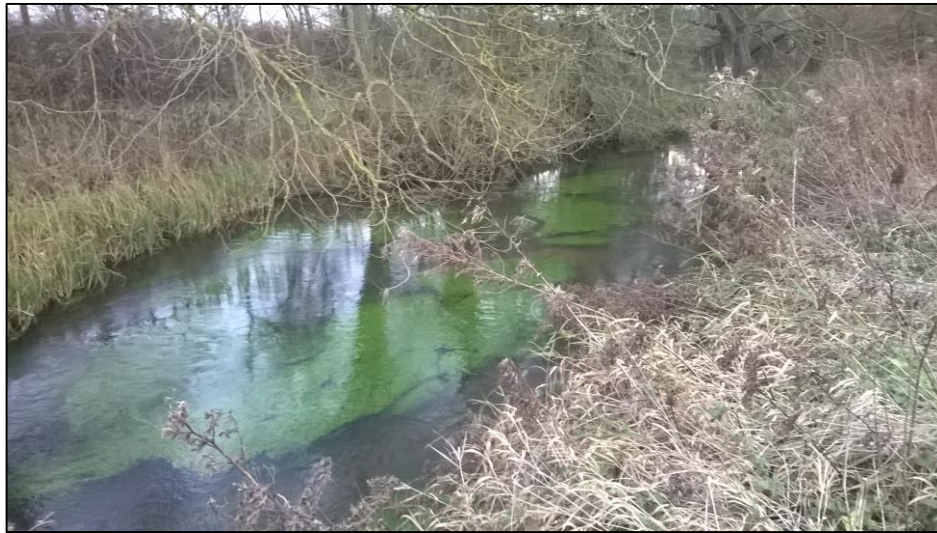
The most western section, below A149 – Cromer Road, shows an over wide section of river with a high southern bank (left hand bank). The right hand bank is heavily vegetated with a range of trees and scrub, Photo 4.

Photo 4 over wide section between the by-pass and Babingley Bridge. Beds of starwort seen.

Below the A149-Cromer Road the river is over wide and heavily embanked. This section would benefit from some berm creation to narrow the channel, BOX 9. Berms could be created in a number of ways, either using the 'dig and dump' method, creating pools in channel to win the material, or by constructing the berm out of woody faggots and coir rolls. A combination of the techniques could also be used. Investigations into the sediment input from the drain would also be beneficial. This is likely resulting from high sediment inputs from the plantation at the top end of the drain.

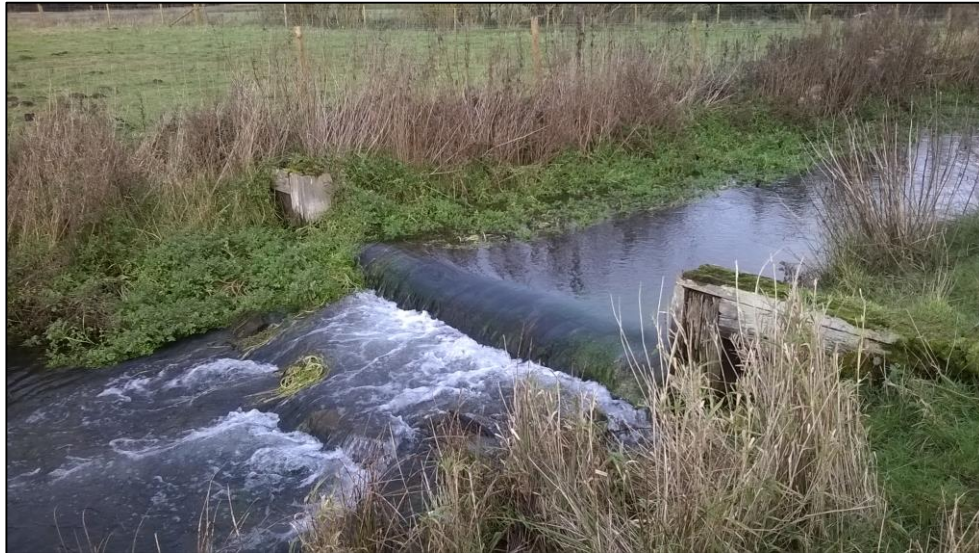
Photo 5 Small weir present through the section - propose to remove it to reduce impoundment upstream.

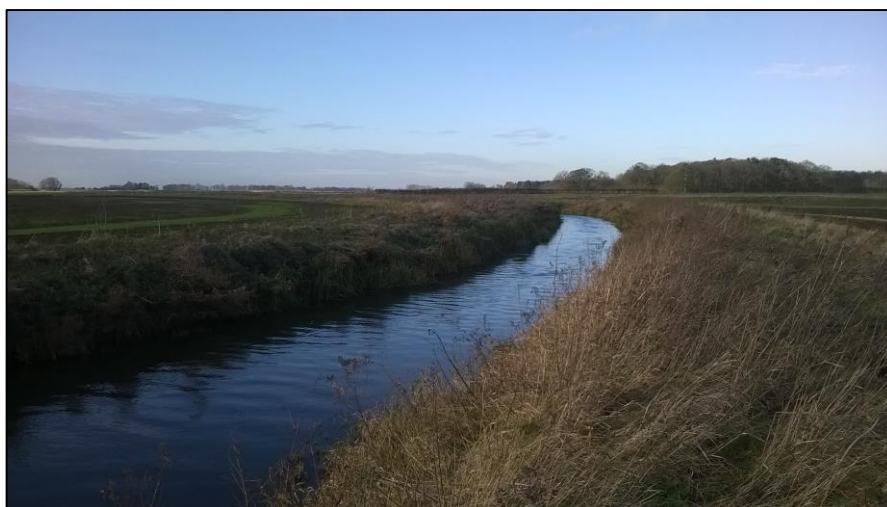
The river is very uniform throughout this section with uniform flow and little in-channel features, Photo 6. The surrounding land use is mainly arable with some semi-improved and some rough grassland on to the west of the stretch. The old sea wall follows the channel for part of its length, with a line of scrub (mostly hawthorn). Localised areas of scrub and trees are also seen where adjoining drains/ditches joining the channel. There are good buffer strips along both banks. Channel widths vary on average between 3-7 m wide, with banks between 1-3m high, disconnecting the river from the floodplain. In a few sections the embankments are slightly lower. The substrates, where visible, are largely sandy and silty.

Photo 6 Uniform channel throughout reach

The current channel is over-wide and disconnected to the floodplain, to restore some of the natural function, whilst maintaining channel capacity it is proposed to pull back the banks in places to create a two-stage channel, BOX 1. This would allow a pseudo flood plain to be created, allowing silt to settle out on the lower ledge in the shallow slow flowing water allowing a wetted berm to become established, whilst maintaining a clear channel for normal flows and an increased channel area for high flows. Modifying the channel in this way allows the overall capacity to be increased, with the creation of a narrower average flow channel.

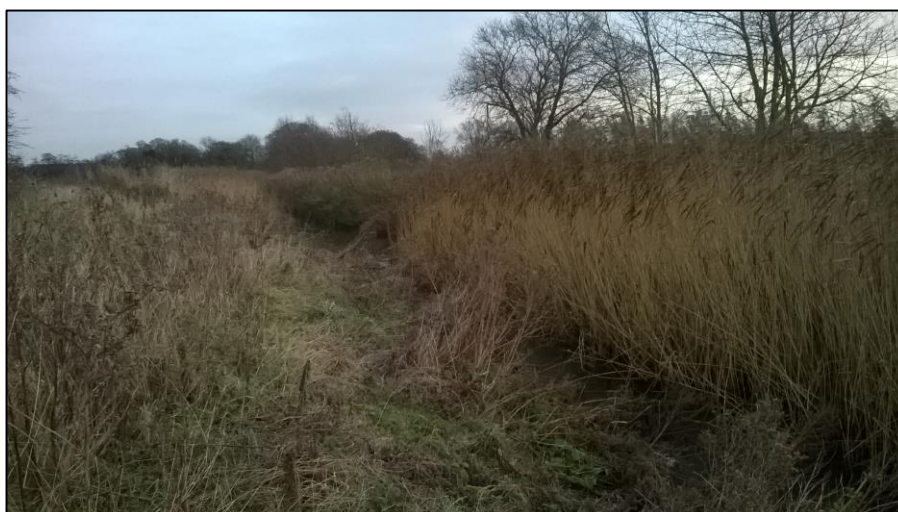
The upstream, or eastern extent shows an over widened river, with large beds of common reed, *Phragmites australis*, Photo 7. This is typical of over wide-deep and silty sections. Some evidence of natural recovery is seen throughout the section, with material being deposited on the in-side of bends and beds of emergent vegetation growing on the margins. These beds narrow the channel to 2-3m wide.

Photo 7 Large beds of *Phragmites australis*

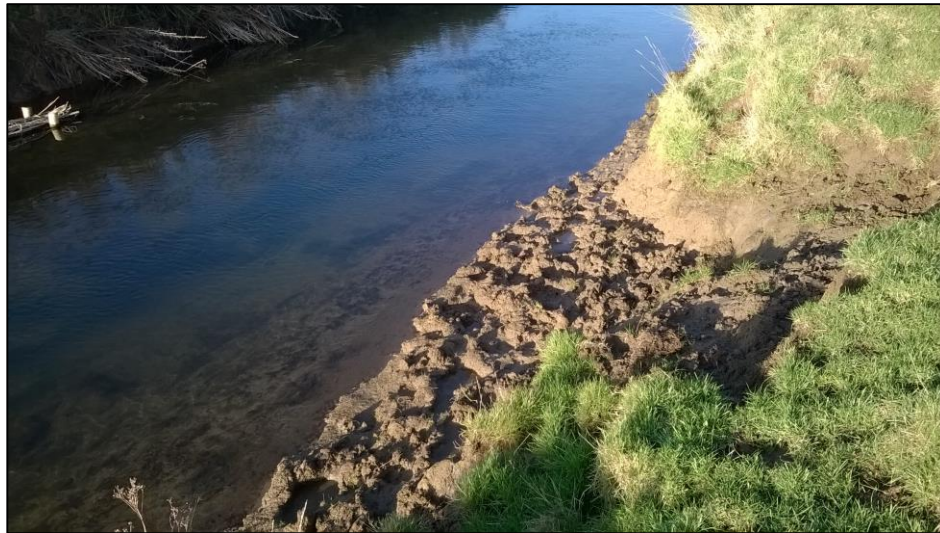
A bridge crosses the river through the middle of the section and there are remnants of older bridge structures or bank revetments. The disused railway bridge marks the end of the reach, the bridge has been removed, but the brick supports still remain lining the channel. The western end of the reach shows evidence of heavy poaching, particularly on outside of the bend prior to the dis-used railway bridge, Photo 8.

Photo 8 heavy poaching near dis-used railway

Where poaching is prevalent to the west of the reach it is proposed to re-grade the banks and create specific cattle drink areas. These could be created via backwater features bringing water off the channel into the field for access, allowing the river bank to be fenced, BOX 2.

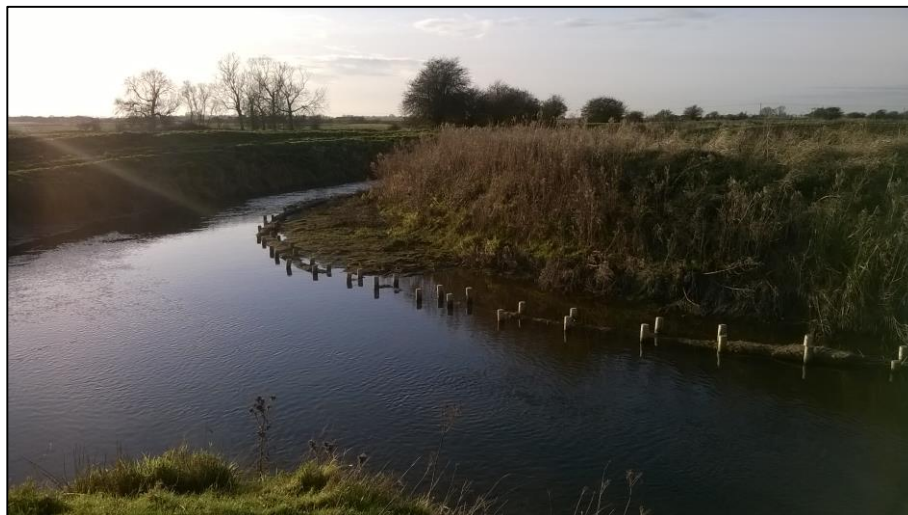
Some restoration efforts have been completed through this section with 3 areas of channel narrowing constructed out of coir rolls, Photo 9. One of these is situated on the inside of a bend creating a shallow berm, another on a straightened section, and one low berm on the outside of a bend at the lower end of the stretch. One field to the north of the site has a large scrape created in it, there are reports of good numbers of avocets that use this feature.

Photo 9 Previous restoration works, creating low berm.

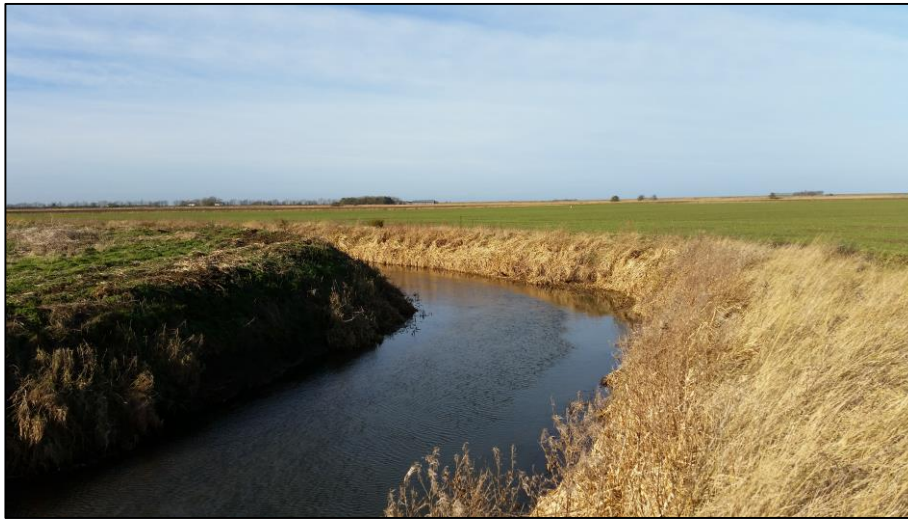
This reach of river, although sinuous, has a wide uniform channel, uniform slow flow with sparse aquatic vegetation, Photo 10. The river is on average 5-6m in width with high steep banks ranging from 1 – 2.5m high, disconnecting the river from its floodplain. The banks are well vegetated, with wide buffer strips present on both banks. The land is largely arable, with a few pasture fields to the eastern extent.

Photo 10 Wide uniform channel, wide uniform flow. Rippled surface is the result of wind.

Throughout this section the river is overly wide with little variation in width or flow, therefore, where space allows the majority of this reach would benefit from the creation of a two-stage channel allowing the channel capacity and maximum conveyance to be achieved or increased, whilst allowing a smaller channel for lower flows, BOX 1. This could be created by using the 'dig and dump' method, creating in channel pools, or re-profiling the river bank widening top of the bank and narrowing the base, or importing woody fagots. A combination of the techniques could also be used. This lower channel with wetted berm area would allow flows to be locally increased, diversifying habitat and allowing natural vegetation management. It should be noted that this measure could be used throughout this reach where space allows, but smaller feasible areas would need to be determined with landowner consent before taking the measure forward.

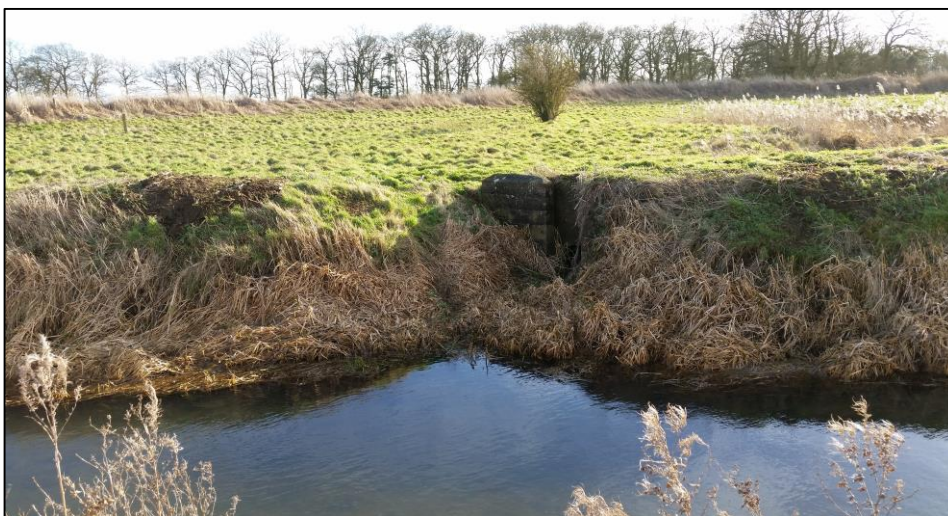
There are two small concrete structures seen on the north bank, highlighting where water flows into and out of lakes on the northern side, Photo 11. Sections of this reach are lined by the historic sea wall, constraining the channel. Some areas of scrub are seen along these boundaries.

Photo 11 Showing concrete structures allowing water management of lake on right hand bank.

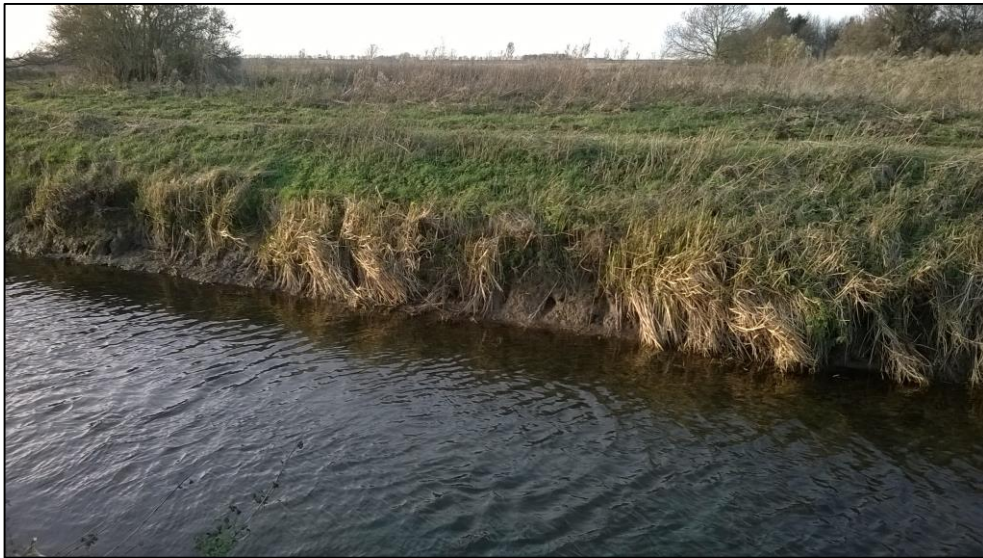
Where the banks are steepest there is little vegetation growth, exposing the bare banks. These are heavily burrowed, Photo 12. Whilst no formal wolver survey was conducted through the survey for this report populations have been confirmed by the Environment Agency. The steep banks present good burrowing habitat, with abundant cover and food source.

Photo 12 Exposed banks, highlighting burrows.

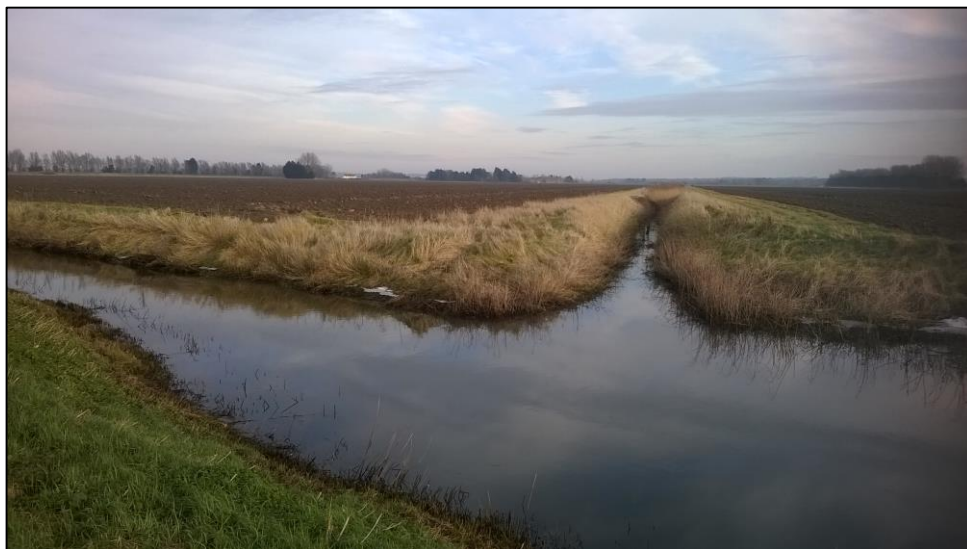
Photo 13. Showing the agriculture extent of the reach, with ploughed field and a field drain connection.

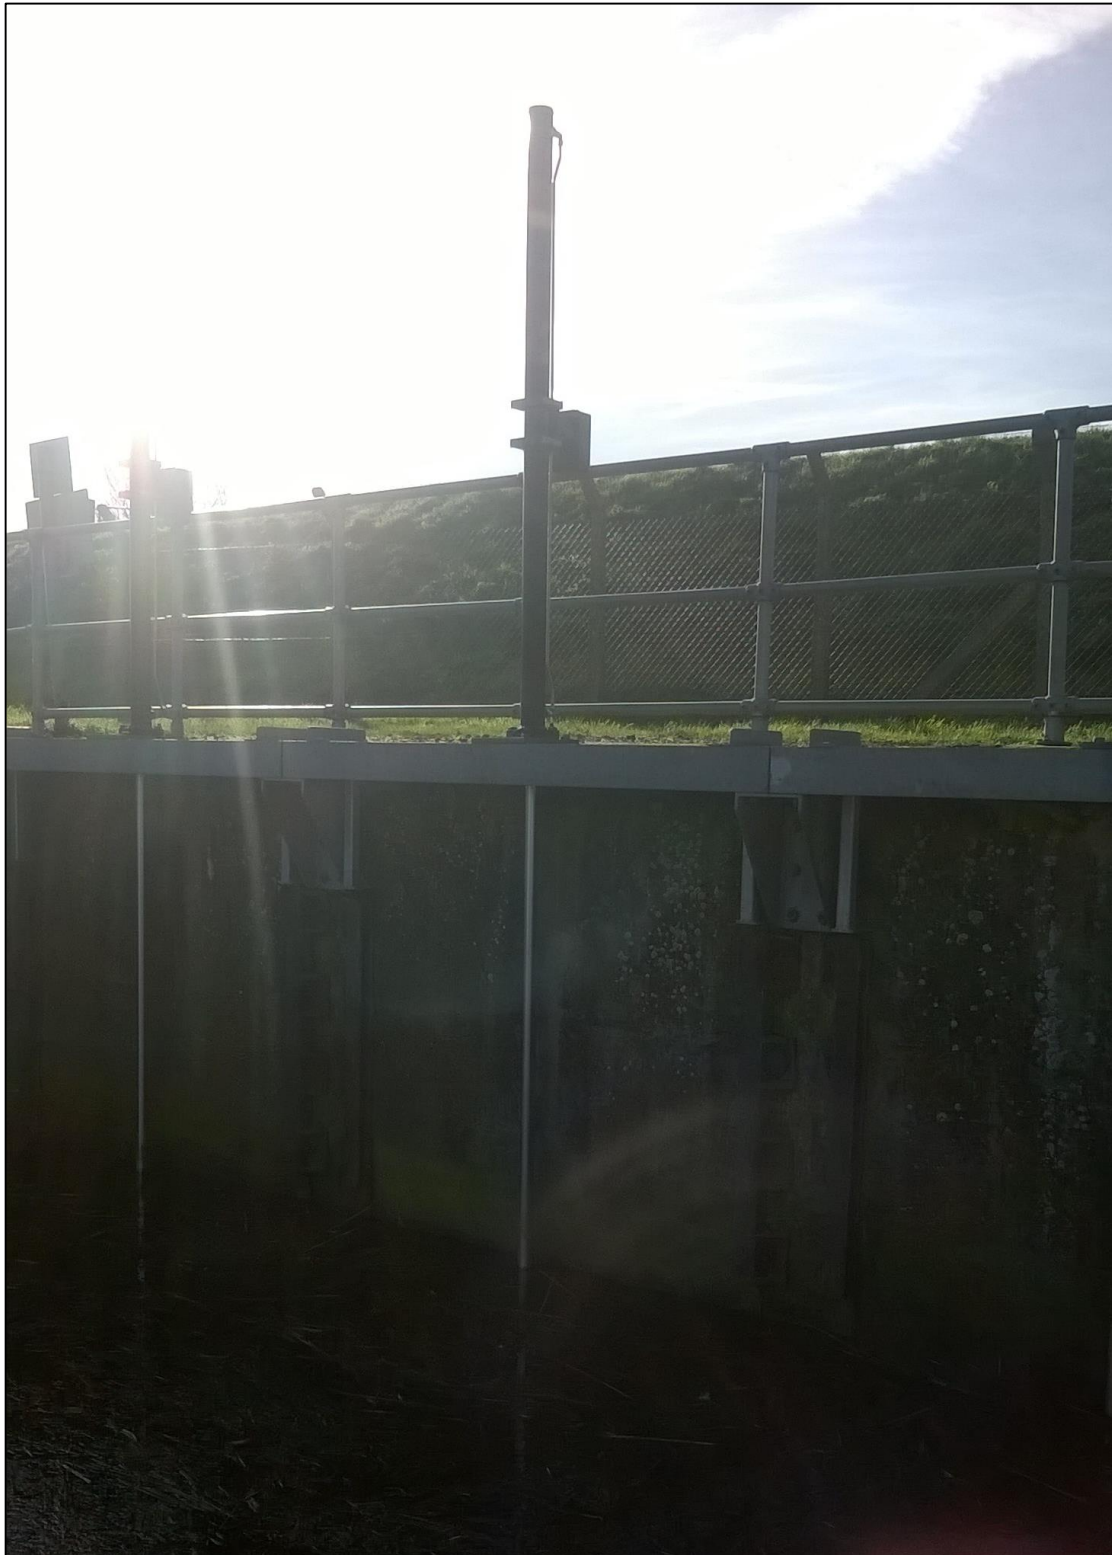
The river drains through three 1.2m wide sluice gates Wooton Marsh, Photo 14, two of which have been fitted with fish friendly 'pet flaps' elongating the available time for migrating species such as trout and eels to pass between the river and estuarine section. During high tide the river becomes tide locked, backing up throughout this section, draining again on the outgoing tide.

Photo 14 Babingley outfall gates
