River Gaywood – River Restoration and Maintenance Proposal

**Prepared for King’s Lynn Internal Drainage Board by Emily long, MSc,
Norfolk Rivers Trust**

April 2015

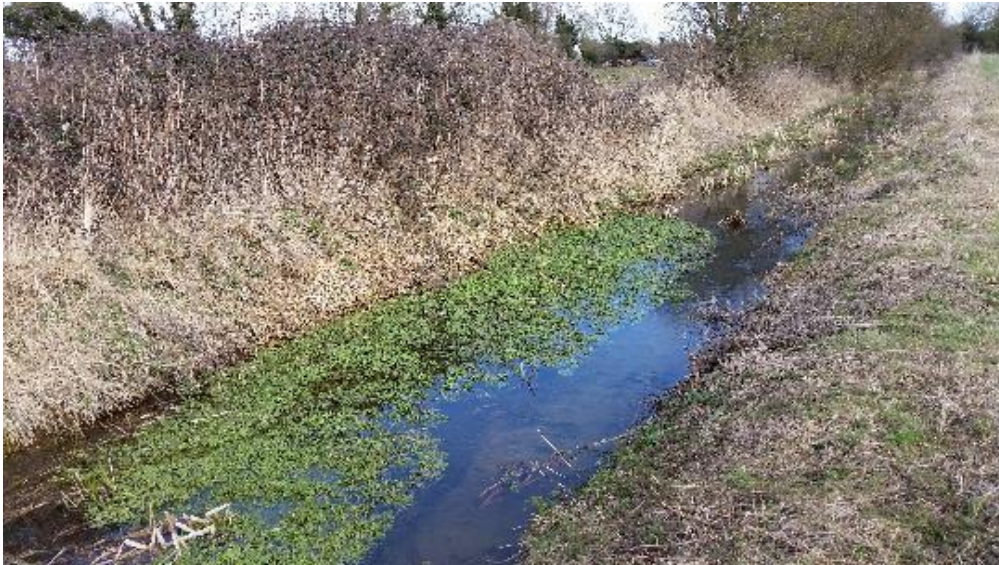
Photo 2 showing the lower section of the reach with *Callichitre agg.* Beds acting to narrow the channel.

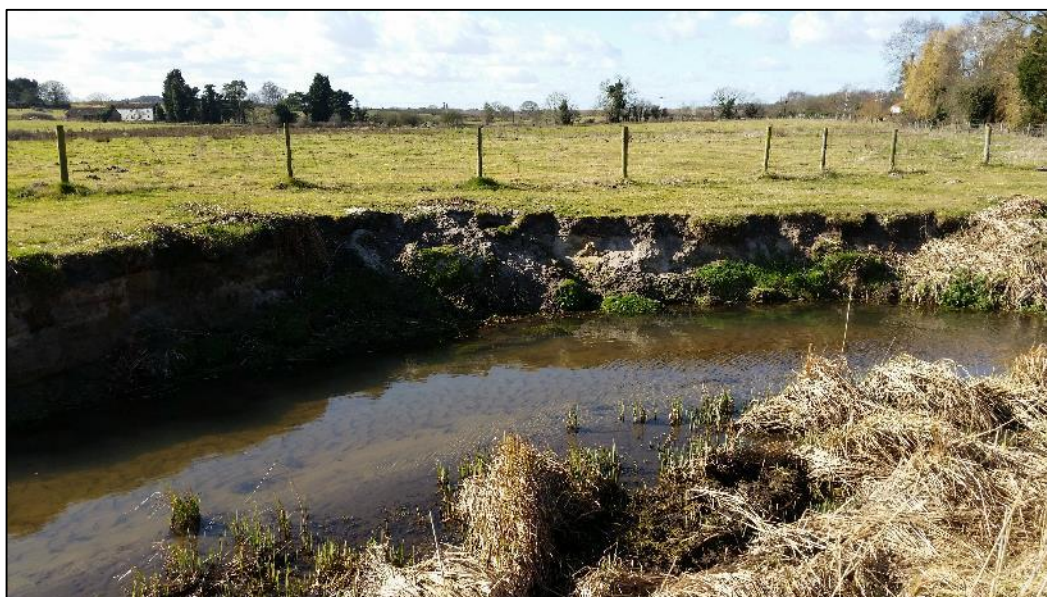
Evidence of heavy poaching is evident, notably on the outside of the meander bends to the south-side (left hand bank), Photo 3. This has resulted in collapsing, steep banks exposing the sandy sediments of the catchment and widening the channel.

Photo 3 erosion from poaching on outside of meander bend. Lower bend shown in photo. Picture taken from right hand bank.

Fencing along the southern, left hand bank is currently being carried out by Norfolk Rivers Trust as part of the 9 Chalk Rivers Project, which will protect the reach from poaching and reduce the sediment input into the river, BOX 1.

Bank repairs are also proposed to encourage stabilisation of the southern bank, BOX 3. This should be carried out after effective fencing is established. Repairs should be achieved using soft-engineering techniques such as coir rolls or matting. This is likely to require additional material which could be won by the construction of scrapes/ponds with landowner agreement.

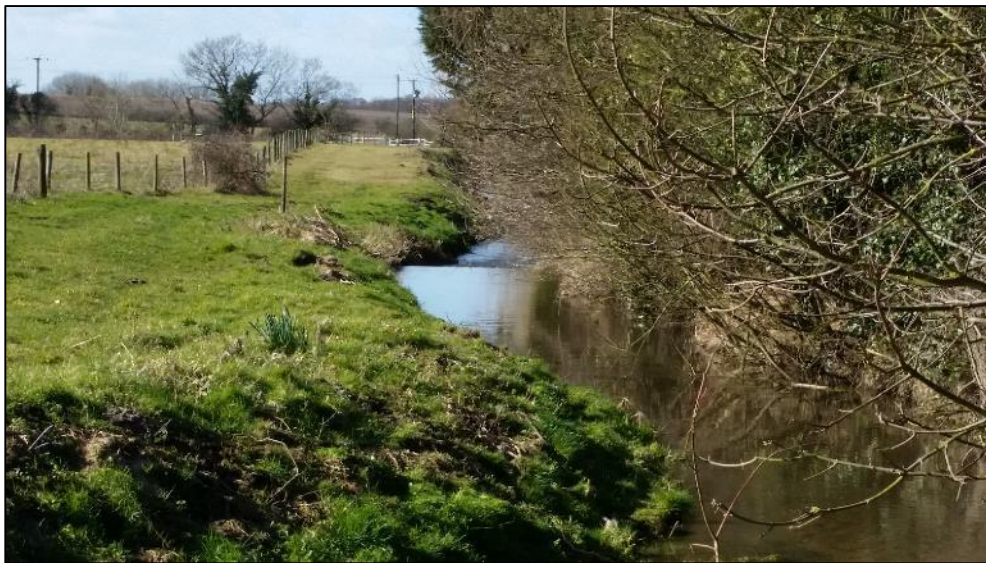
The lower end of the restored section is marked by a low level weir. This is causing a small impounding effect through the meanders, Photo 4. Below the weir the channel narrows and banks increase in height with the channel become straight and featureless.

Photo 4 showing impounded section above low level weir.

The removal of the small weir is also proposed, releasing the impounded stretch and allowing natural processes to occur, BOX 4. If undertaken simultaneously with channel narrowing no detrimental impacts would be seen in the upstream section. These measures can be seen in Figure 2.

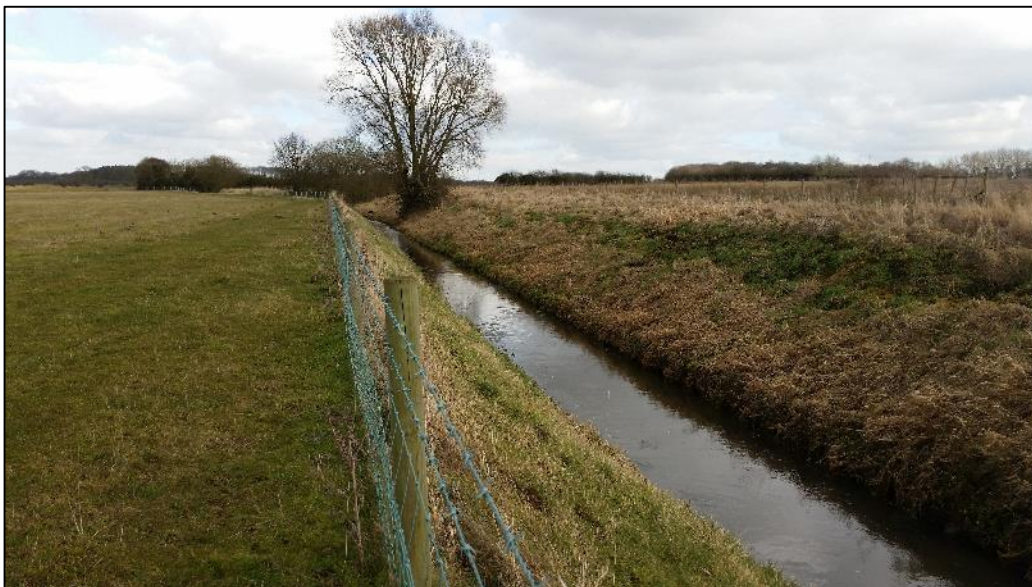
Photo 6 the uniform sections of the lower reach, taken looking upstream from the right hand bank.

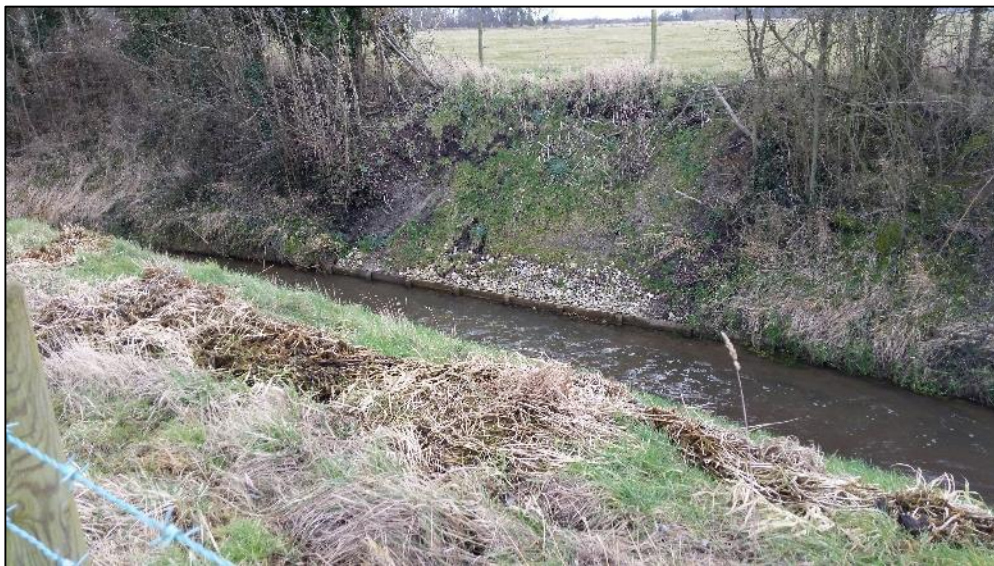
Some bank protection is seen through the lower section with wooden revetment lining the southern bank, Photo 7. Through the mid-section of the reach the southern bank shows a high embankment which slopes up gradually over 10-15m, with a fence running along the top. This is typical of the reach, with the southern bank rising quicker up the valley sides than the northern, flatter floodplain.

Photo 7 Showing wooden revetment on left hand bank.

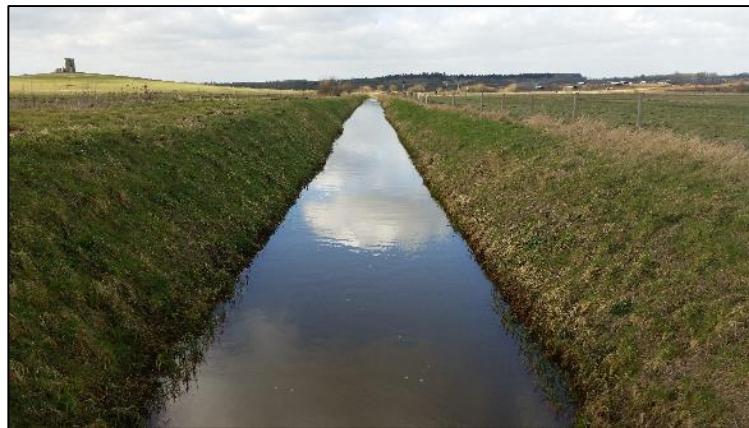
The channel is featureless throughout this stretch with uniform flows and little channel variation, Photo 9. The reach is managed by the King's Lynn IDB cutting the in-channel vegetation and one bank. Bankside cuttings reveal reed sweetgrass, *Glyceria maxima*, common reed, *Phragmites australis* and creeping bent *Agrostis stolonifera*.

Photo 9 highlighting the uniform nature of the reach.

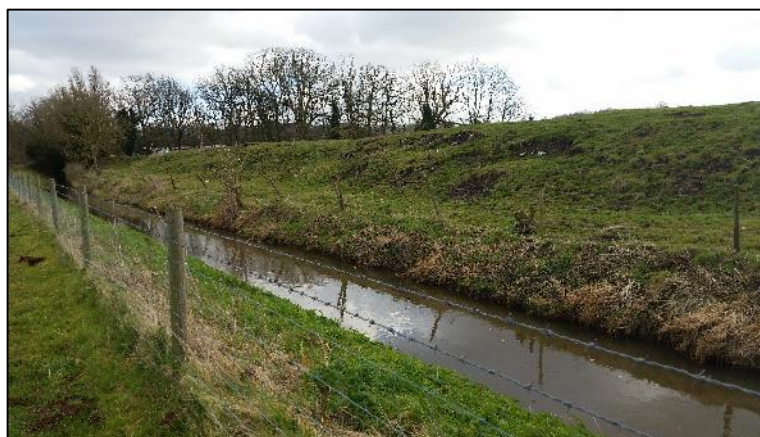
The southern, left hand bank, displays high level terracing to the eastern, upstream, end of the reach, with an upper terrace of a 4m high embankment, Photo 10. Fencing is present on the lower terrace 1-2m high, but is poorly maintained. Two vehicular bridges cross the reach, the lower housing telemetry on the downstream side.

Photo 10 showing the terracing on the left hand bank.

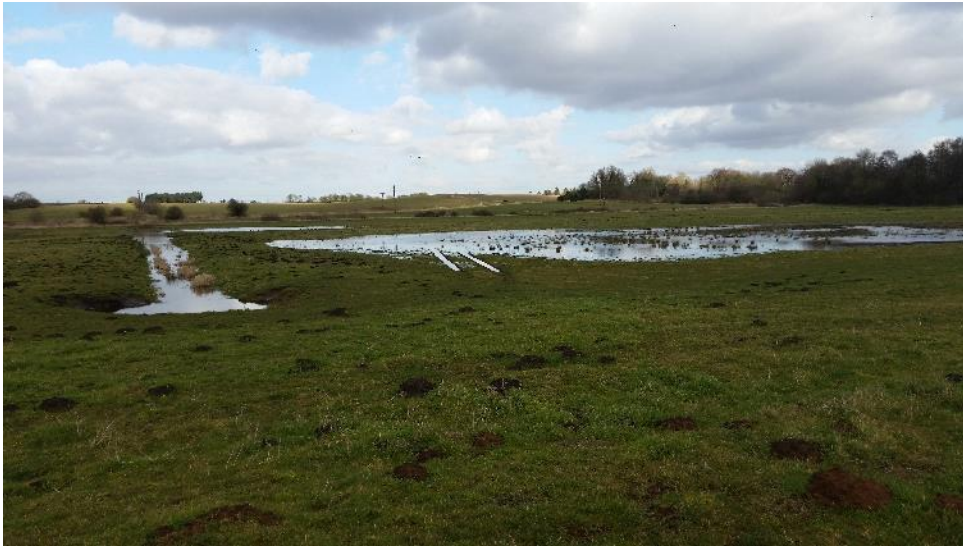
Photo 11 Blocked drain and wet scrapes on field of right hand bank.

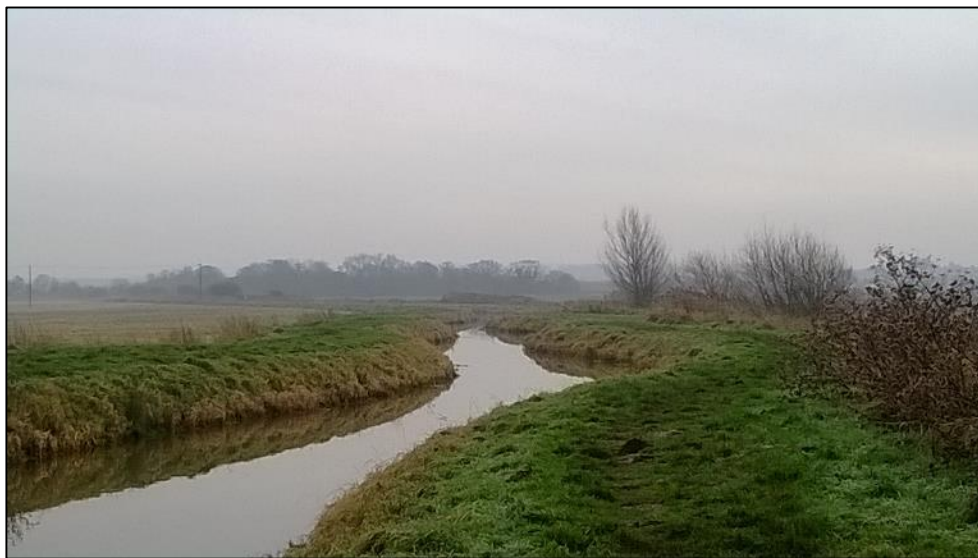
The river is featureless with uniform flows and no bank features, Photo 12. The river is maintained by the King's Lynn IDB, cut from the southern, left hand bank removing all in channel vegetation and cutting the banks. No vegetation was seen throughout the survey, but previous visits to the site have shown evidence of foals watercress *Apium nodiflorum* and floating pondweed *Potamogeton natans* in the channel. These demonstrate the slow flowing, ponded nature of this stretch.

Photo 12 showing the limited in channel features of the reach.

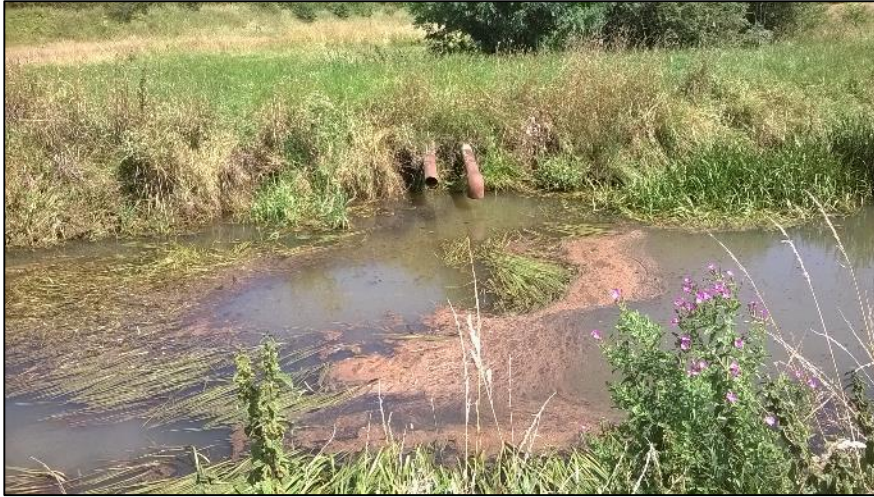
Photo 13 Showing discoloured water and scum on the top of the drain to the north of the Gaywood.
