The Water Management Alliance (WMA) Consortium have a bespoke coastal maintenance team, consisting of team members with specific skills in repair, maintenance and coastal civils works.

# **Featured Projects**

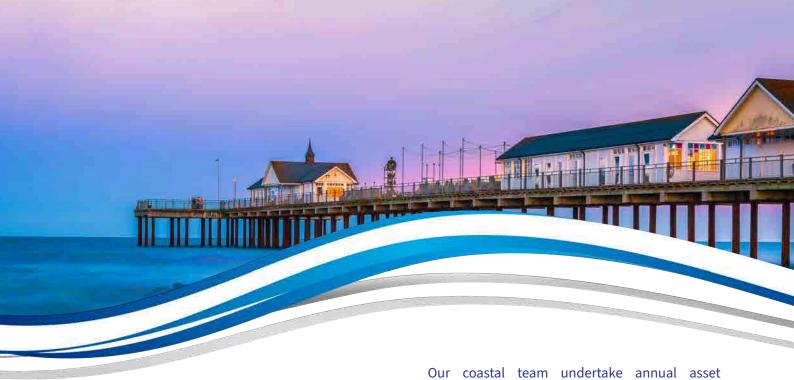
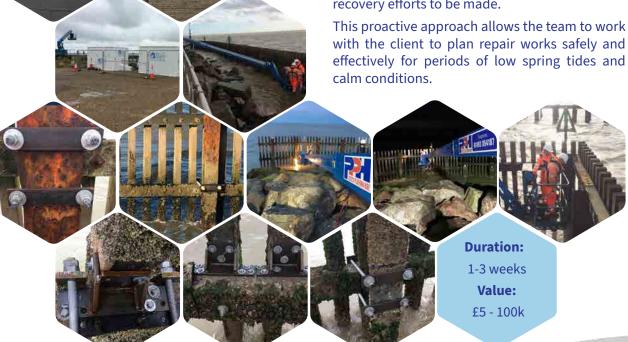
#### **Southwold Fender**

inspections of the Southwold Fender structure, including an assessment of the condition of all welds, joints and fixings to enable proactive works for repairs to be undertaken.

Inspection records are used to facilitate the fabrication of bespoke fittings, so that post storm damage or general wear and tear to different elements, can be replaced quickly and easily.

Using our in-house fabrication workshop the WMA team are able to make new fixings and structures quickly and easily, enabling speedy recovery efforts to be made.

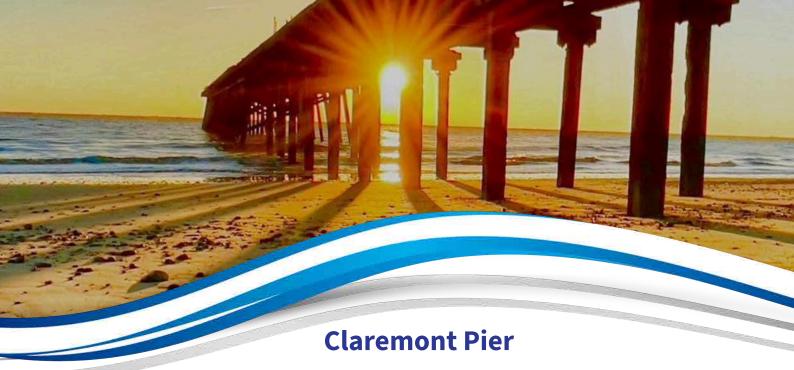
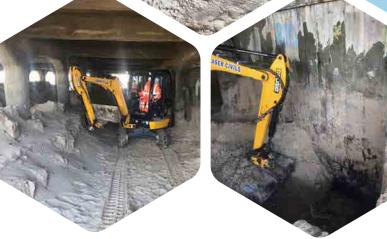
Following health and safety concerns the WMA team were engaged to undertake a programme of improvement to the pier foundations, through applying spray concrete to strengthen certain elements.

Working with a specialist contractor, the WMA team agreed design and application standards, acting as Principle Designer & Principle Contractor for the works.

Further to this we also carried out repairs to the foul drainage system under the pier, filling voids and securing the site for the future.

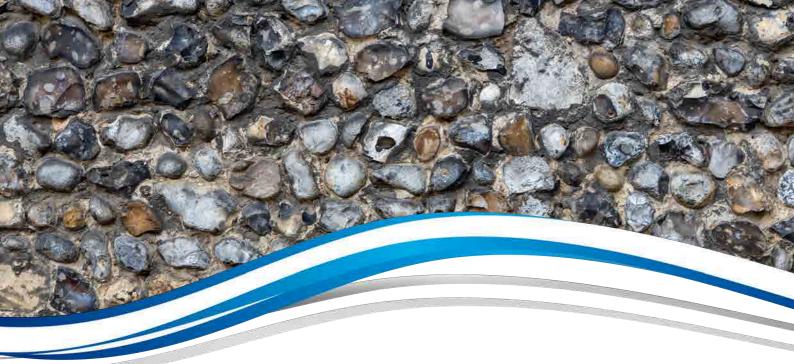
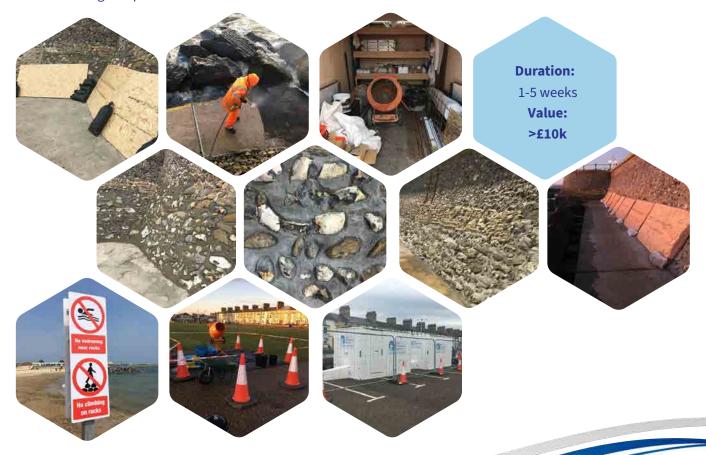
# **Lowestoft Flint Wall Repointing**

The WMA team have a number of skilled craftsmen able to undertake sympathetic, detailed, architectural work. Our team frequently undertake structural repairs to Lowestoft's historic flint sea wall, to help maintain its structural integrity without affecting its traditional visual aesthetic.

Working during periods of low tide our team carefully plan and programme activities to maximise the working windows in a given period.

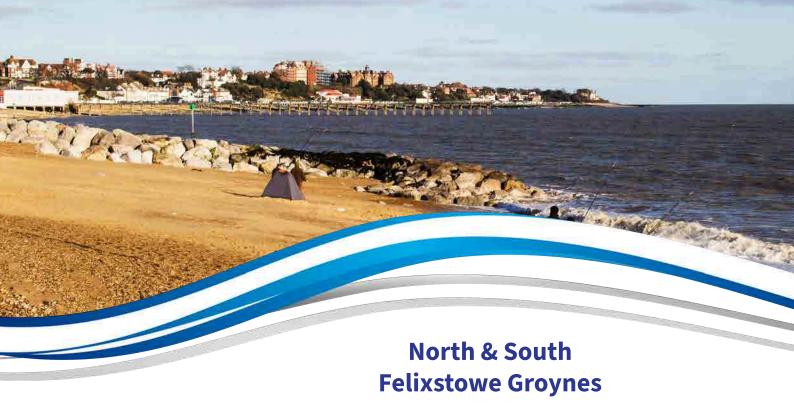
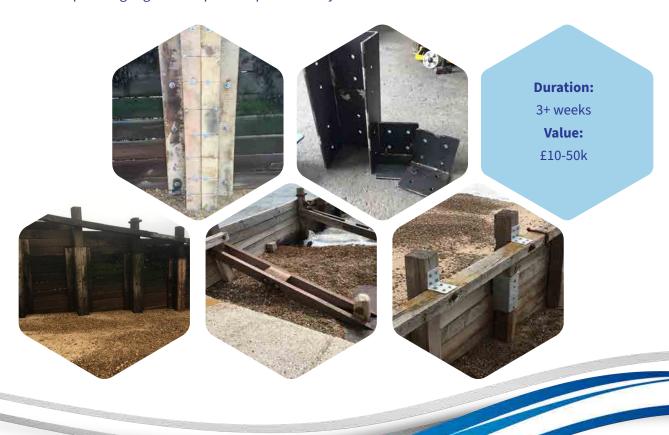
The WMA team frequently manage coastal timber groyne fields to increase the life span of these historic but crucial assets, which maintain beach levels on our dynamic coastline. Our team are able to repair timbers as and when required, removing damaged sections and installing new ones, whilst also repairing connecting metalwork and fixings.

All metal works can be fabricated in house, using our dedicated workshop, allowing for safer and more efficient works on site.

Our team are fully resourced with mobile plant to remove any sharp sections from structures and often install or replace signage to compliment public safety.

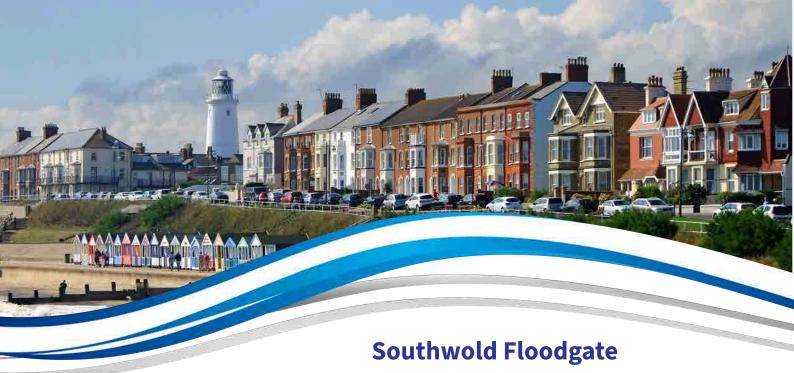
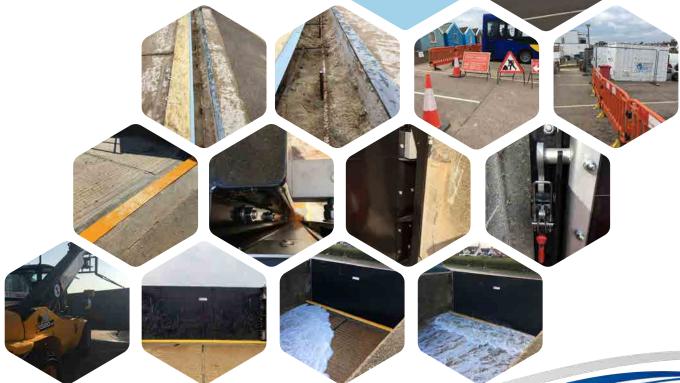
Working closely to understand our client's needs the WMA team undertook the role of Principle Designer to develop a bespoke floodgate solution. Using our GPS levelling equipment we surveyed the site and designed seawall and ramp alterations to construct an accessible and attractive solution. We then worked as Principle Contractor to install the works, which included reinforced concrete, tarmacking and drainage adjustments.

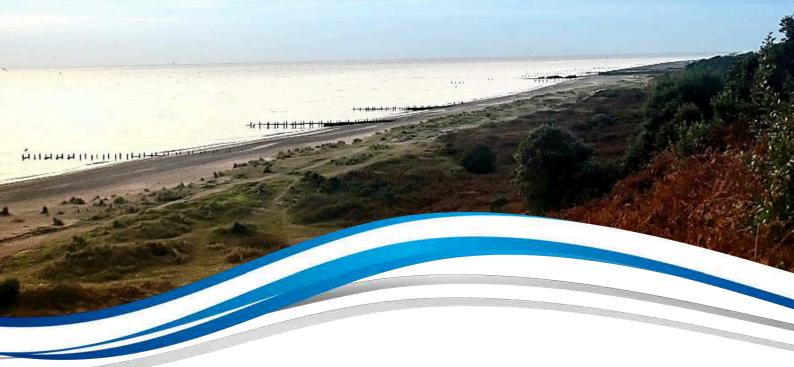
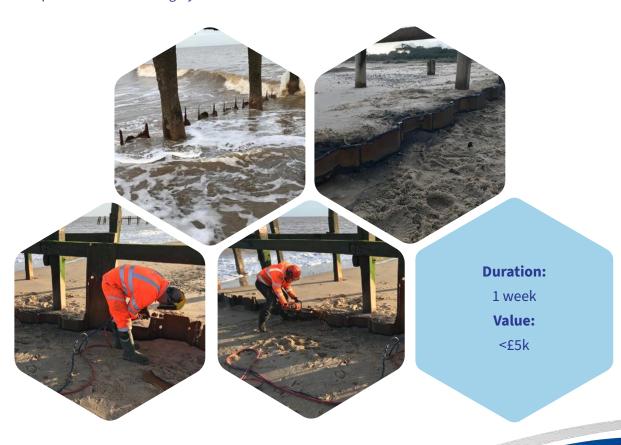
## **Gunton Steel Groyne Safety Repairs**

Following a health and safety inspection our client identified sharp sections of steel, which needed to be made safe. Our team quickly attended site with mobile plant and cutting equipment, removing and making safe the areas required.

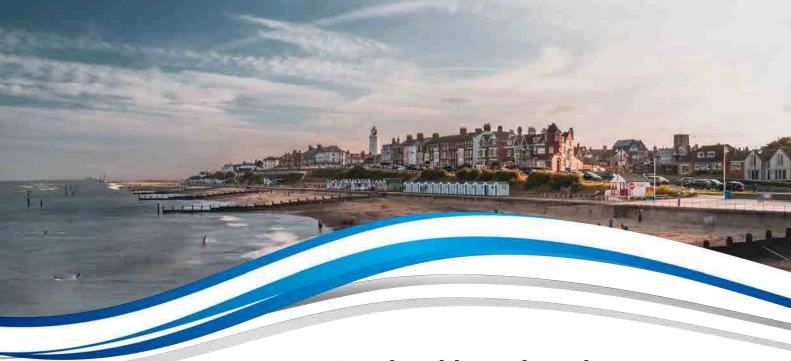
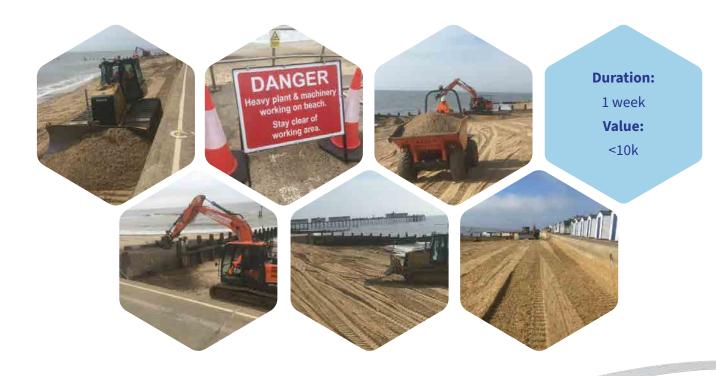
## **Southwold Beach Recharge**

After storm and erosion damage had stripped material from Southwold beach, an unprotected large drop from the promenade had formed. The WMA team were tasked with reprofiling the beach, in order to level to remove this risk.

Using a variety of plant our team developed a safe working method, which allowed the works to happen without closing large areas of public access.

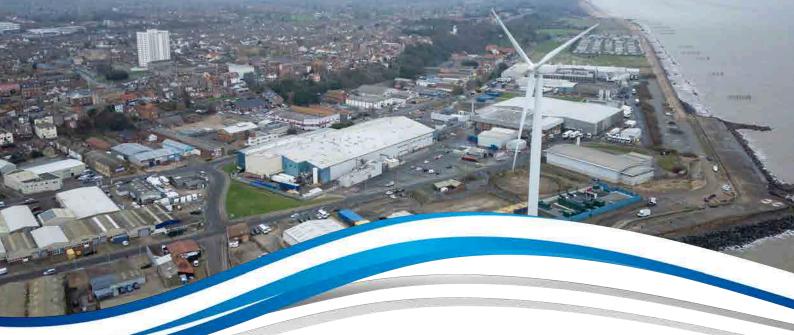
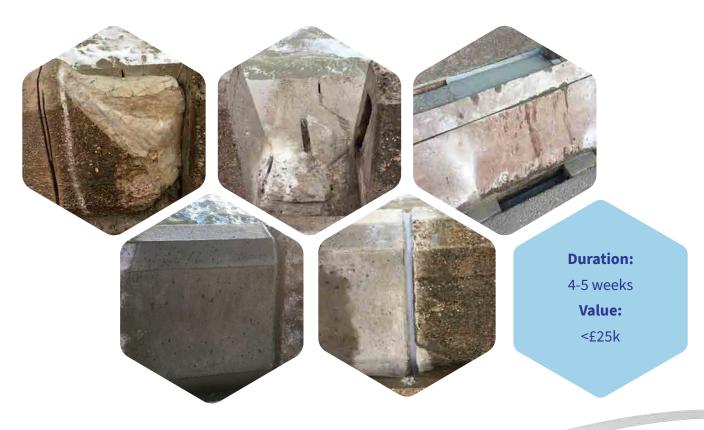
# North Denes and Silver Rail Floodwall and Promenade

On the North Denes and Silver Rail Floodwall and Promenade, Lowestoft, the WMA team has undertaken numerous concrete sea wall and slab repairs. The most recent work carried out by our team has reinforced the structural integrity of the floodwall, while enhancing the durability of the promenade. These improvements not only strengthen coastal defences, but also contribute to the overall safety and accessibility of the space for both residents and visitors alike.

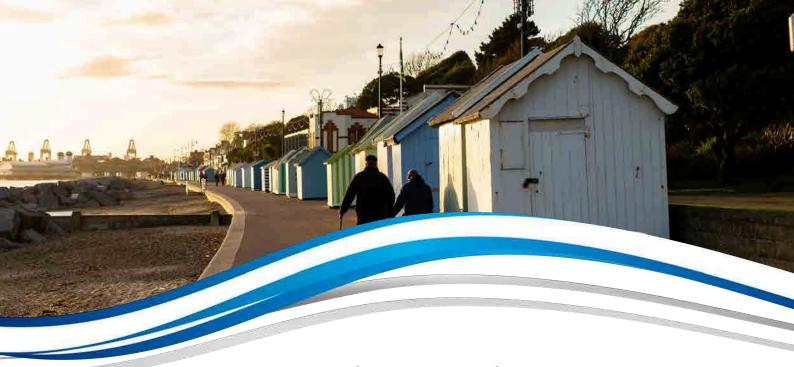
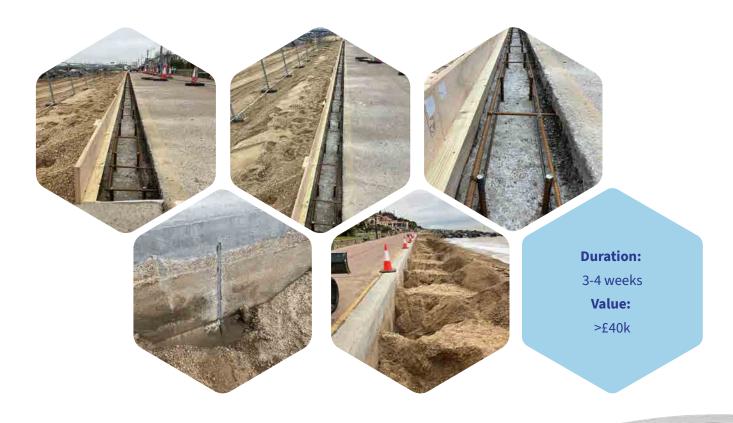
# **Felixstowe Coping Stones**

At Felixstowe, the WMA team carried out essential maintenance on the coping stones by re-bedding and replacing them where necessary. In cases where replacement was not feasible, we installed concrete capping as a durable alternative. These repairs help maintain the structural integrity of the sea defences, while ensuring long-term resilience against coastal conditions.

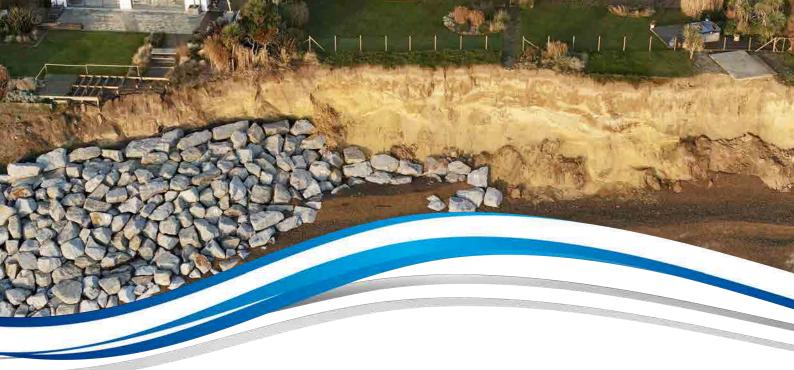
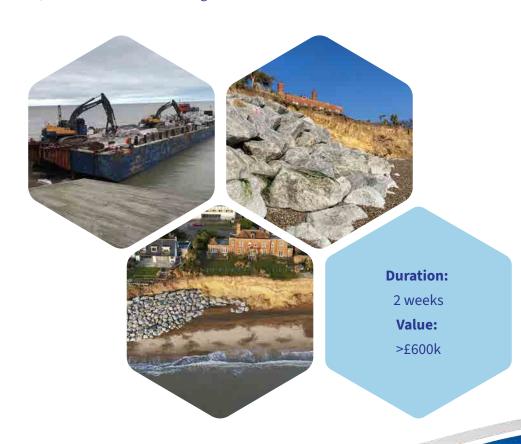
## **Thorpeness Rock Revetment (Private Project)**

The coastal village of Thorpeness is threatened by erosion and storms, causing damage to properties and infrastructure. In February 2021, WMA Engineers worked with a private landowner to address the severe risk of cliff top failure and property loss. We designed an emergency stabilisation scheme with East Suffolk Council to mitigate immediate damage and we acted as principle contractor to construct the design; a substantial rock armor revetment, within a two week working window.
