Pevensy, Cuckmere and Combe Haven Winter 2022/23 Flood Review

Final Report

**Pevensy and Cuckmere Water Level
Management Board**

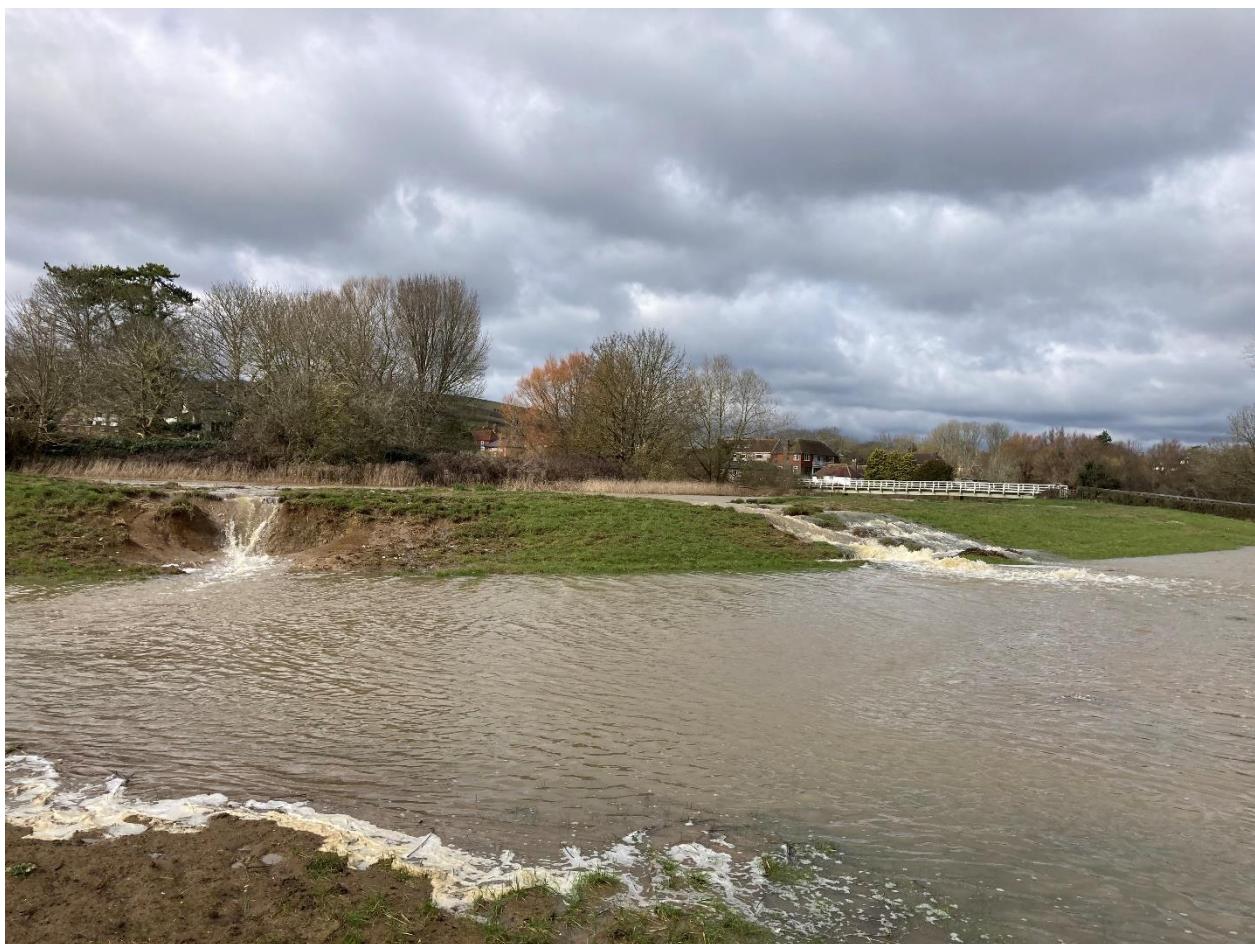
Reports of flooding from the River Cuckmere and Wick Stream noted the presence of debris in the river, which prevented the river from draining effectively. Debris was also reportedly transported across the floodplain by floodwaters, knocking over fences within its path.

Figure 6-3: Overtopping of the River Cuckmere at eroded sections of embankment (credit: PCWLMB).

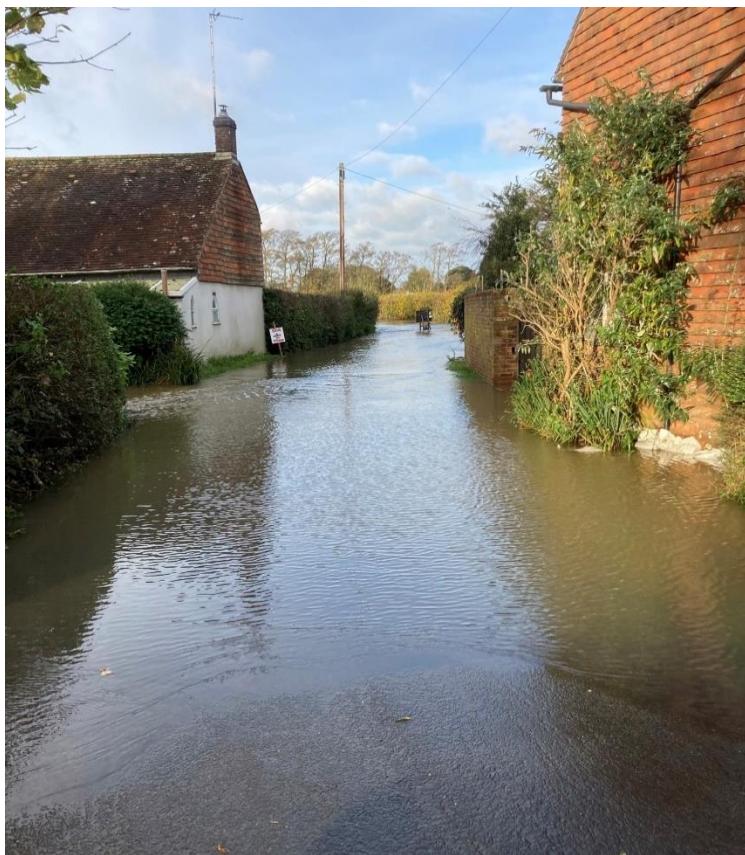
Figure 6-4: Flooding from the River Cuckmere and Bull River in Hellings.

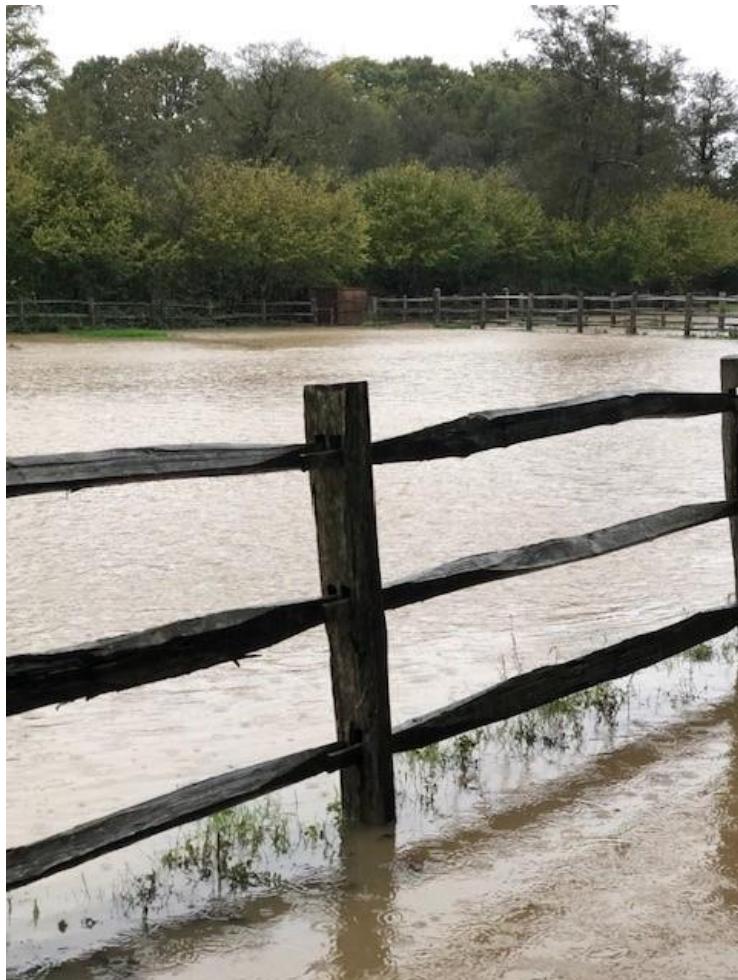
The flooding resulted in damage to grassland, as well as damage to stock fences by debris transported in floodwater, and rapid deterioration of fences submerged in floodwater.

Figure 6-5: Flooding to grazing land in Chiddingly (date not specified)

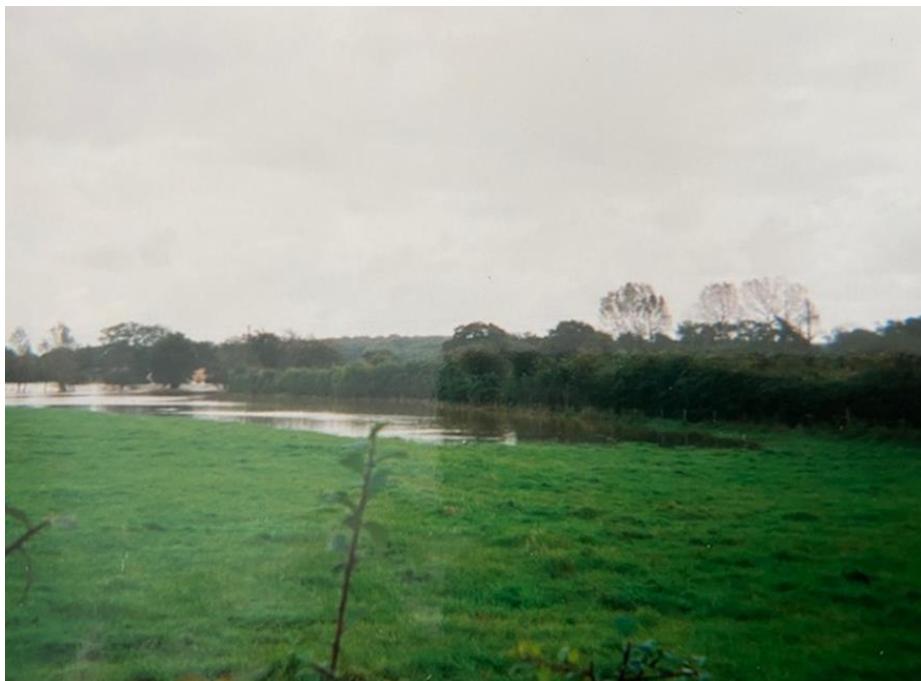
Figure 6-6: Flooding to grazing land in Upper Dicker (date not specified)

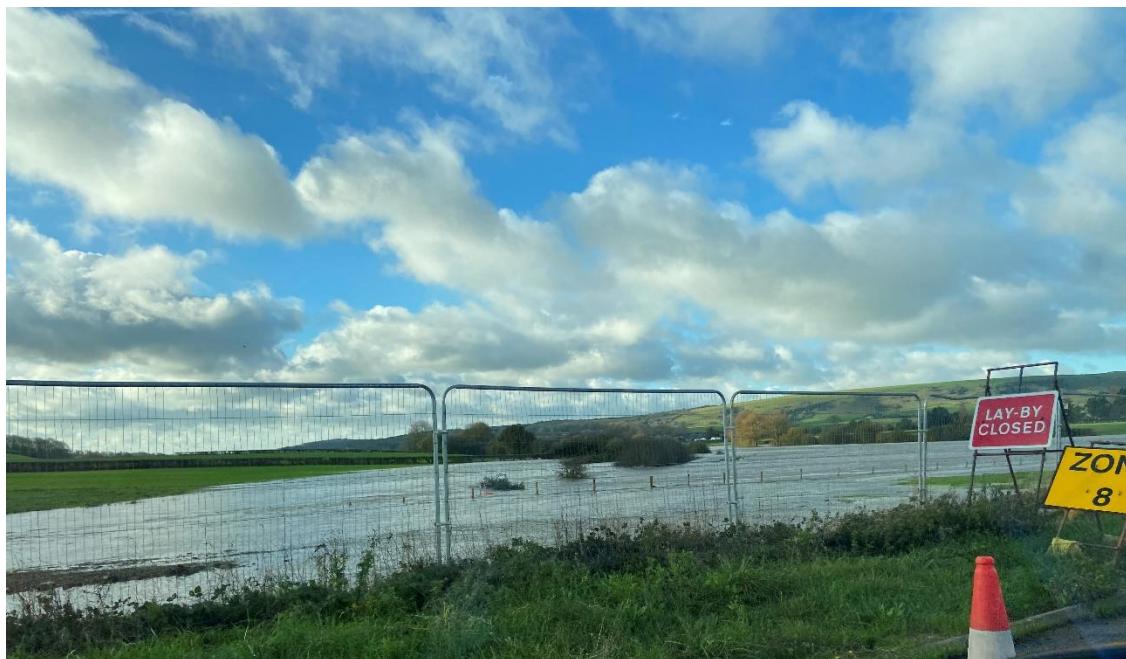
- 17 November 2022 (09:00 to 21:00) - Flooding of A27 where it crosses the River Cuckmere (between Berwick and Wilmington) (see Figure 6-7 and Figure 6-8)
 - Reports of standing water on agricultural land and eastbound carriageway, extending 200m. Road remained open. Cause reported to be flooding from River Cuckmere, and surcharging of surface water drainage system due to surcharged outfalls.
- 23 December 2022 (14:00) - Berwick, at junction between A27 and the village, extending 20m. Surface water flooding to the carriageway.

Figure 6-7: Flooding to agricultural land by A27 between Berwick and Wilmington on 17

November 2022 (credit: National Highways)

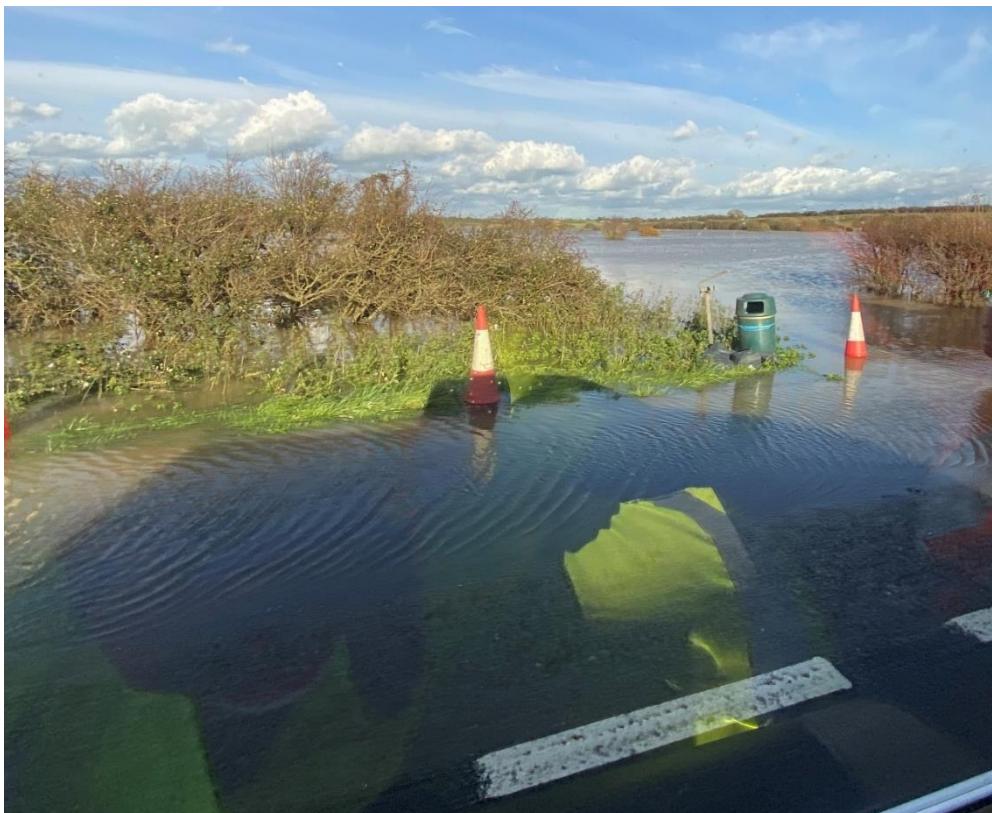
Figure 6-8: Flooding to layby of A27 between Berwick and Wilmington on 17

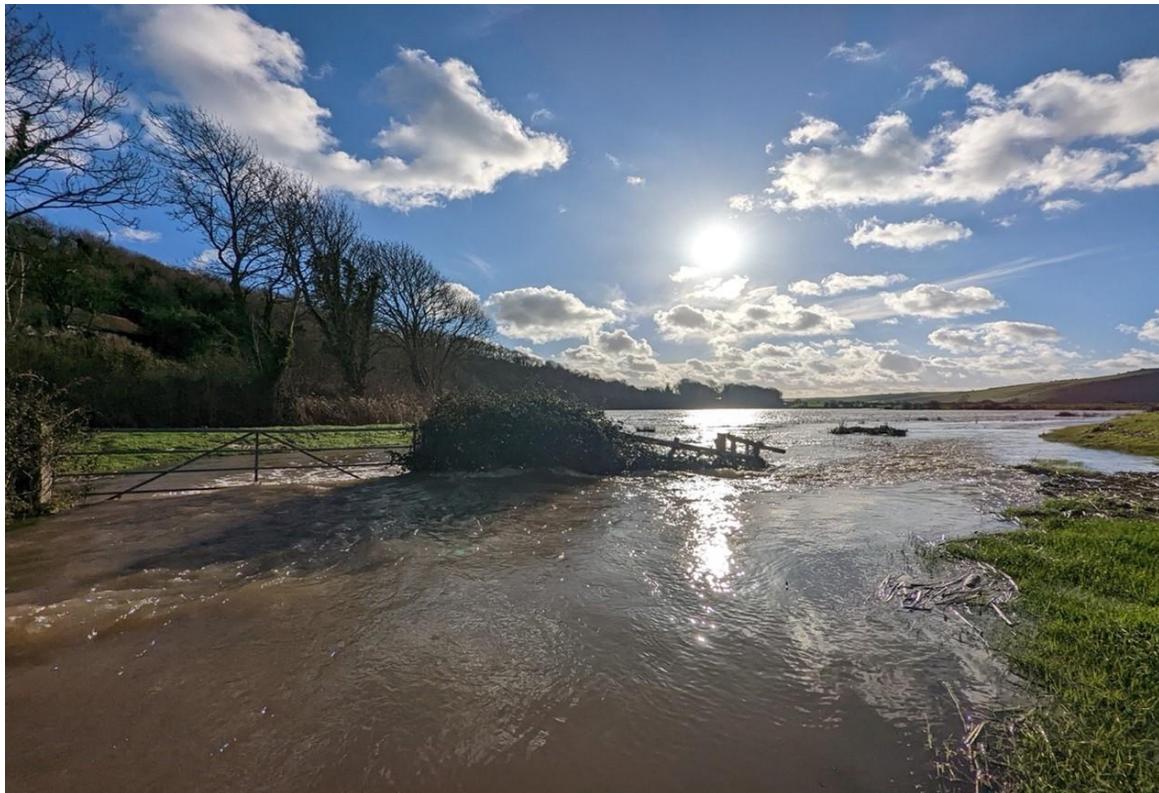
Figure 6-9: Flooding around Litlington on 17 November 2022 (credit: Dave Boddington)

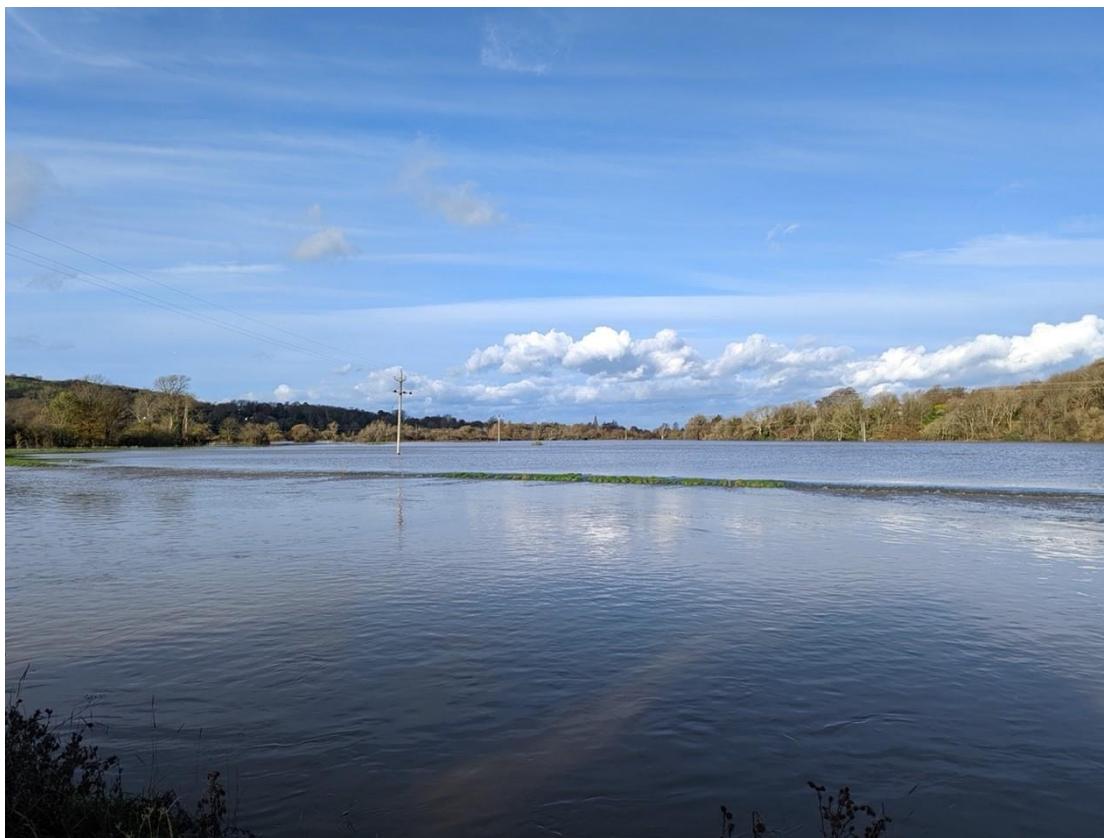
Figure 6-10: Flooding at Litlington looking towards Alfriston on 17 November 2022 (credit: Dave Boddington)

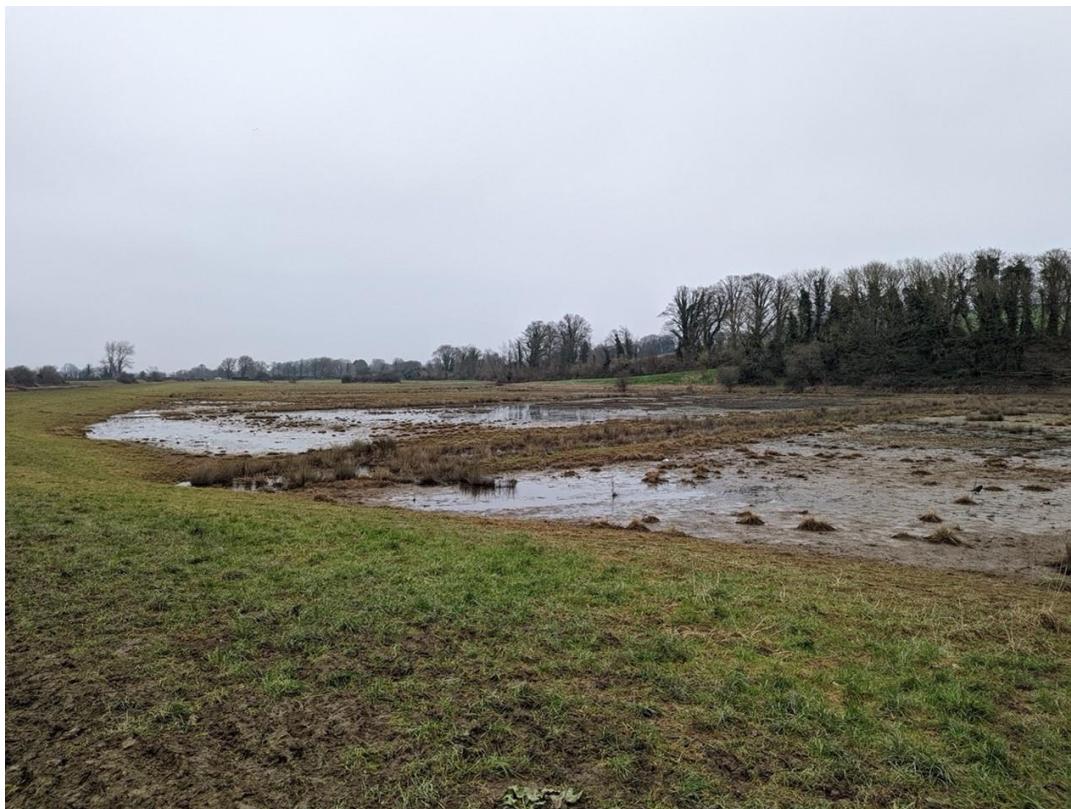
Figure 6-11: Less extensive flooding on eastern bank of Cuckmere, north of Alfriston, on 25 January 2023 (credit: Dave Boddington)

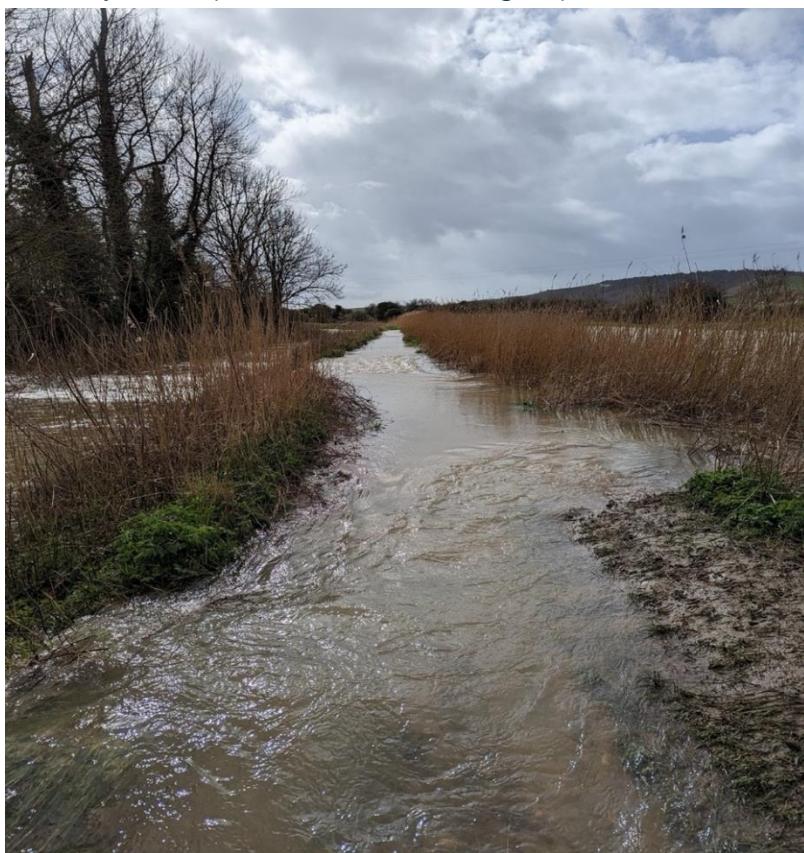
Figure 6-12: Flooding from River Cuckmere at Litlington footbridge on 21 March 2023 (credit: Dave Boddington)

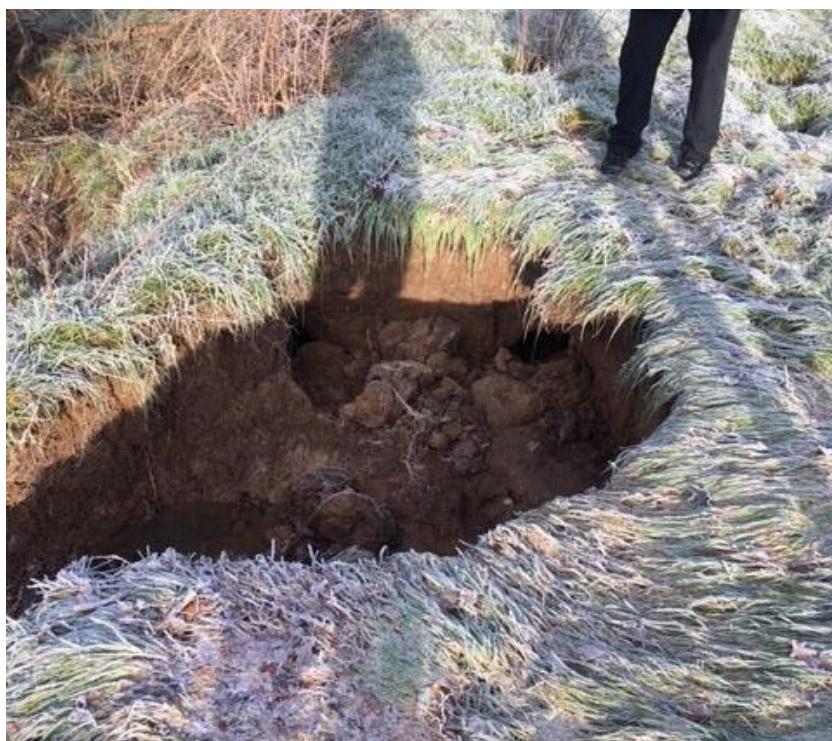
Figure 6-15: Damage to banks on Moorhall Stream (credit: PCWLMB).

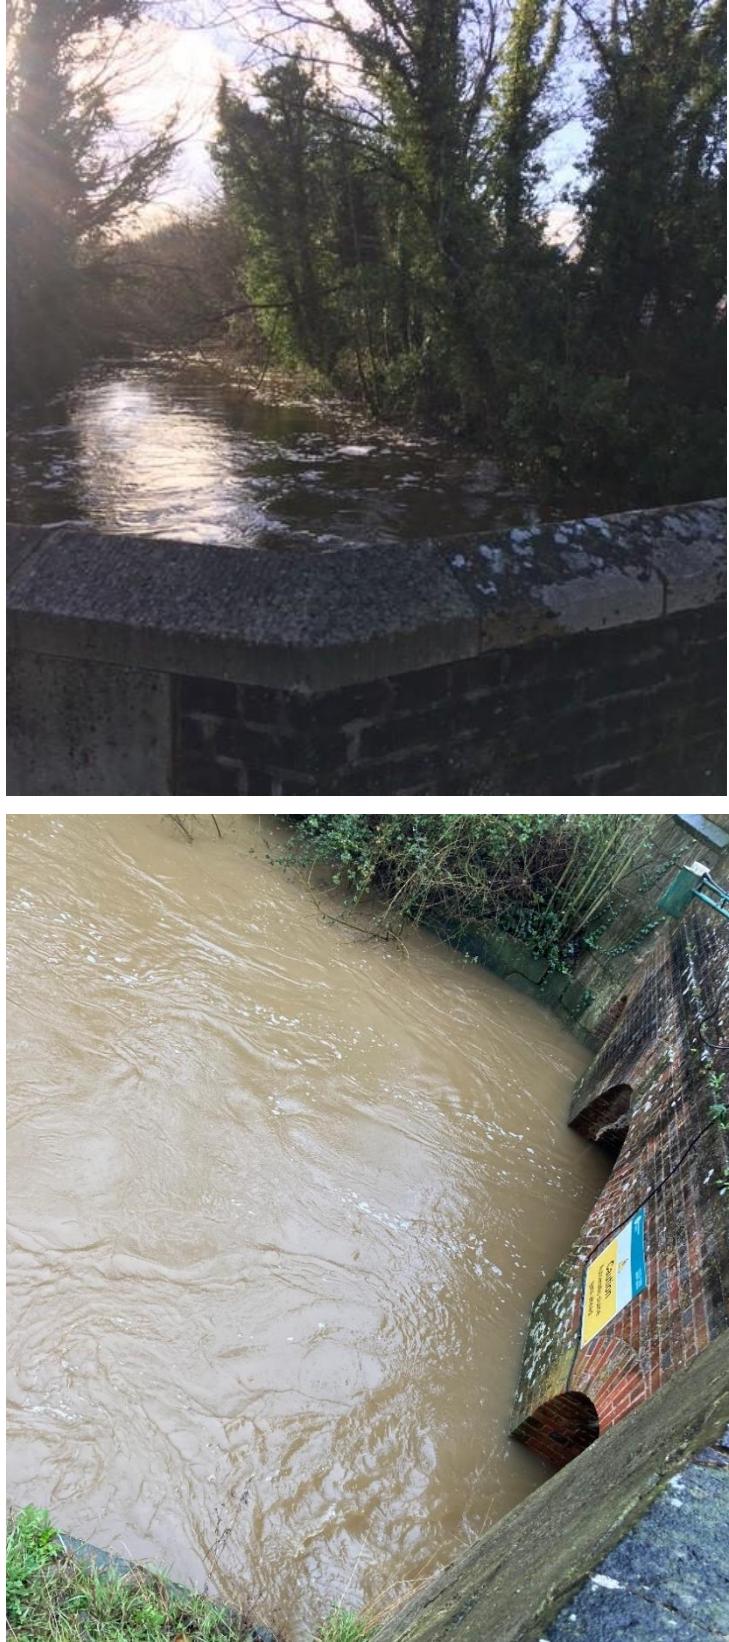
Figure 6-16: Water levels upstream of Pevensey Bridge gates during Winter 2022 - 2023 (credit: PCWLMB).

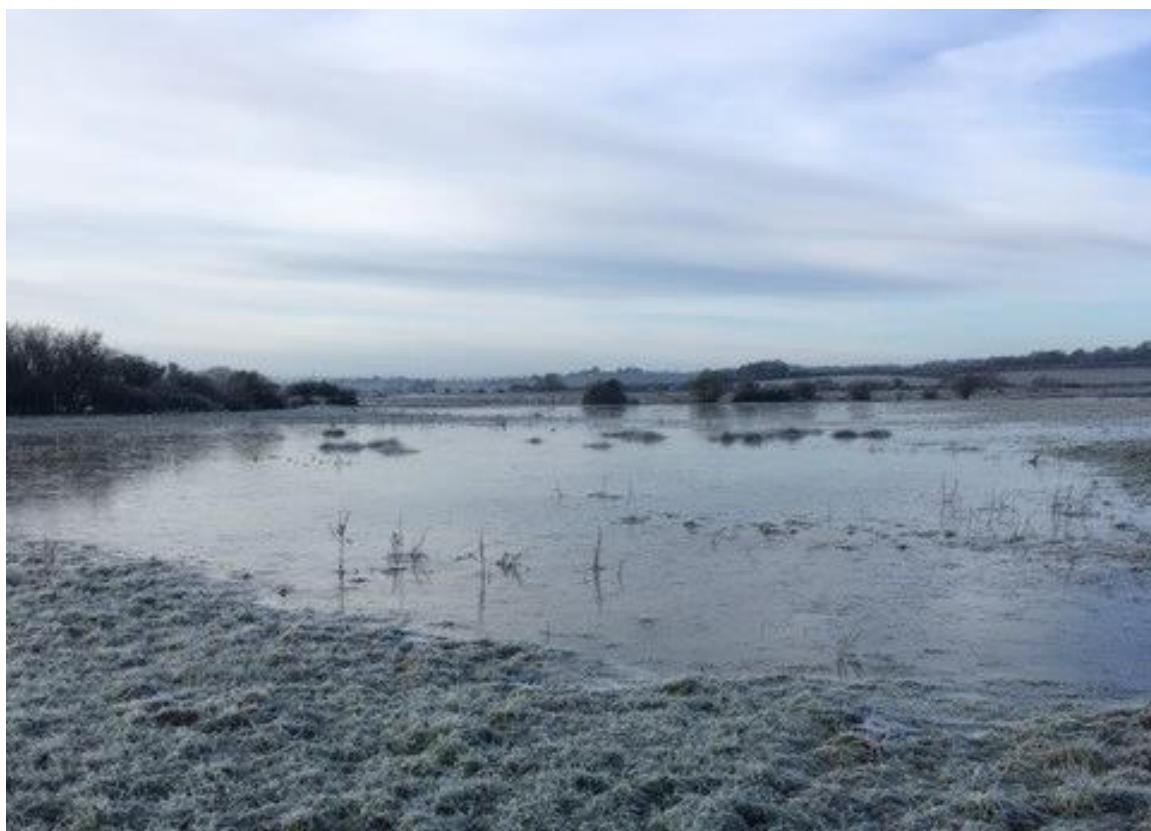
Figure 6-17: Flooding to land from Moorhall Stream on 19 January 2023 (credit: PCWLMB).

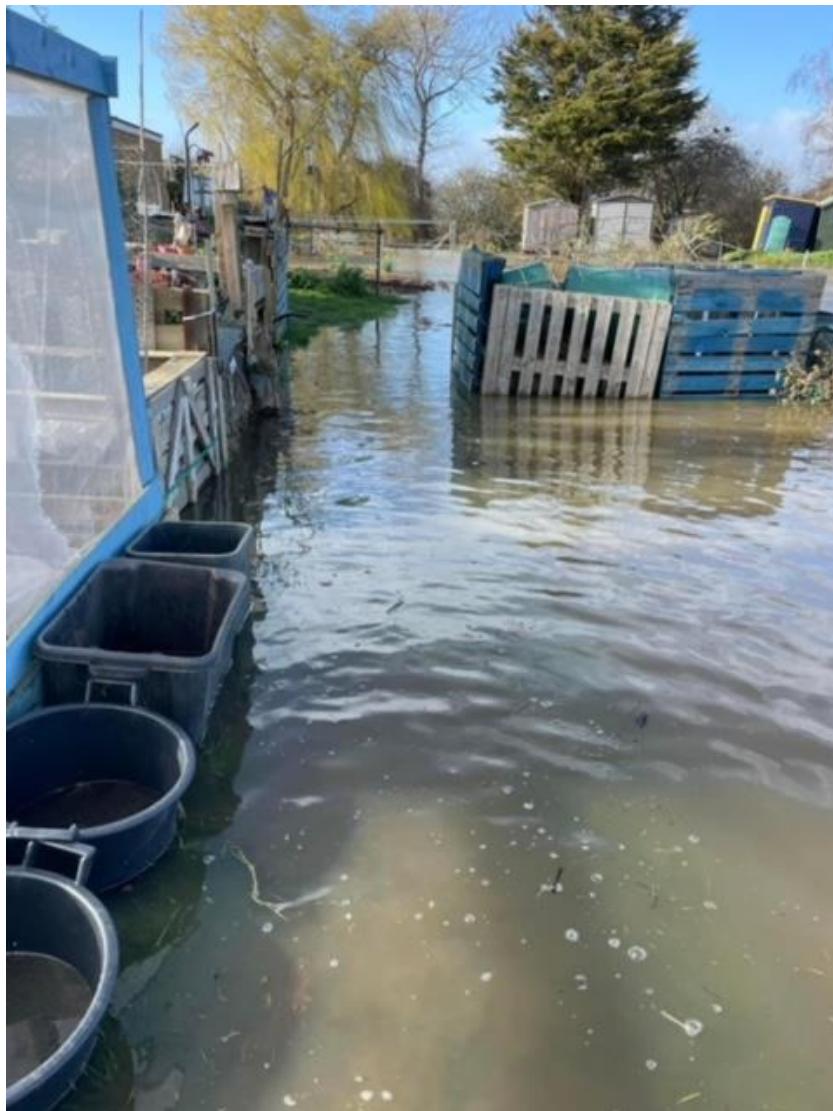
Figure 6-18: Flooding of allotments at Waverley Gardens, Pevensey (Credit: Pevensey Parish Council)

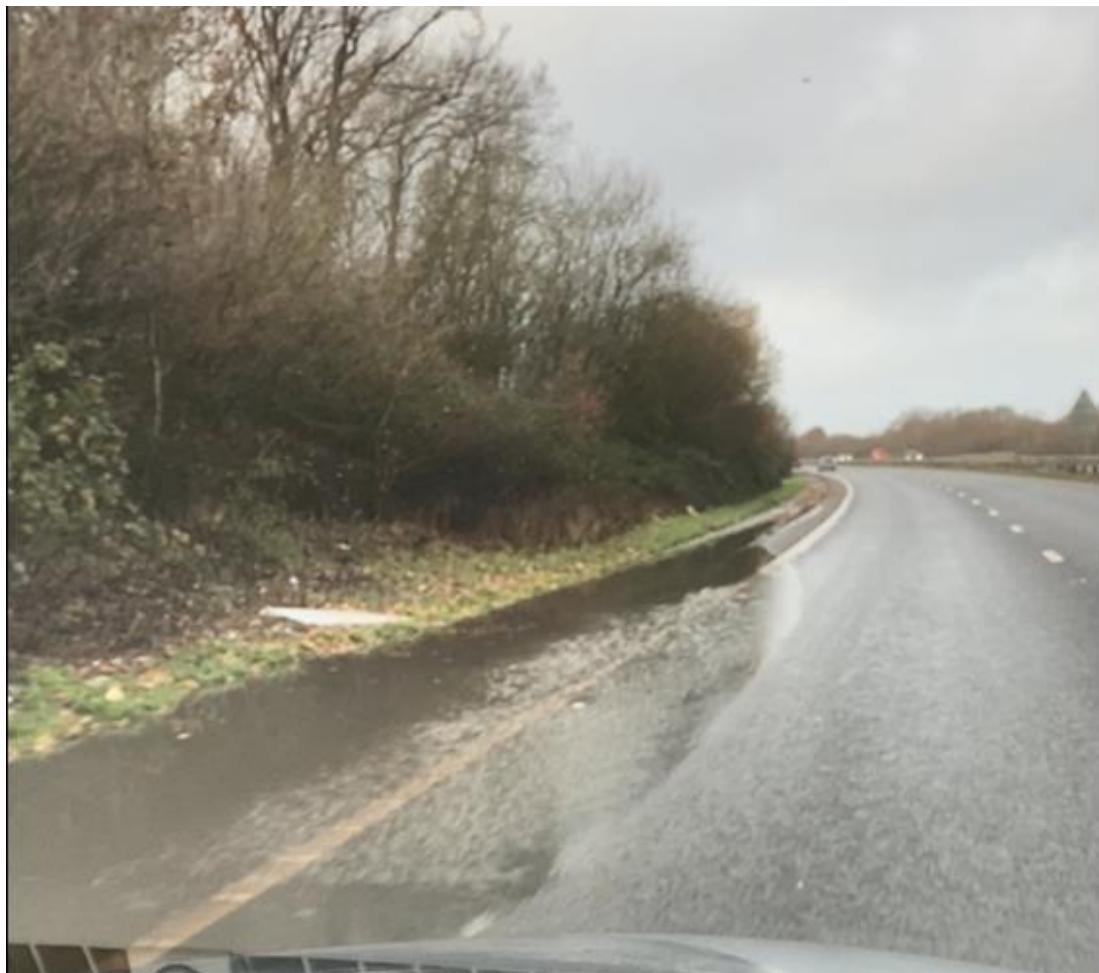
Figure 6-19: Flooding to carriageway on A27 Polegate Bypass (westbound) on 23 December 2022 (credit: National Highways)

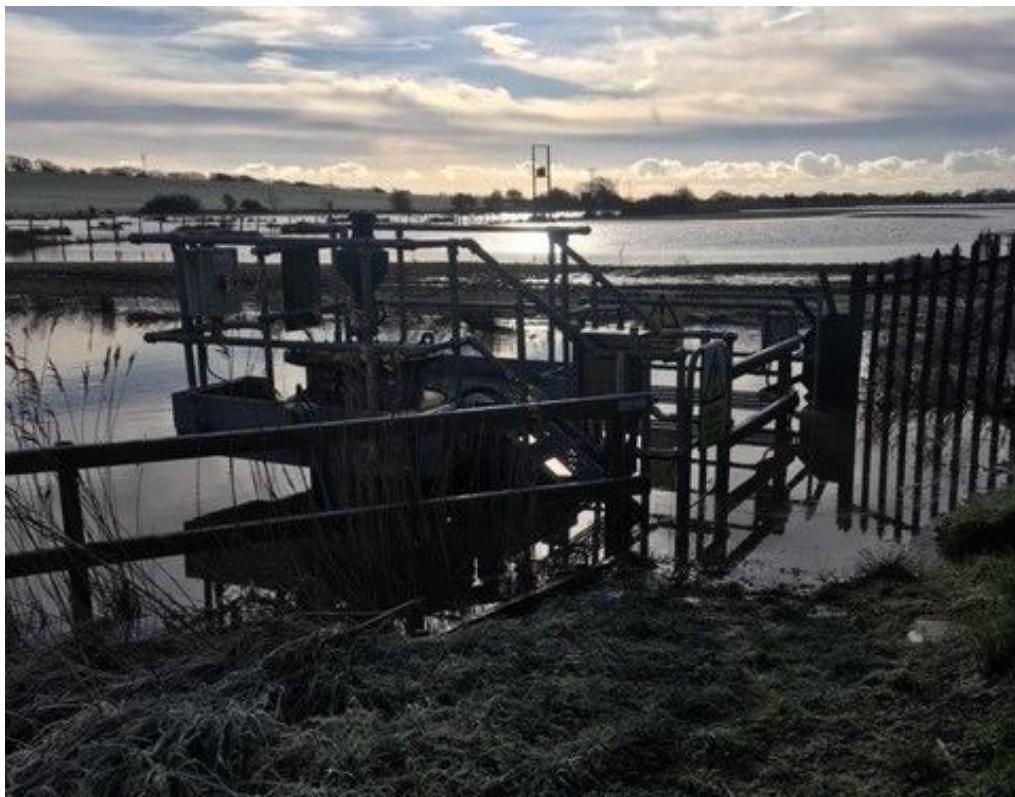
Figure 6-21: River levels at Horsebridge Pumping Station on 17 January 2023 (credit: PCWLMB).

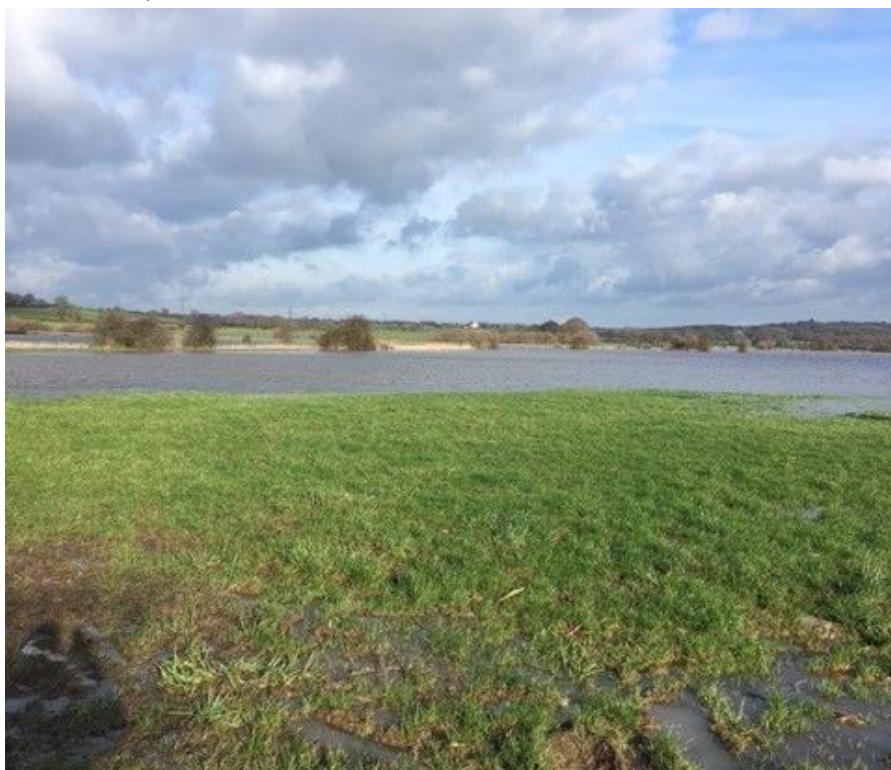
Figure 6-22: Flooding near Barnhorn Pumping Station on 16 January 2023 (credit: PCWLMB)

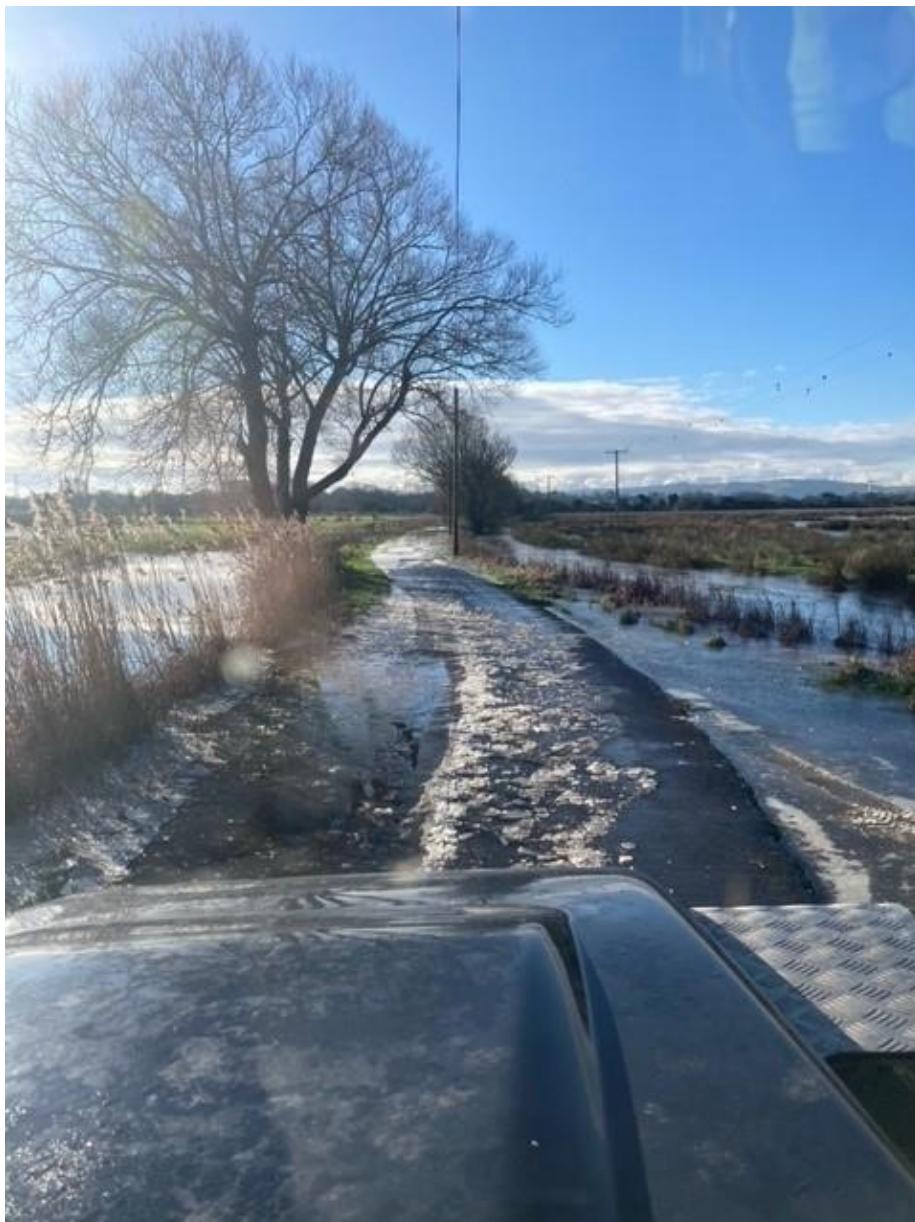
Flooding to access roads on private land was also reported to cause issues, with further hazard was introduced when the floodwaters froze, as occurred at Rickney Road, Hailsham (Figure 6-23).

Figure 6-23: Frozen flooded farm access track at Rickney Road, Hailsham (date not specified)

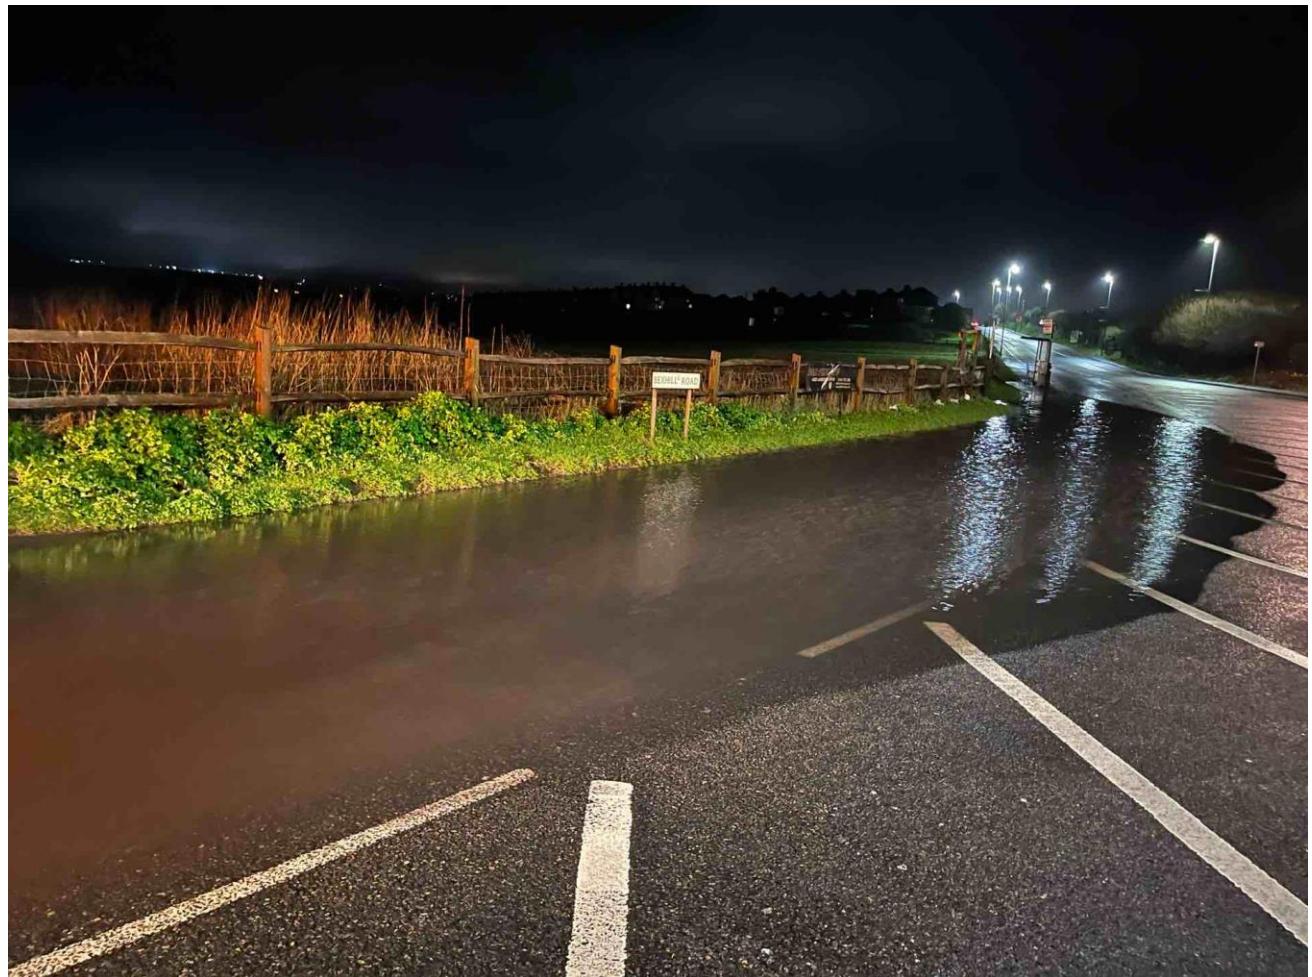
Figure 6-24: Flooding to carriageway on A259 at Glyne Gap on 23 March 2023 (credit: National Highways)
