**ECOLOGICAL SURVEYS IN THE CUCKMERE VALLEY  
OVERARCHING REPORT**

**Report to the  
Pevensey and Cuckmere  
Water Level Management Board**

**NOVEMBER 2023**

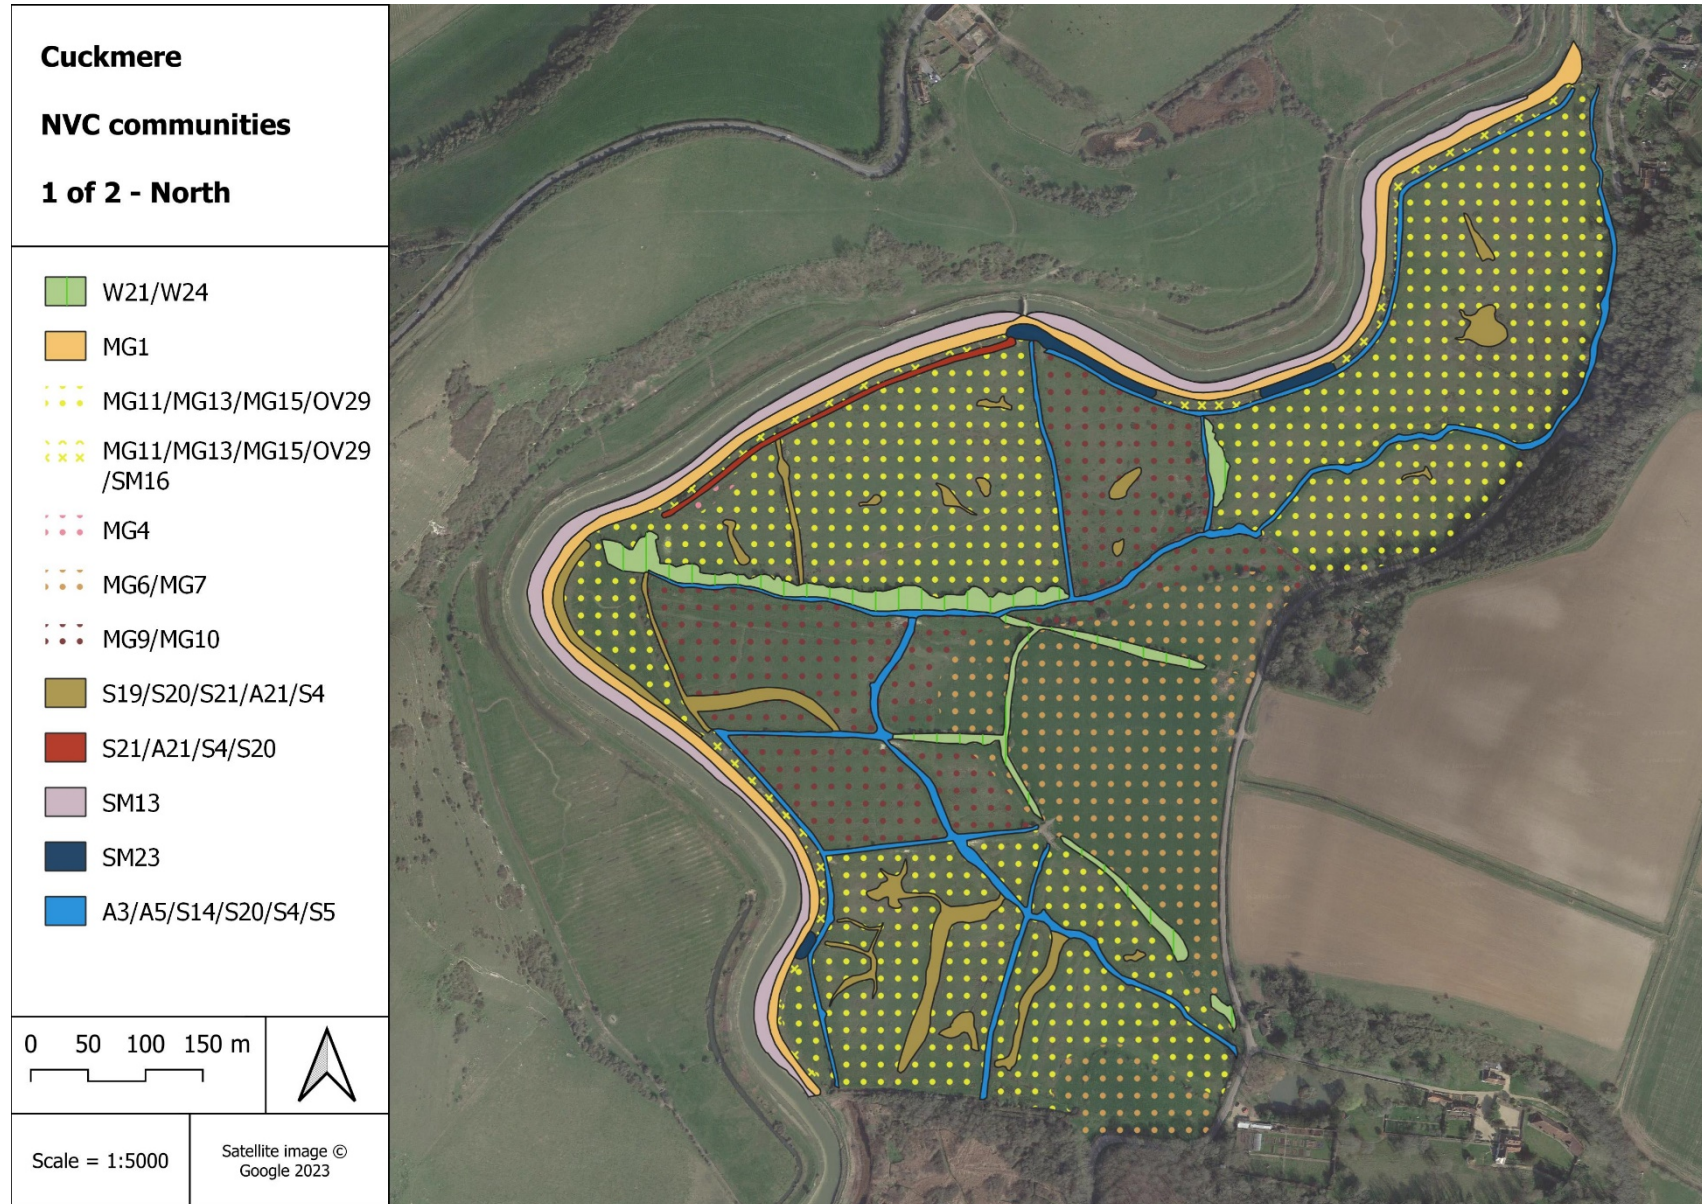
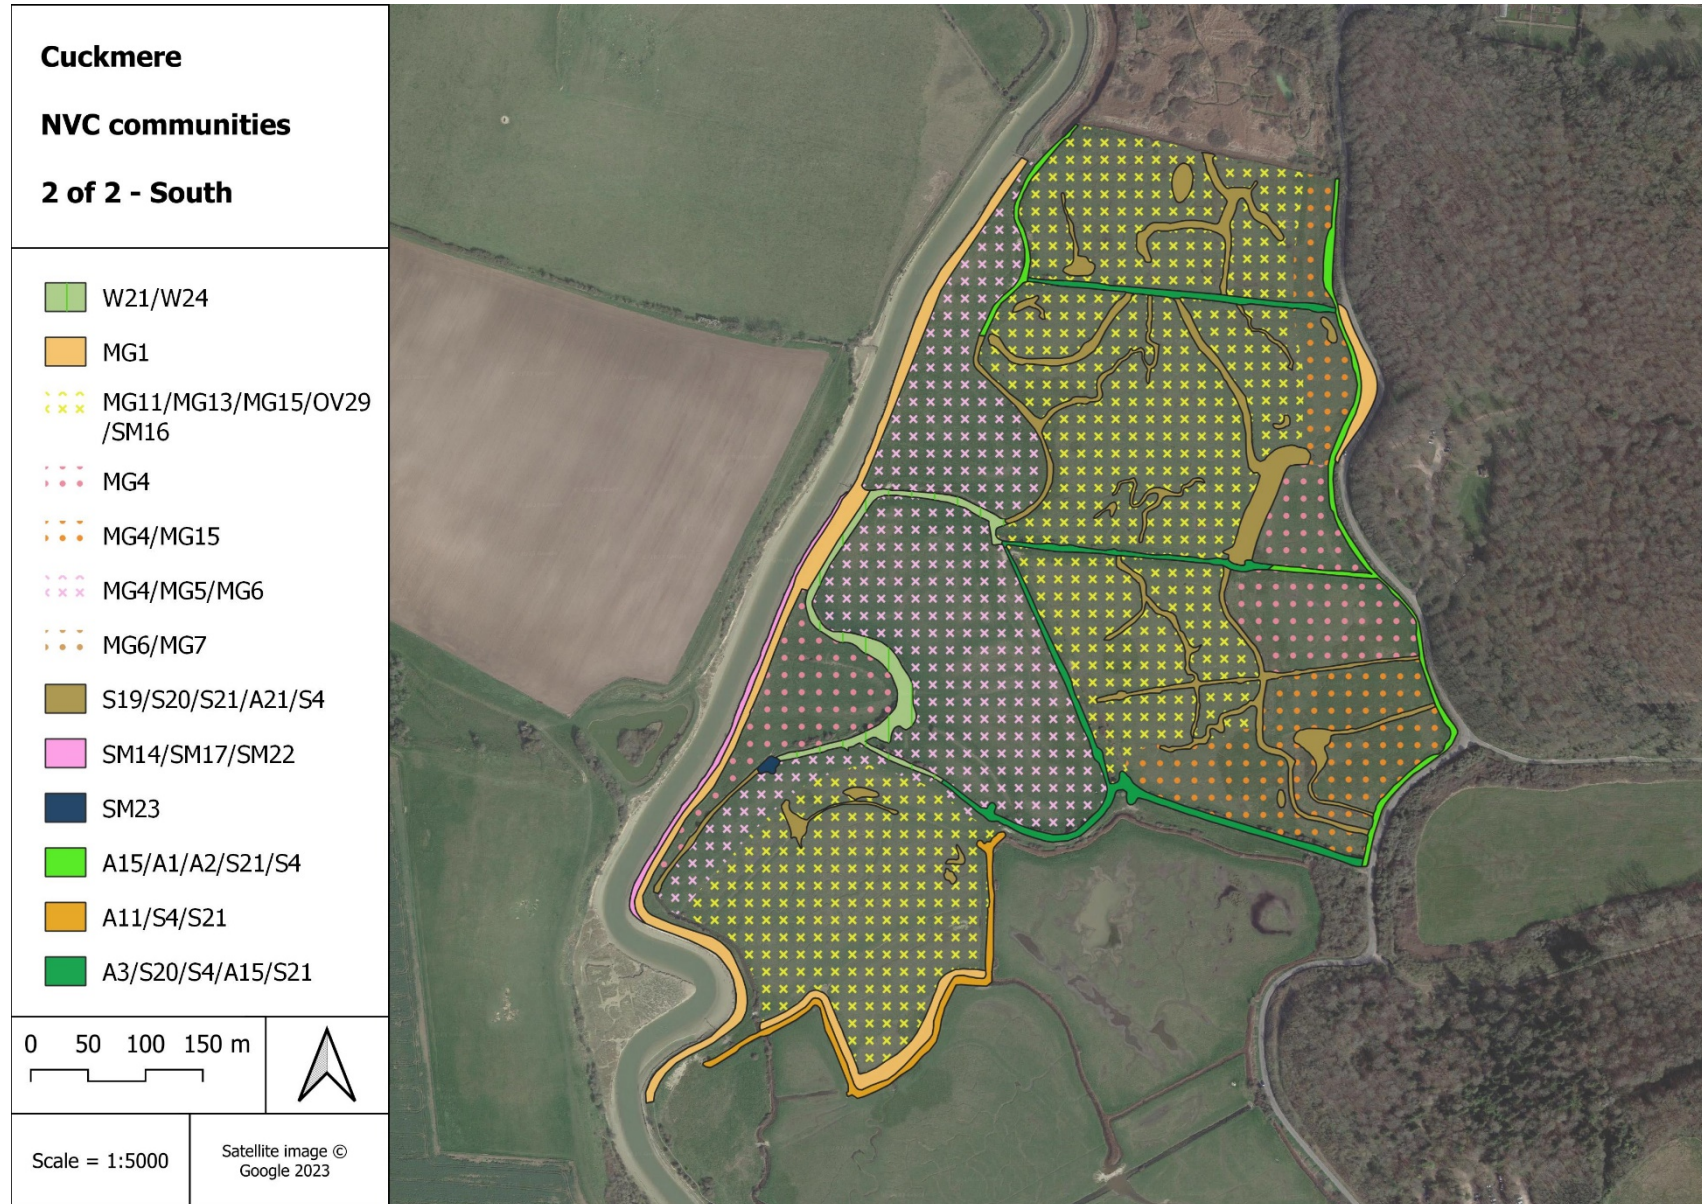
**FIGURE 2: NVC MAPS****Key**

<b>Description</b>	<b>Constituent NVC Communities</b>
Rank dry grassland, sea bank and banks of Freshwater Drain	MG1 <i>Arrhenatherum elatius</i> grassland
Rank grassland on damp soils	MG9 <i>Deschampsia cespitosa</i> - <i>Holcus lanatus</i> grassland / MG10 <i>Deschampsia cespitosa</i> - <i>Holcus lanatus</i> grassland
Semi-improved / improved grassland on free draining soils	MG6 <i>Lolium perenne</i> - <i>Cynosurus cristatus</i> grassland / MG7 <i>Lolium perenne</i> - <i>Trifolium repens</i> ley
Unimproved to semi-improved grassland on free-draining soils	MG4 <i>Alopecurus pratensis</i> - <i>Sanguisorba officinalis</i> flood meadow / MG5 <i>Centaurea nigra</i> - <i>Cynosurus cristatus</i> grassland / MG6 <i>Lolium perenne</i> - <i>Cynosurus cristatus</i> grassland
Unimproved, species-rich grassland on occasionally inundated free-draining soils	MG4 <i>Alopecurus pratensis</i> - <i>Sanguisorba officinalis</i> flood meadow

Unimproved, moderately species-rich grassland on land with more prolonged inundation, but free-draining soils	MG4 <i>Alopecurus pratensis</i> - <i>Sanguisorba officinalis</i> flood meadow / MG15 <i>Alopecurus pratensis</i> - <i>Poa trivialis</i> - <i>Cardamine pratensis</i> grassland
Species-poor alluvial grassland, frequently inundated, mostly freshwater, remaining wet for prolonged periods	MG11 <i>Festuca rubra</i> - <i>Agrostis stolonifera</i> - <i>Potentilla anserina</i> grassland / MG13 <i>Agrostis stolonifera</i> - <i>Alopecurus geniculatus</i> grassland / MG15 <i>Alopecurus pratensis</i> - <i>Poa trivialis</i> - <i>Cardamine pratensis</i> grassland / OV29 <i>Alopecurus geniculatus</i> - <i>Rorippa palustris</i> community
Species-poor alluvial grassland, frequently inundated, brackish, remaining wet for prolonged periods	MG 11 <i>Festuca rubra</i> - <i>Agrostis stolonifera</i> - <i>Potentilla anserina</i> grassland / MG13 <i>Agrostis stolonifera</i> - <i>Alopecurus geniculatus</i> grassland / MG15 <i>Alopecurus pratensis</i> - <i>Poa trivialis</i> - <i>Cardamine pratensis</i> grassland / OV29 <i>Alopecurus geniculatus</i> - <i>Rorippa palustris</i> community / SM16 <i>Juncus gerardii</i> saltmarsh

Deep brackish watercourse	A11 <i>Potamogeton pectinatus</i> - <i>Myriophyllum spicatum</i> community / S4 <i>Phragmites australis</i> swamp / S21 <i>Bolboschoenus maritimus</i> swamp

Description	Constituent NVC Communities
Shallow brackish watercourse	<i>S21 Bolboschoenus maritimus</i> swamp / <i>A21 Ranunculus baudotii</i> community / <i>S4 Phragmites australis</i> swamp / <i>S20 Schoenoplectus tabernaemontani</i> swamp
Internal species-rich ditches with brackish influence	<i>A3 Spirodela polyrhiza-Hydrocharis morsus-ranae</i> community / <i>A15 Callitriche</i> agg. community / <i>S20 Schoenoplectus tabernaemontani</i> swamp / <i>S4 Phragmites australis</i> swamp / <i>S21 Bolboschoenus maritimus</i> swamp
Southern saltmarsh	<i>SM14 Atriplex portulacoides</i> community / <i>SM17 Artemisia maritima</i> salt-marsh / <i>SM22 Atriplex portulacoides - Frankenia laevis</i> salt-marsh
Northern saltmarsh	<i>SM13 Puccinellia maritima</i> salt-marsh
Saltmarsh on internal side of sea bank	<i>SM23 Spergularia marina - Puccinellia distans</i> salt-marsh
Dry scrub	<i>W21 Crataegus monogyna - Hedera helix</i> scrub / <i>W24 Rubus fruticosus - Holcus lanatus</i> underscrub

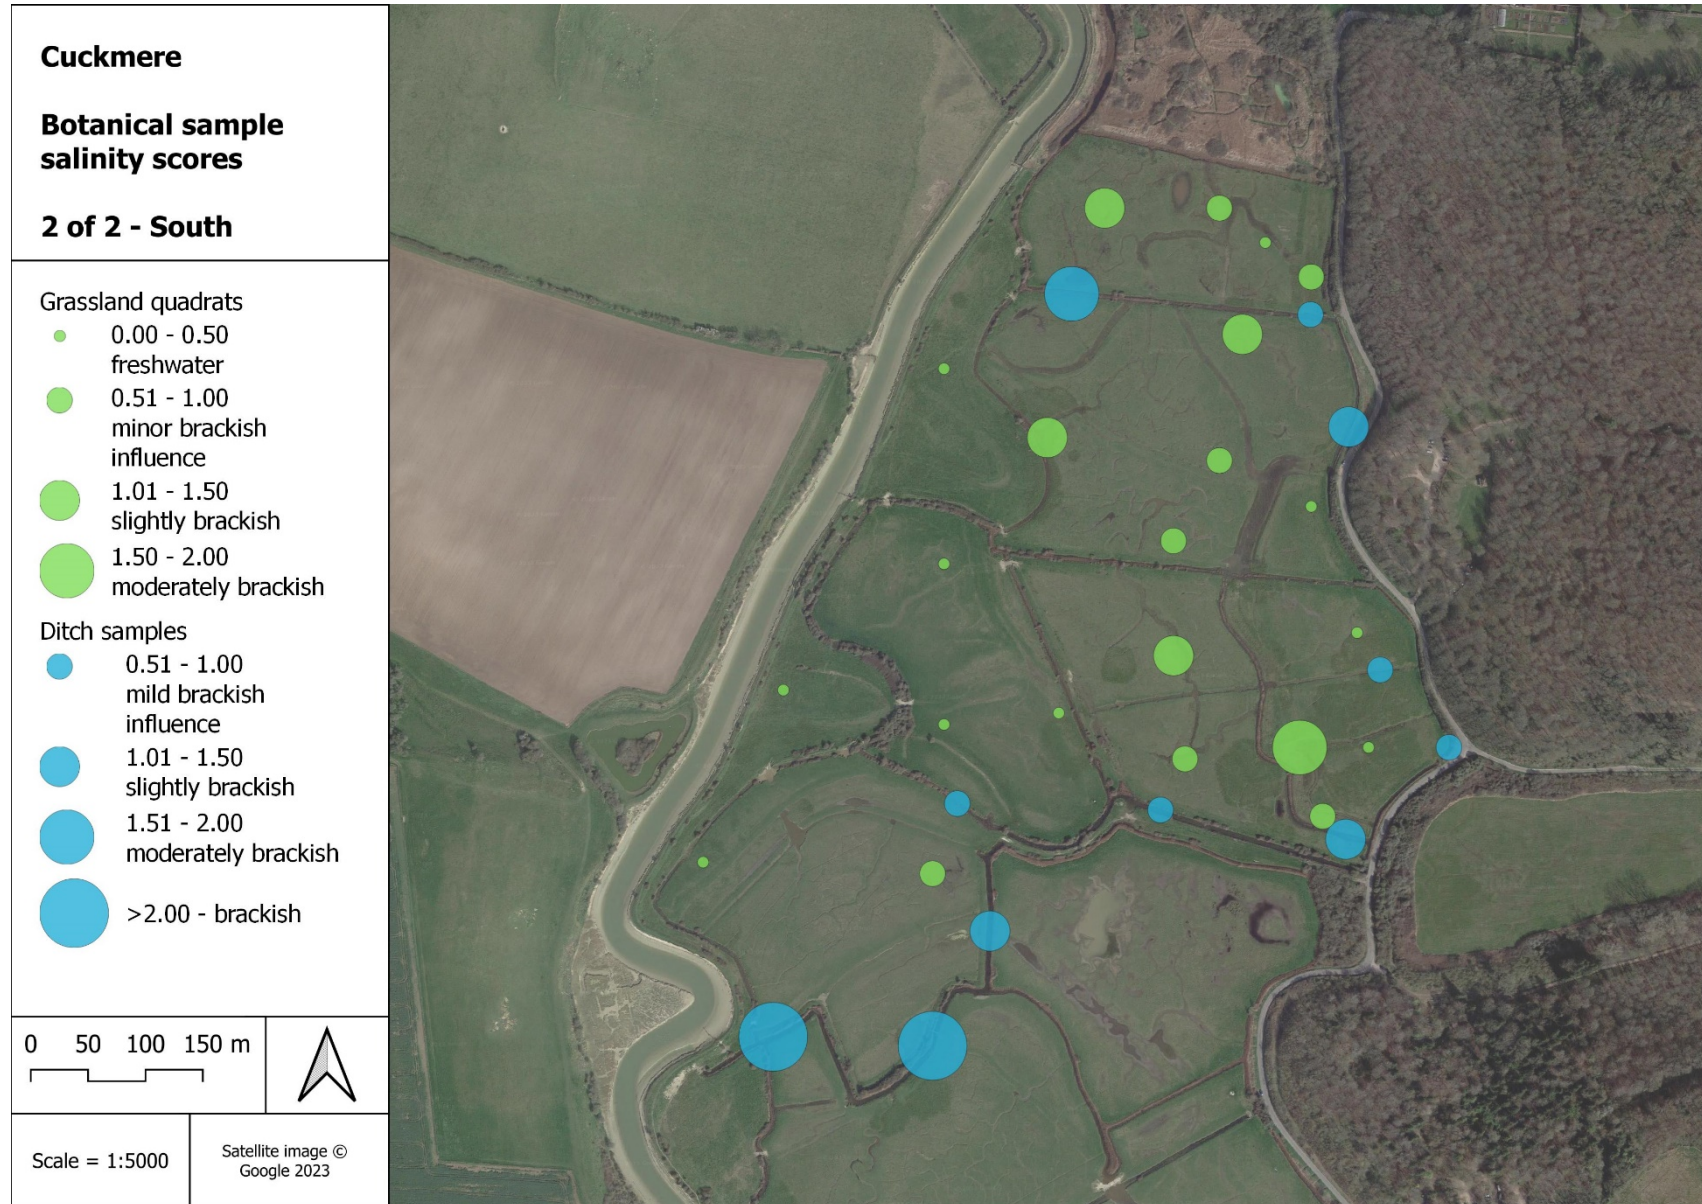
**FIGURE 4: CUCKMERE VALLEY UNIT 6 SALINITIES**

5.3.3 Figure 4 shows the relative salinities of Unit 6. The salinity of the grazing marsh vegetation is most closely related to the micro-topography, with the most strongly brackish vegetation being found in former creeks and pools, and on low-lying ground. The southern part of Unit 6 has a more strongly brackish character than the northern part.

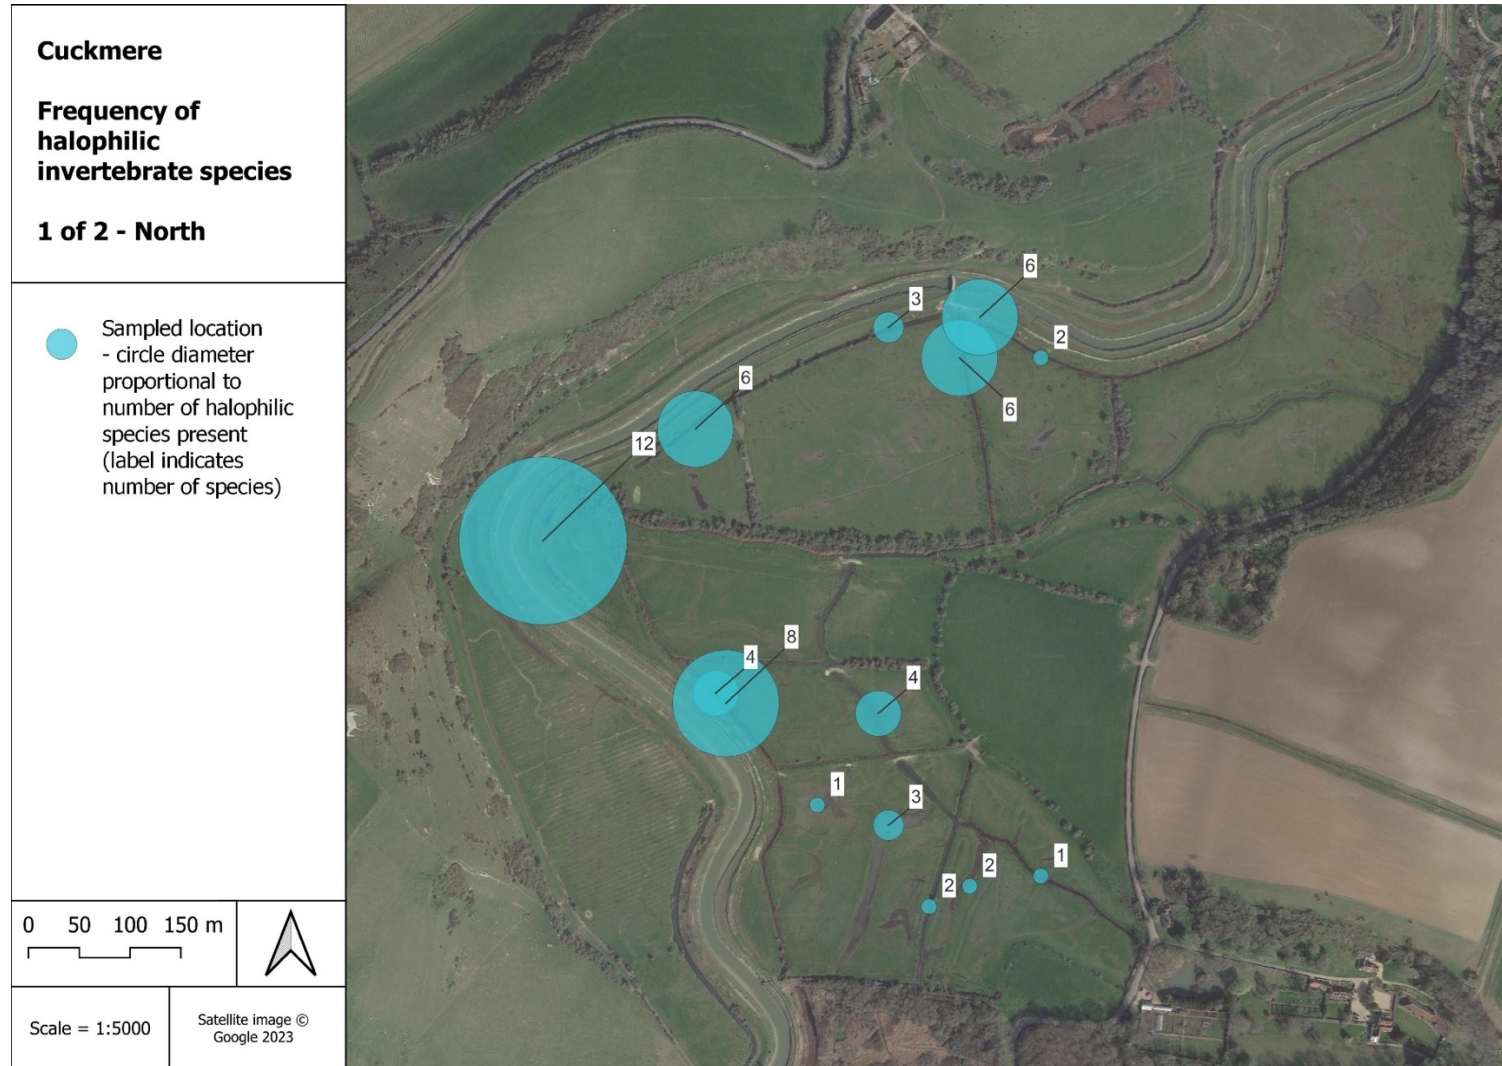
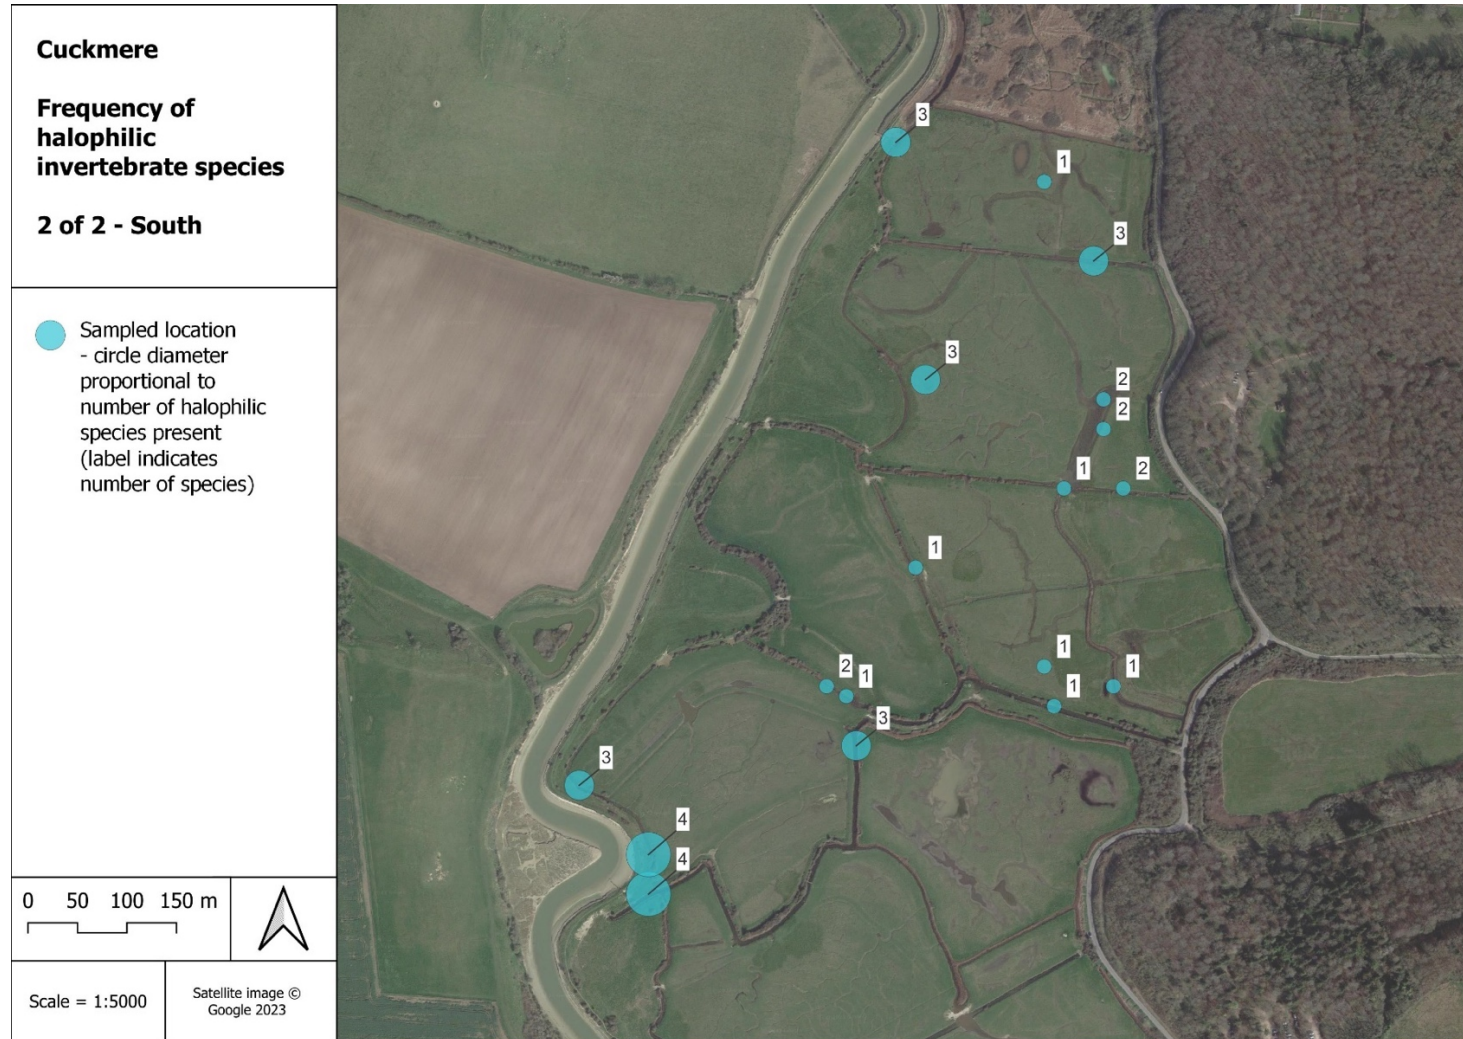
**FIGURE 5: DISTRIBUTION OF HALOPHILIC INVERTEBRATE SPECIES**

6.3.1 Figure 5 shows the distribution of the halophile species as given in the Table 5 below. It is likely that residual salinity in the soil and seepage through, and over topping of, the bank of the Cuckmere River provide a range of moderately to weakly brackish conditions, modified by freshwater input from the Freshwater Stream and rainfall. Thus, there is a dynamic
