River Gaywood – River Restoration and Maintenance Proposal

**Prepared for King’s Lynn Internal Drainage Board by Emily long, MSc,
Norfolk Rivers Trust**

April 2015

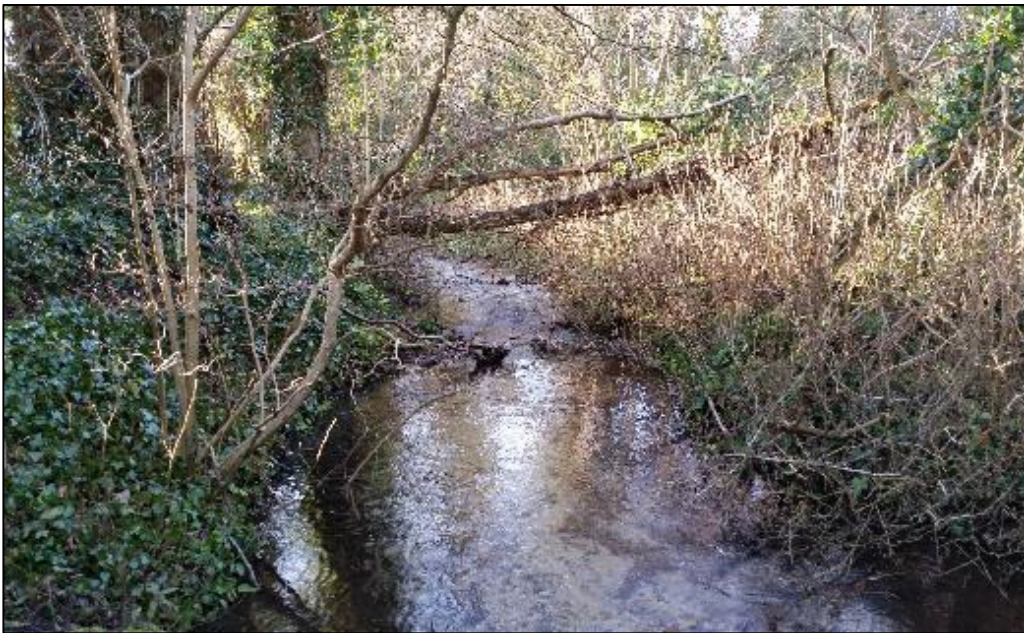
The upper reaches of the River Gaywood show its natural chalk stream character, despite being straightened. The upper sections, below the springs and ornamental lakes of Well Hall show a dynamic stream with gravel bed, photo 1. Bank widths vary dramatically from 2 to 5m wide with variable bank heights of 0.3 – 3m. The top section runs through woodland, before opening out onto arable land, although the river still has a high level of cover through this section. Grazing pastures are seen to the north, right hand bank, at the lower end of the reach. Water depths range from 20cm in the upper reaches to 40cm by Derby fen. Substrate moves from uncovered gravels to a sandier bed moving through the reach.

Photo 1. Upper reaches of the River Gaywood, showing gravel bed and woody debris. Located at the top of the catchment.

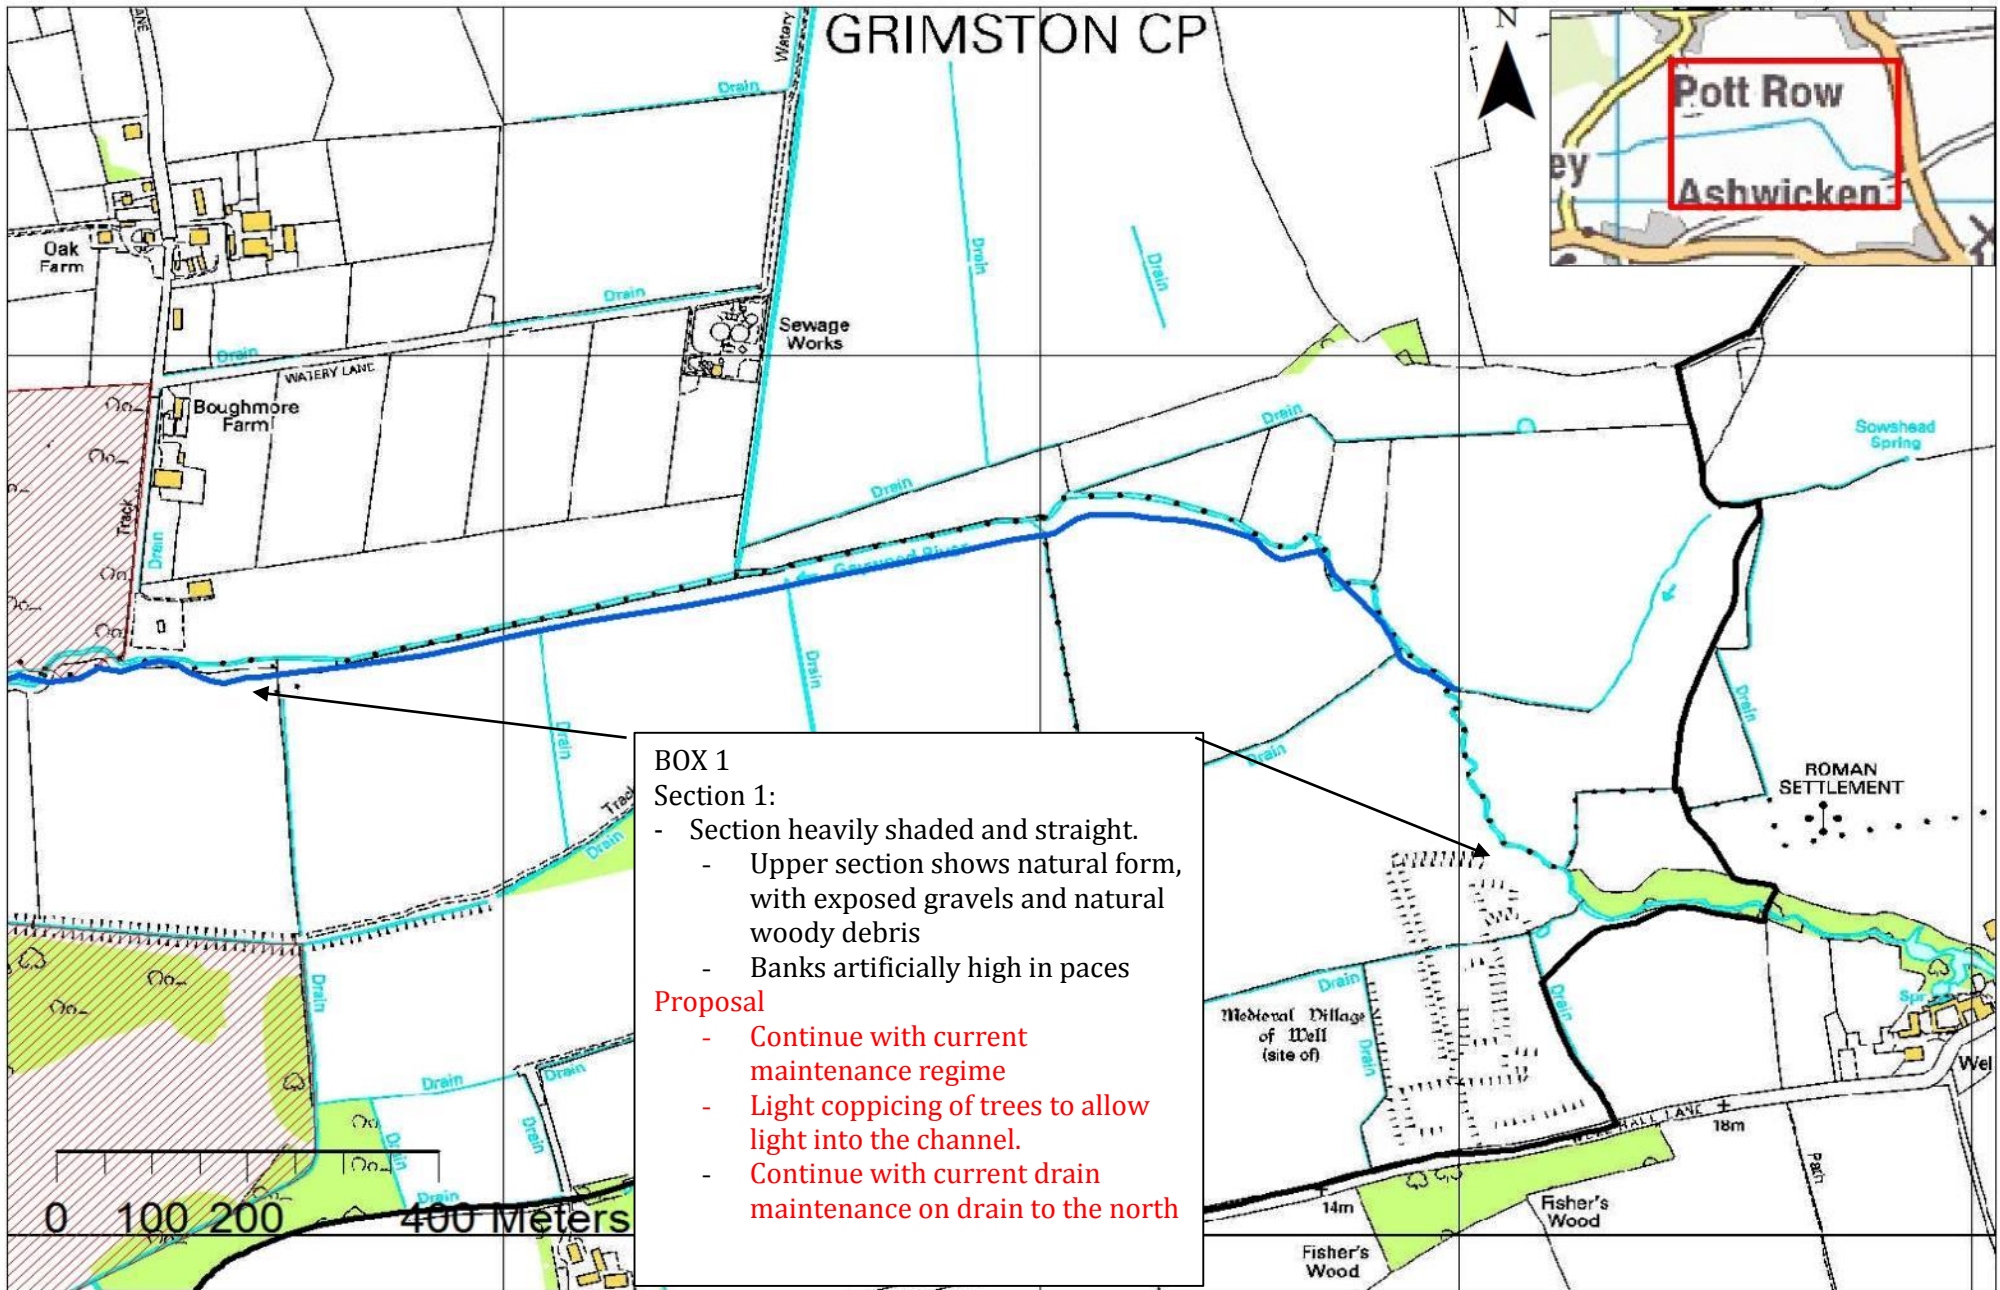
Figure 2 Proposed restoration measures for Reach 1. Black text indicates current features/state, red text indicates proposed measure.

There is currently no maintenance on this section and it is proposed that this continues, Box 1. There is limited flood risk to agricultural land or properties and access is restricted.

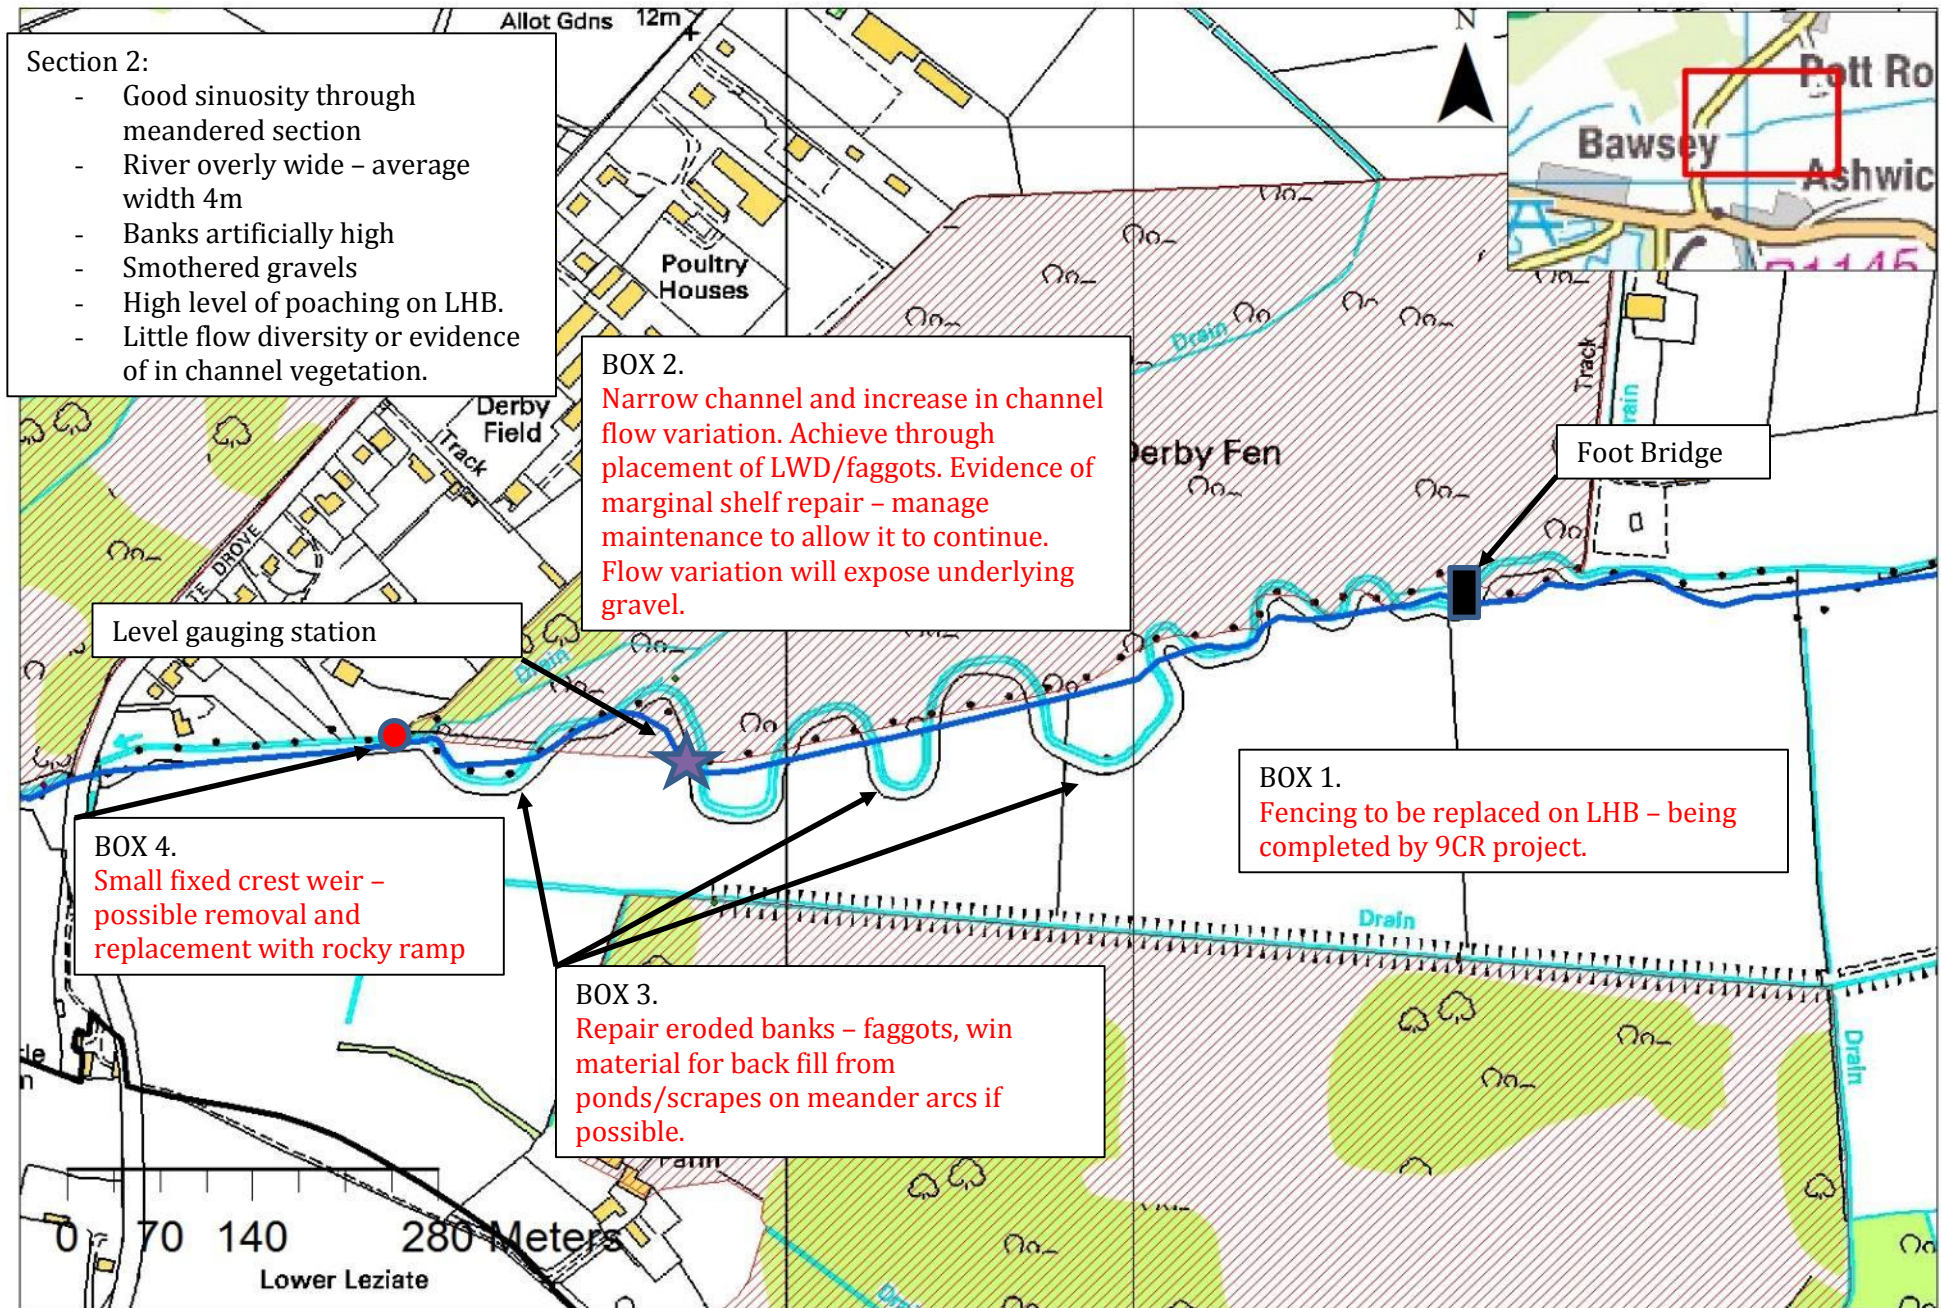
Figure 3 Proposed restoration options for Reach 2. Black text highlights current features. Red text indicates proposed measure.

Evidence of heavy poaching is evident, notably on the outside of the meander bends to the south-side (left hand bank), Photo 3. This has resulted in collapsing, steep banks exposing the sandy sediments of the catchment and widening the channel.

The lower end of the restored section is marked by a low level weir. This is causing a small impounding effect through the meanders, Photo 4. Below the weir the channel narrows and banks increase in height with the channel become straight and featureless.

Bank repairs are also proposed to encourage stabilisation of the southern bank, BOX 3. This should be carried out after effective fencing is established. Repairs should be achieved using soft-engineering techniques such as coir rolls or matting. This is likely to require additional material which could be won by the construction of scrapes/ponds with landowner agreement.

The removal of the small weir is also proposed, releasing the impounded stretch and allowing natural processes to occur, BOX 4. If undertaken simultaneously with channel narrowing no detrimental impacts would be seen in the upstream section. These measures can be seen in Figure 2.

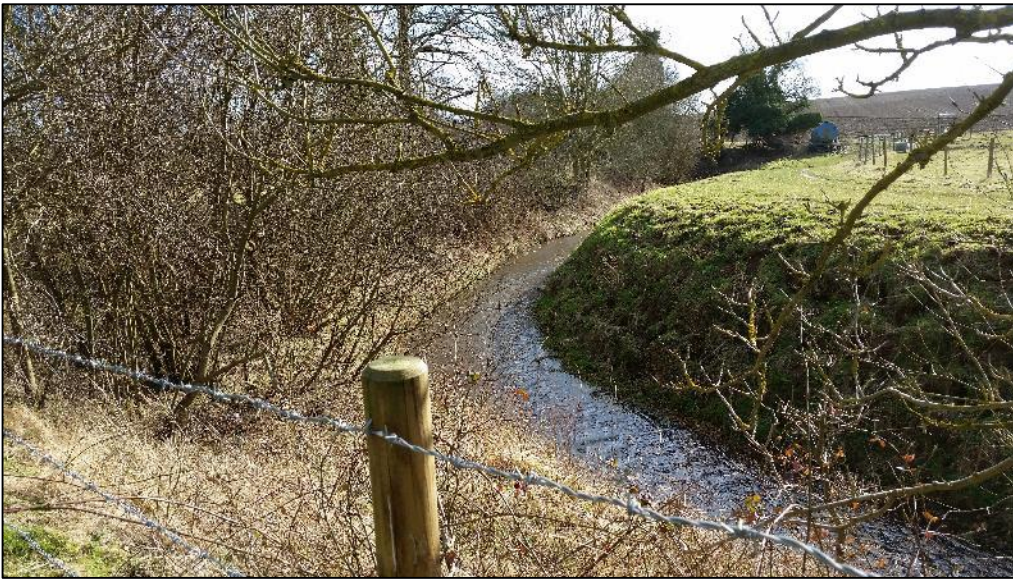
The top of this section is marked by Sugar Fen SSSI on the right hand bank, which shows the most variation in channel, Photo 5, with the lower reaches being marked by straightened, uniform channels with little flow variation, Photo 6. The channel is 2.5-3m wide at the top of the reach with some sections narrowing to 1m wide downstream. The banks are generally high and steep ranging between 1-3m high undulating along the rivers course. Grazing pastures dominate the surrounding land use. The northern bank is well fenced along the reach with the southern edge periodically fenced. An access track is seen along the river's edge to the south.

Photo 5. Sugar fen, showing channel riffle and over-hanging cover.

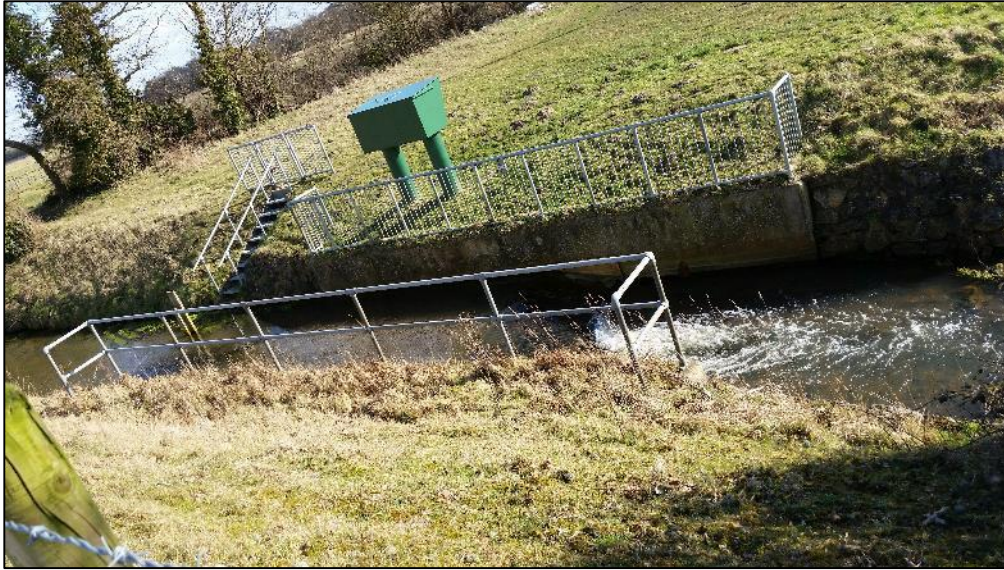
A gauging station marks the top of the reach with a concrete flume, Photo 8. One access bridge is seen through the middle of this section providing vehicular access on a rough track. Field drains are evident draining the surrounding land use.

Photo 8 Environment Agency gauging station at Sugar Fen

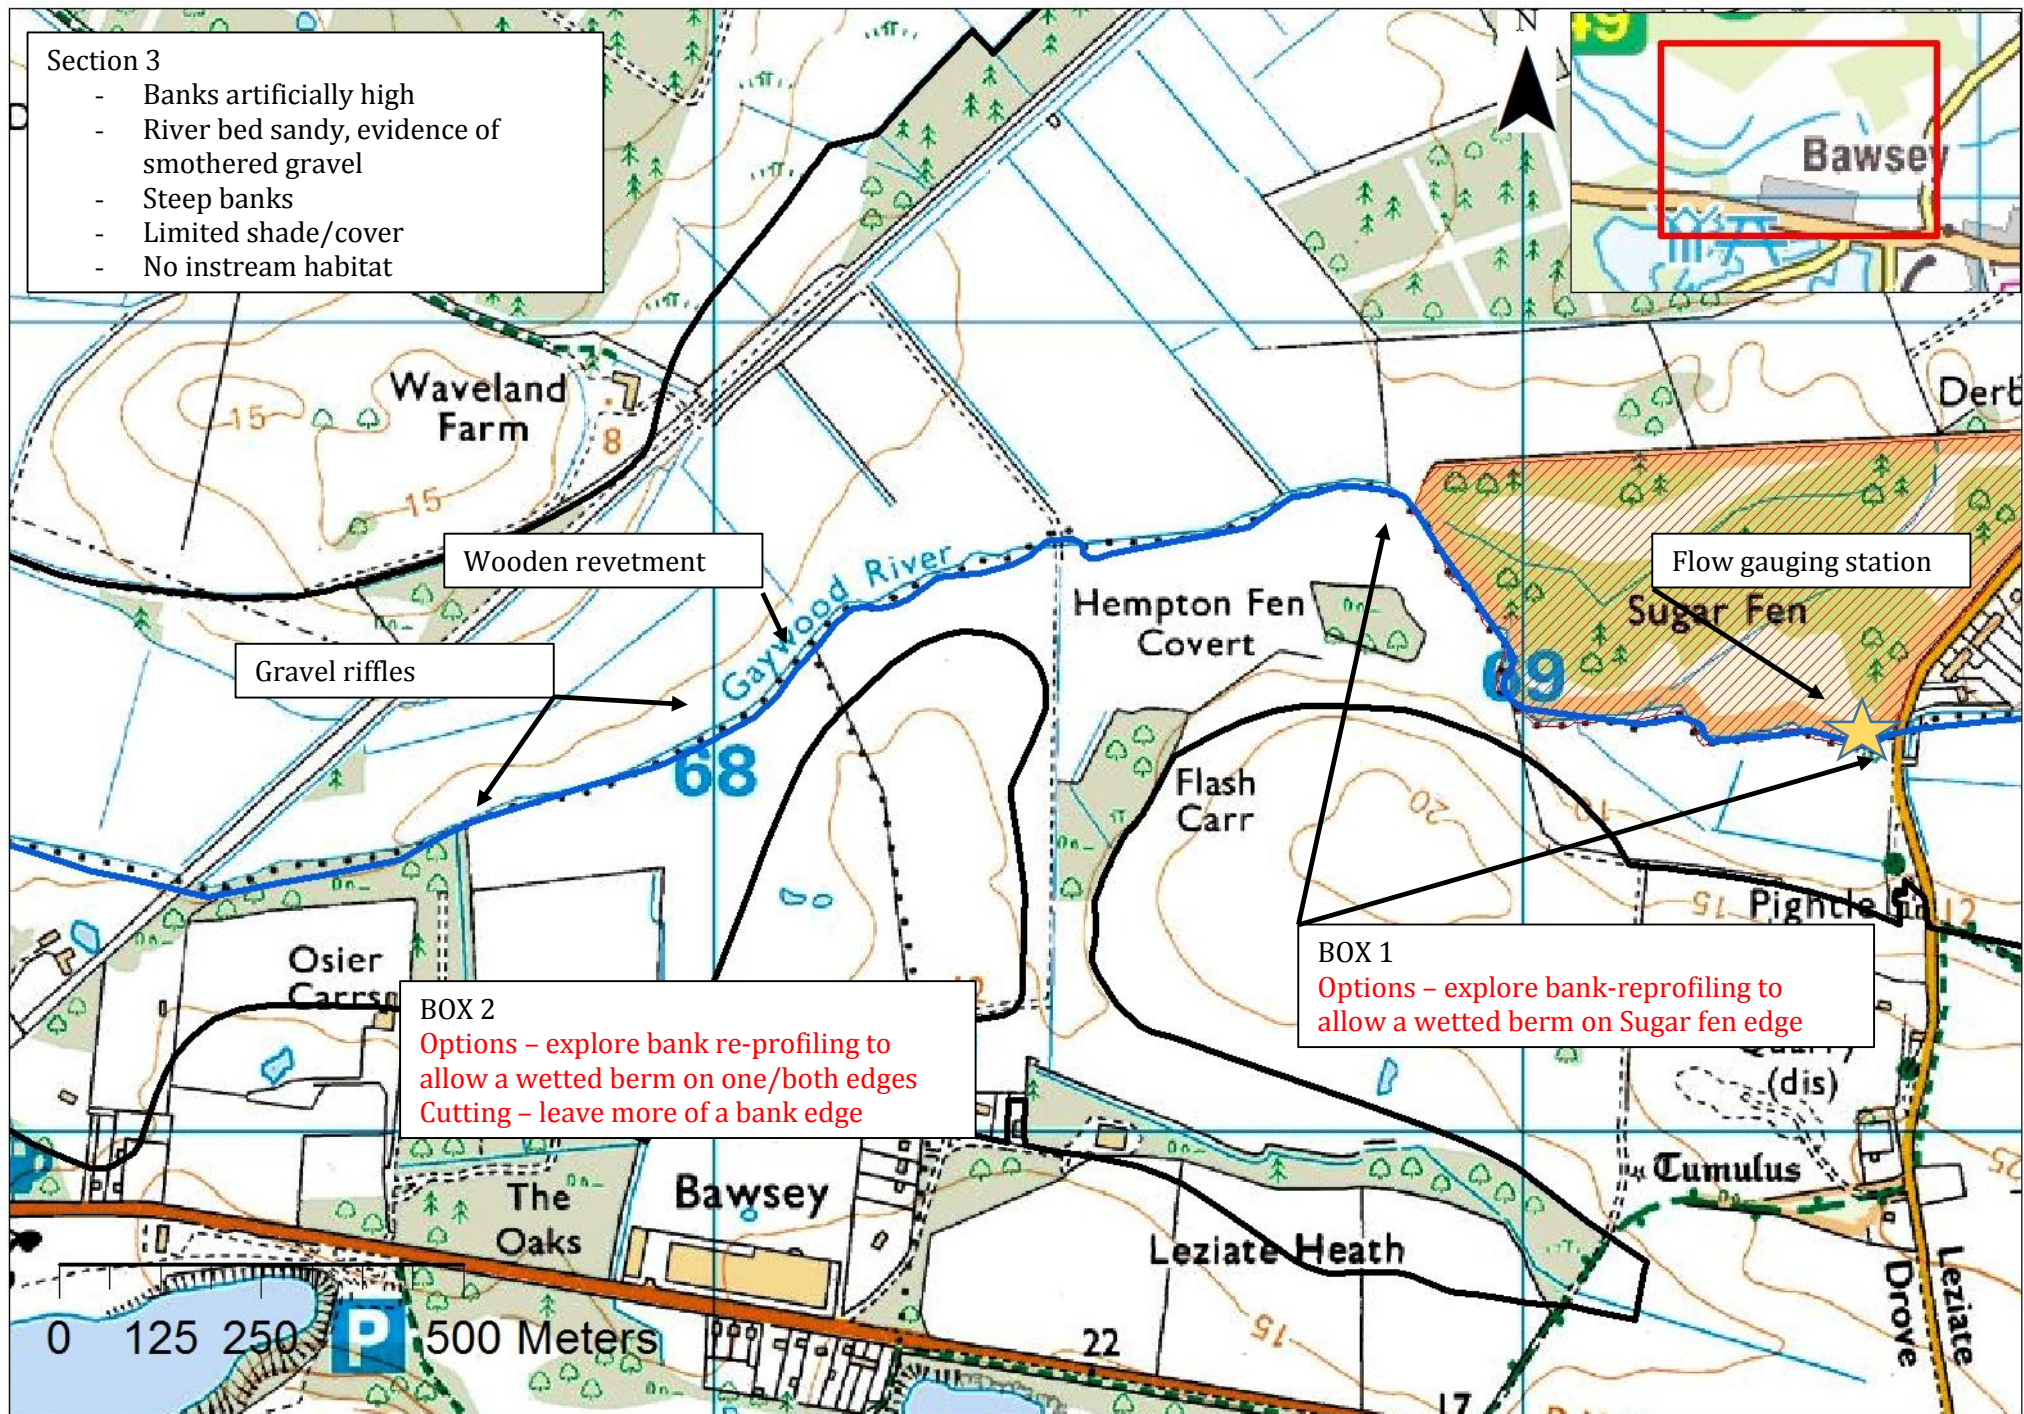
Figure 4 Proposed restoration and maintenance measures for Reach 3 and the top of Reach 4. Black text states current features/state, red text states proposed measure

This reach is currently cut on an annual basis, removing all in-stream vegetation and one bank. At the present morphology this programme will need to continue with reports of large beds of water cress choking the channel. With the creation of wetted berms and two staged channels the increased flow diversity should hopefully reduce the need for such a rigorous maintenance regime.

Gravels are present where flows are faster, by increasing the flow diversity through the creation of wetted berms/marginal fringes additional natural gravels may be excavated. Restoration options are shown in Figure 4.

It is proposed that a full macrophyte survey is undertaken through the survey season (May-July) to record growth and determine full required extent of cutting requirements. This is proposed to be reviewed on a regular basis to ensure that un-necessary maintenance isn't carried out and natural processes allowed to develop around the proposed restoration when implemented. Consideration for field drainage will also be made throughout this process to ensure ample drainage.

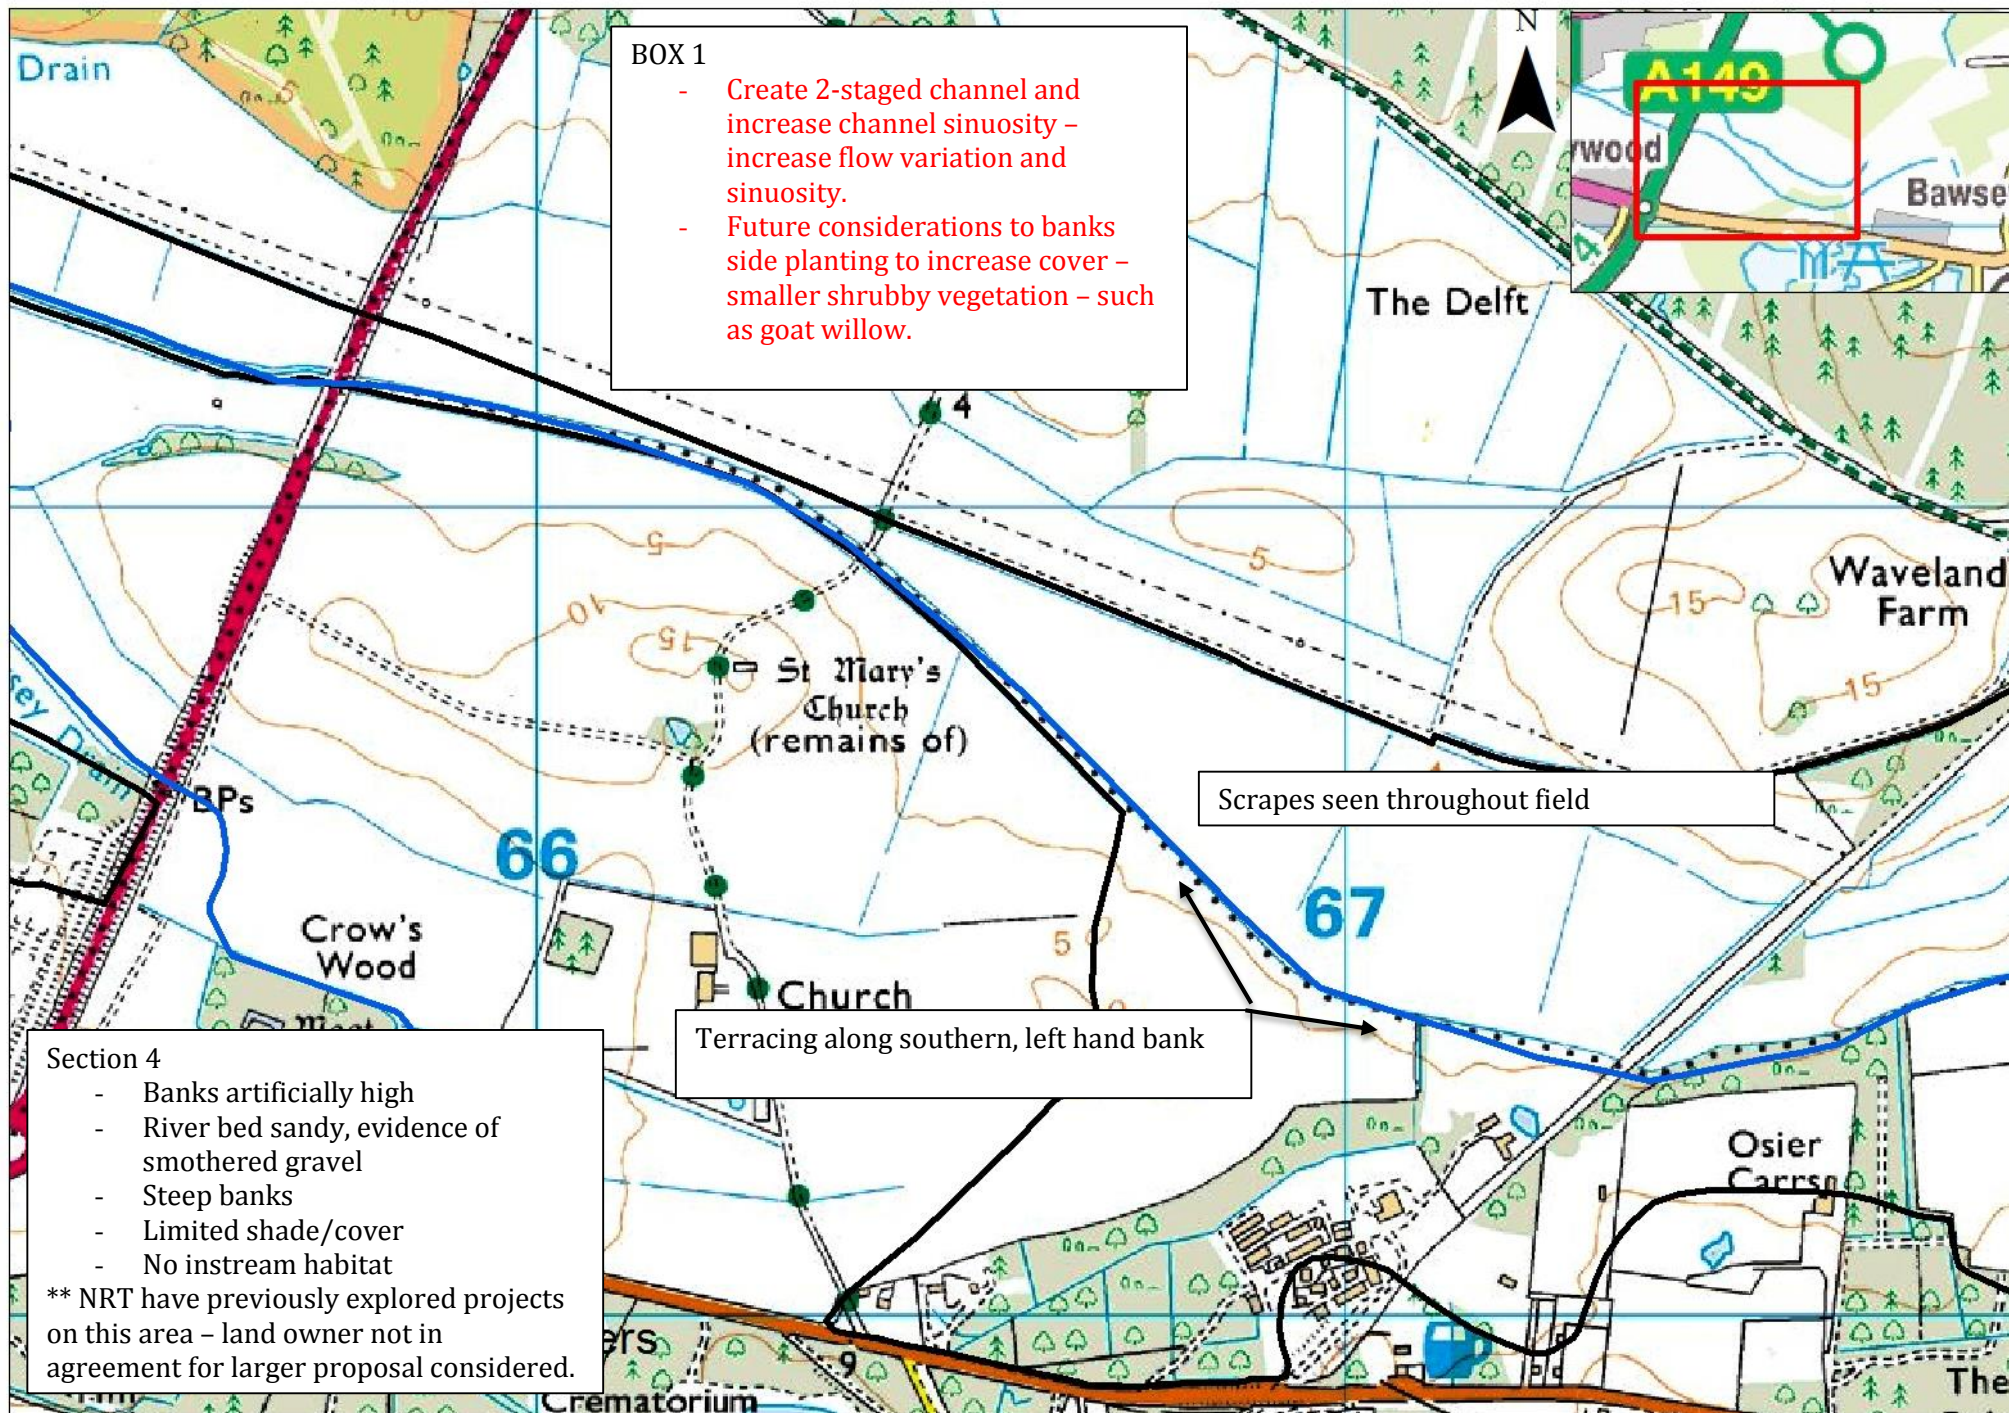
Figure 5. Proposed restoration and maintenance options for Reach 4. Black text outlines current features, red text indicates proposed actions.

The channel is featureless throughout this stretch with uniform flows and little channel variation, Photo 9. The reach is managed by the King's Lynn IDB cutting the in-channel vegetation and one bank. Bankside cuttings reveal reed sweetgrass, *Glyceria maxima*, common reed, *Phragmites australis* and creeping bent *Agrostis stolonifera*.

Gravels are present where flows are faster, by increasing the flow diversity through the creation of wetted berms/marginal fringes the sandy bed may be scoured, exposing the underlying gravels. Restoration options are shown in Figure 5.

It is proposed that a full macrophyte survey is undertaken through the survey season (May-July) to record growth and determine full required extent of cutting

requirements. This is proposed to be reviewed on a regular basis to ensure that un-necessary maintenance isn't carried out and natural processes allowed to develop around the proposed restoration when implemented. Consideration for field drainage will also be made throughout this process to ensure ample drainage.

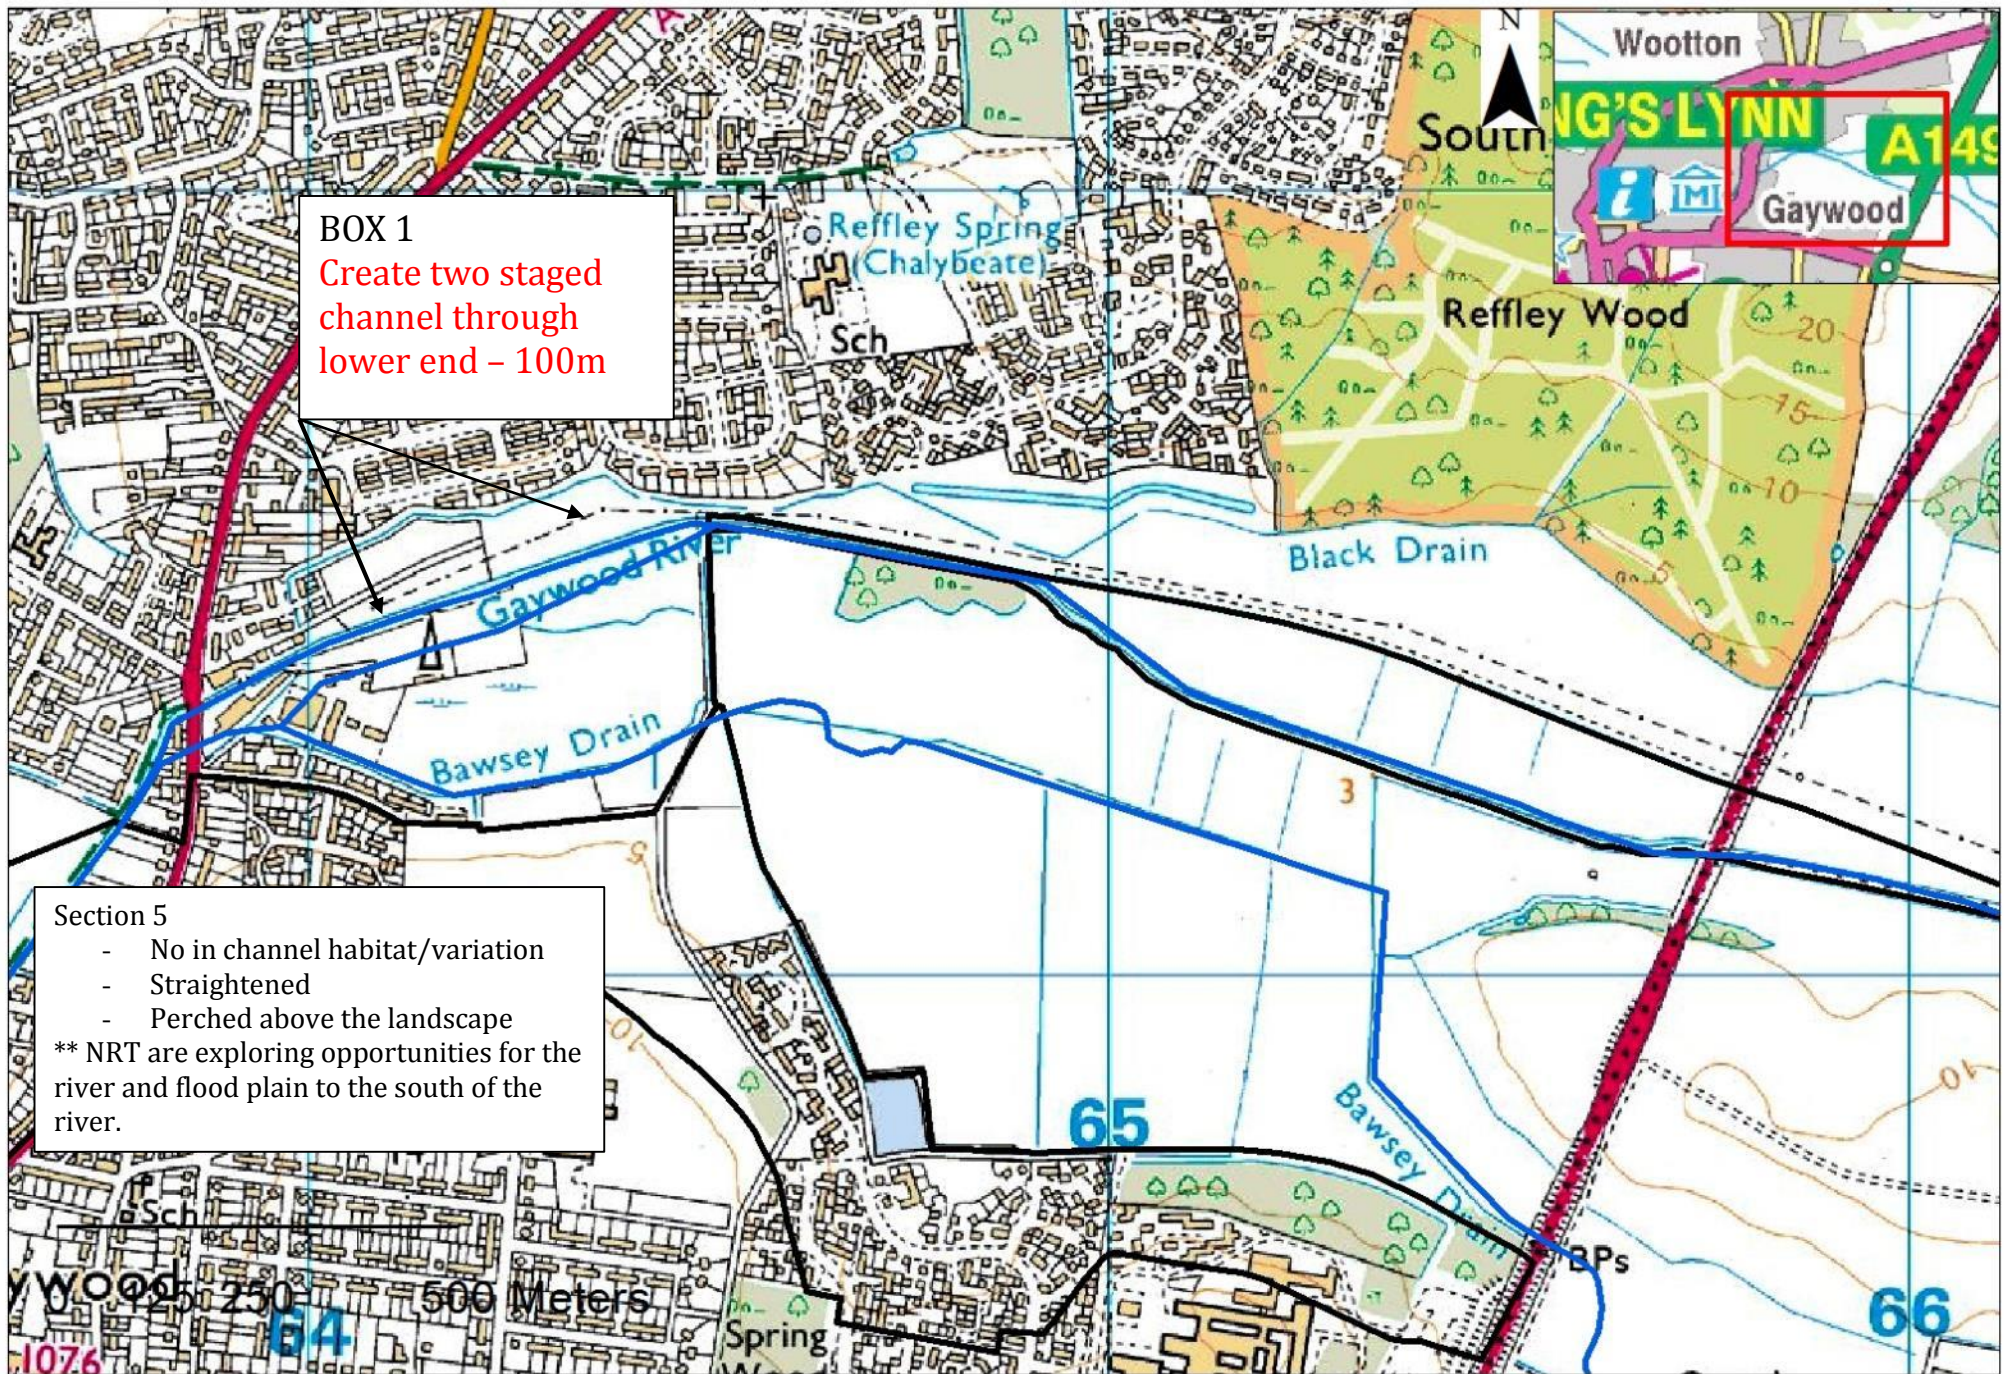
Figure 6 Proposed restoration and maintenance options for Reach 5. Black text outlines current features, red text indicates proposed actions.

The channel is very uniform throughout this stretch, lacking in wetted margins and flow variation. Few opportunities are presented throughout the reach to increase these habitats and flow diversity by re-profiling the banks under the current site configuration. One opportunity to create a two-stage channel is seen at the western extent. This would allow a narrower low flow channel to be created with a wetted berm. This area is located between the footbridge and A148, as shown in Figure 6, BOX 1.

This reach is currently cut on an annual basis, removing all in-stream vegetation and one bank. At the present morphology this programme will need to continue with reports of large beds of water cress choking the channel. With the creation of wetted berms and two staged channels the increased flow diversity may allow for some reductions in weed cutting through this stretch. Due to the location of the reach on the edge of King's Lynn this would need to be carefully modelled and considered.

It is proposed that a full macrophyte survey is undertaken through the survey season (May-July) to record growth and determine full required extent of cutting requirements. This is proposed to be reviewed on a regular basis to ensure that un-necessary maintenance isn't carried out and natural processes allowed to develop around the proposed restoration when implemented. Consideration for field drainage will also be made throughout this process to ensure ample drainage.

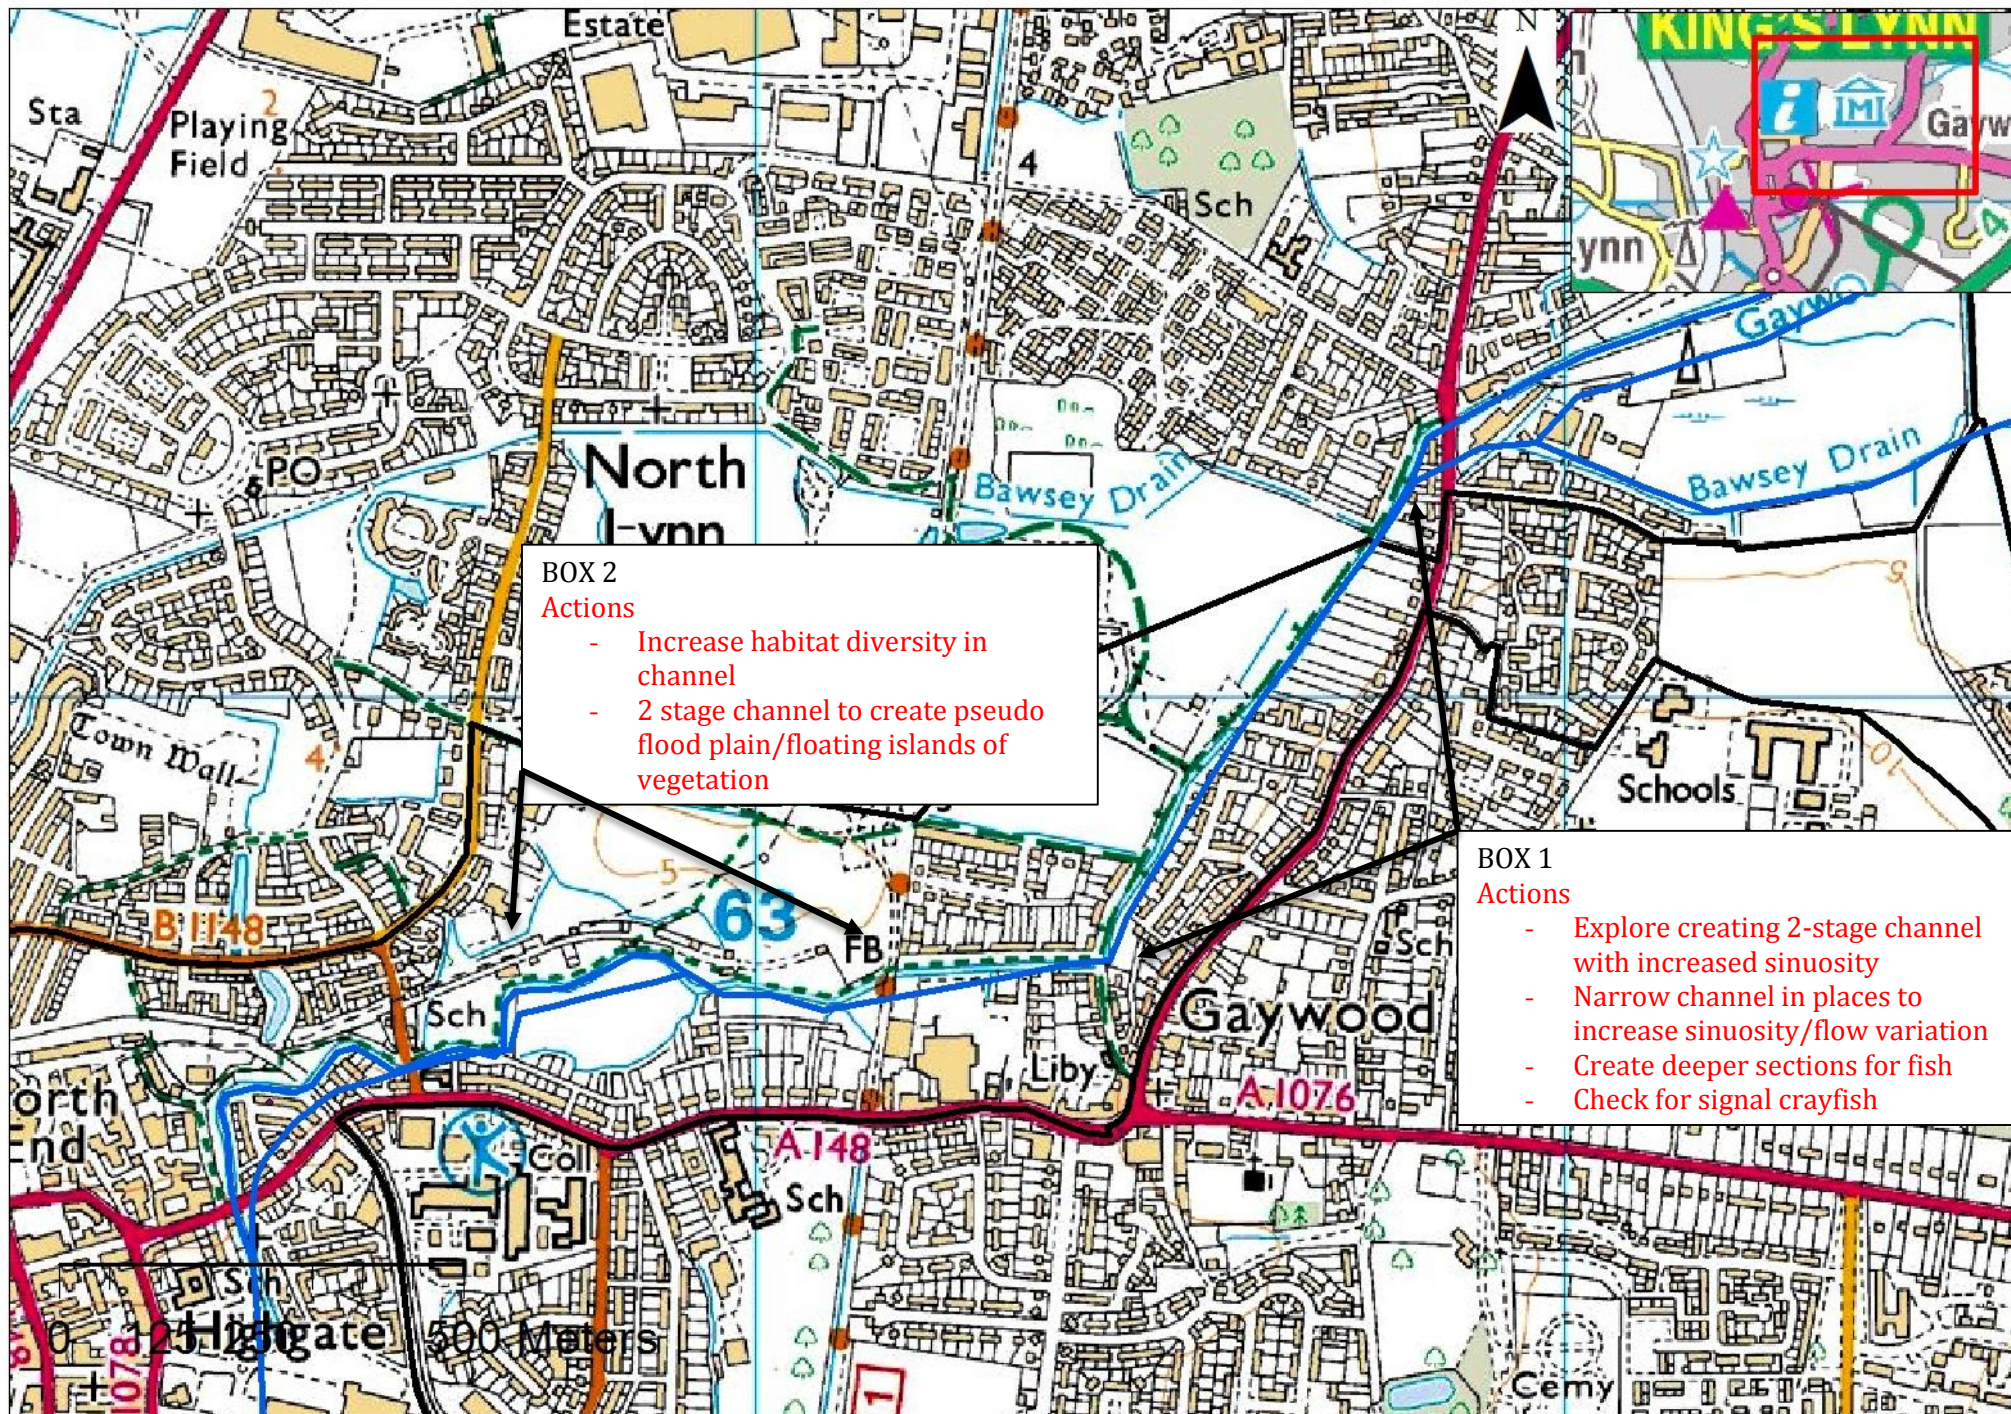
Figure 7 Proposed restoration and maintenance options for Reach 6. Black text outlines current features, red text indicates proposed actions.

As little vegetation growth is seen through the reach, no maintenance is currently required. .

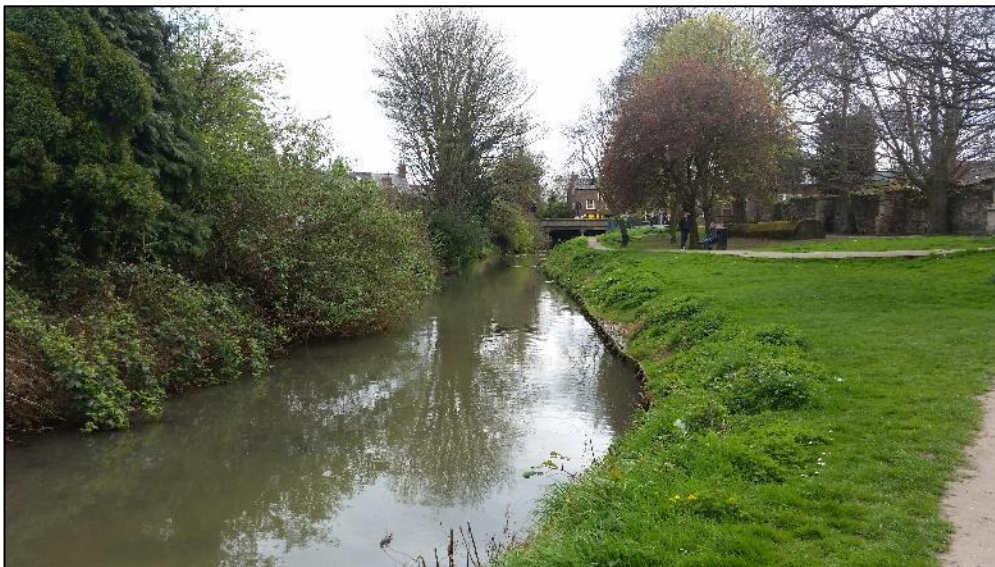
The top section of this site near Kettlewell Lane has had restoration efforts undertaken, improving the green space and the river. These measures have seen scrubby vegetation cleared, banks repaired and the channel modified slightly to increase flow variation, Photo 14.

Photo 14 The River Gaywood at Kettlewell Lane.

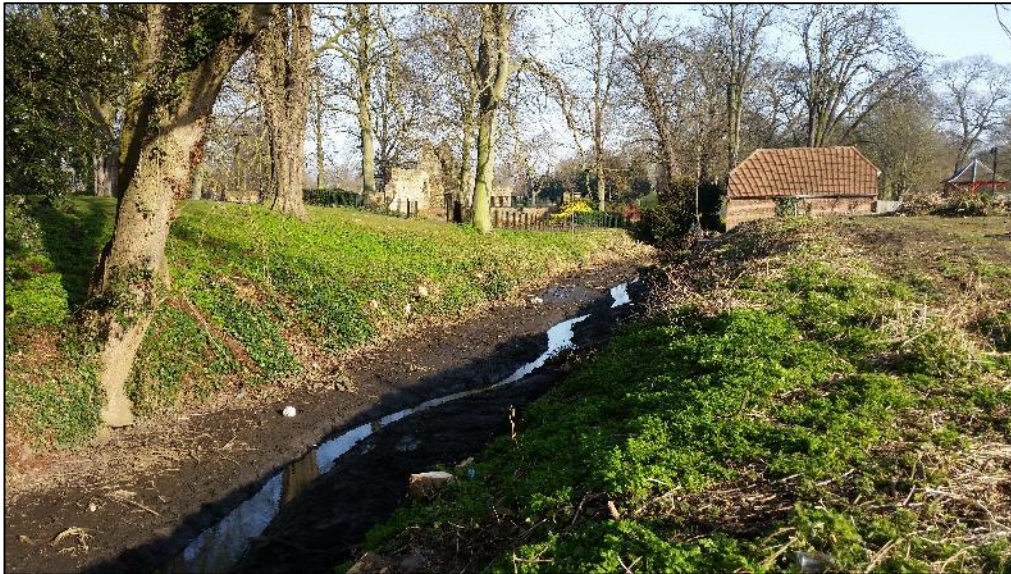
Seven Sisters drain joins the channel at the lower end of the walks providing an informal overflow channel for the river whilst draining surrounding housing estates. This drain was enhanced in March 2015 to include a more sinuous channel, areas of open water and bankside planting. The structure at the southern end was uncovered, Photo 15.

Photo 15 Seven Sisters drain project, before planting, but after excavation of new channel.
