River Gaywood – River Restoration and Maintenance Proposal

**Prepared for King’s Lynn Internal Drainage Board by Emily long, MSc,
Norfolk Rivers Trust**

April 2015

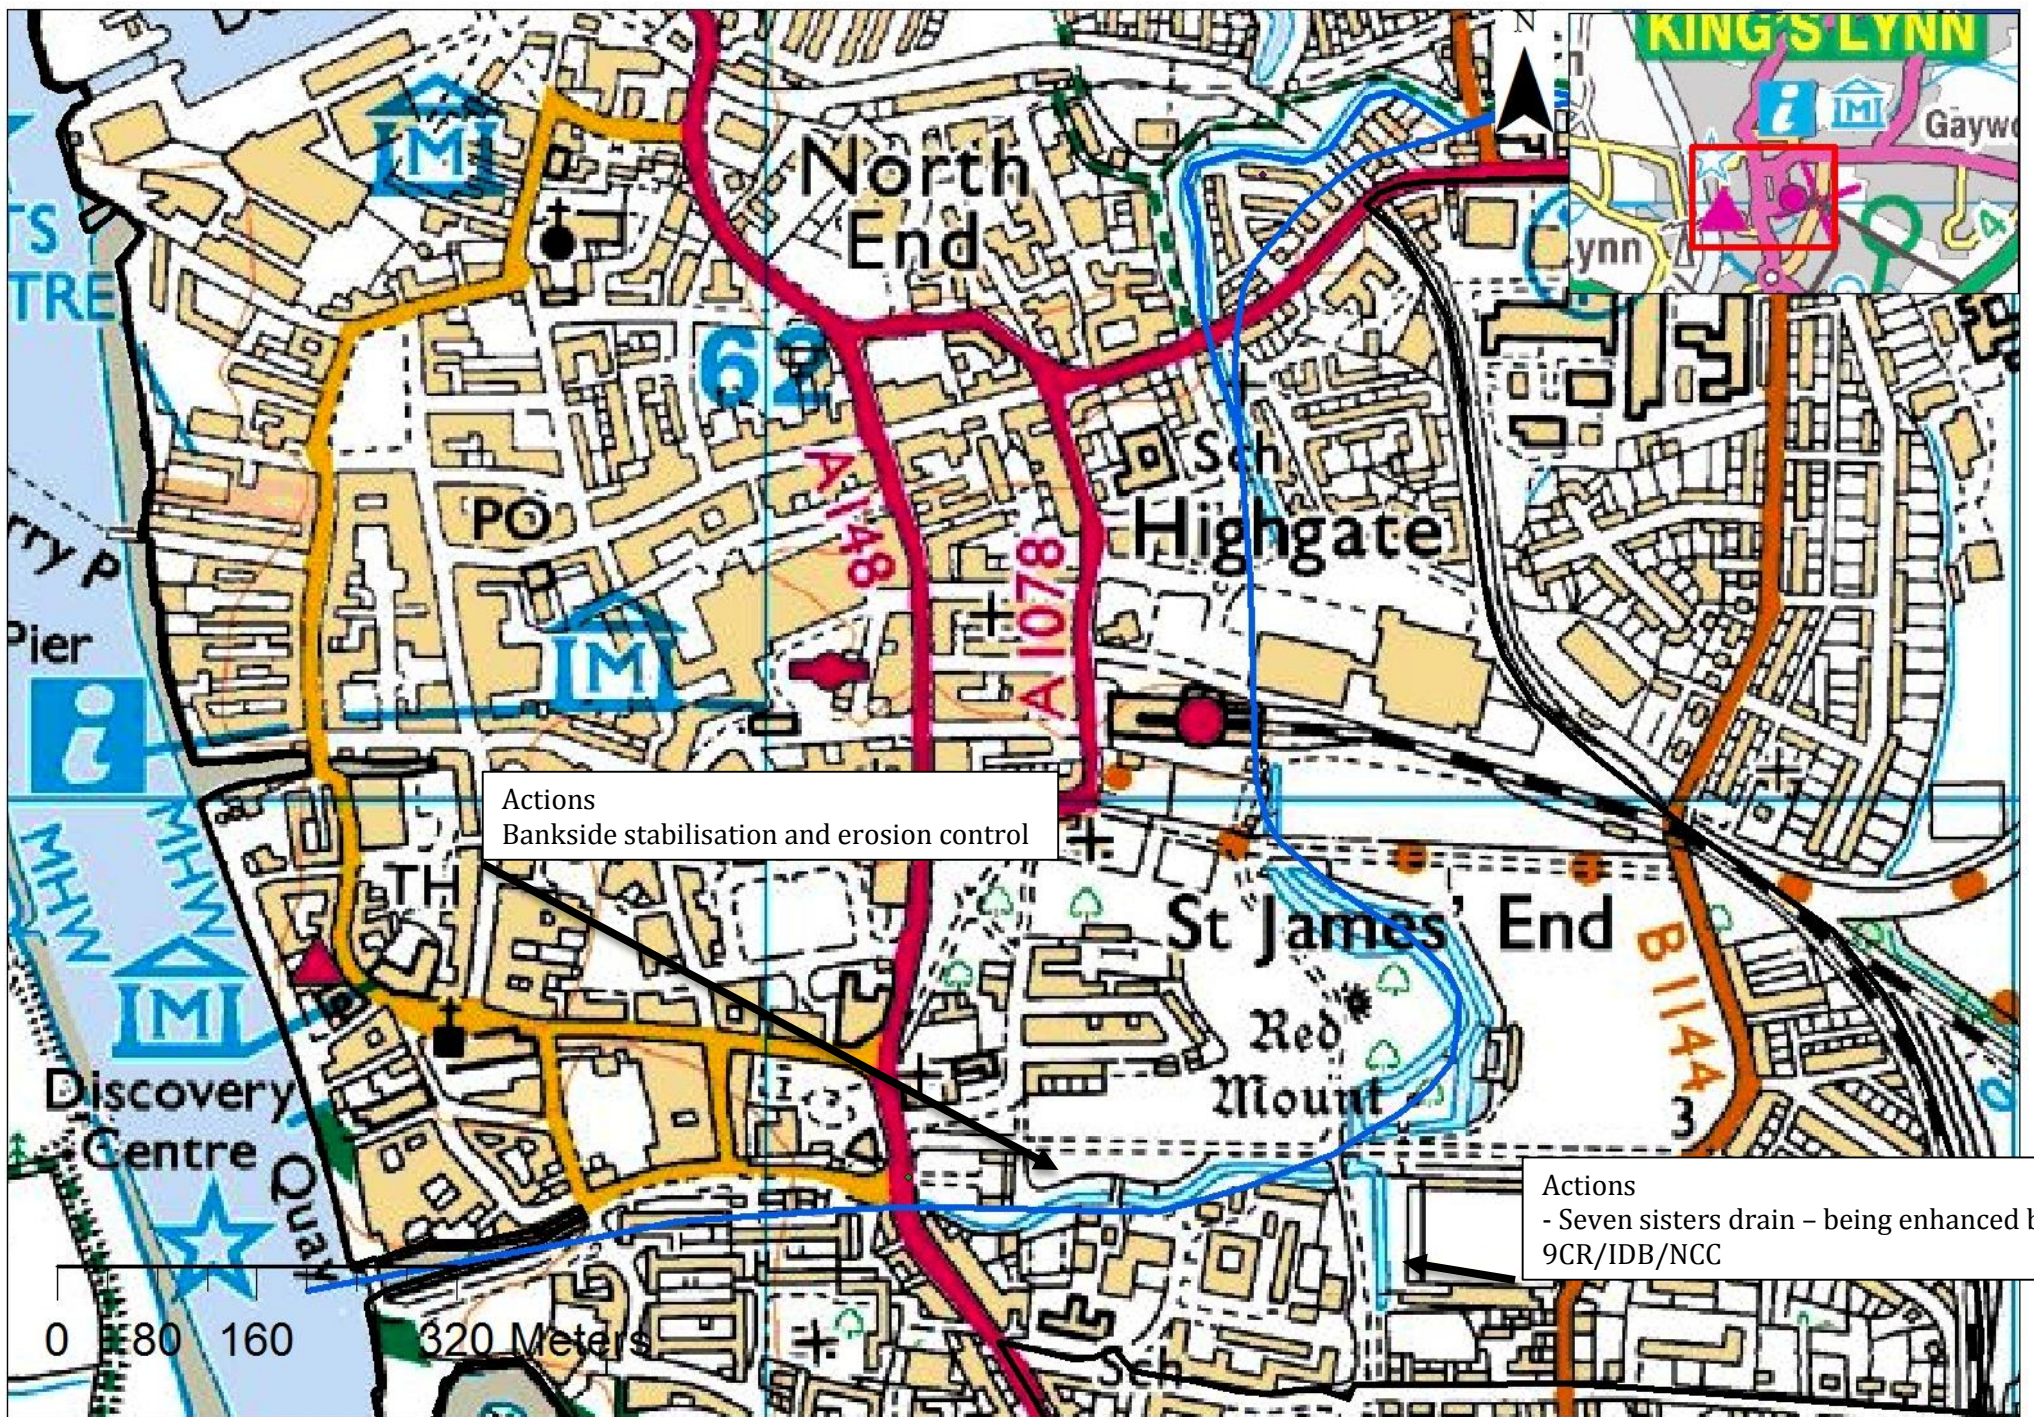
Figure 8 Figure 7 Proposed restoration and maintenance options for Reach 7. Black text outlines current features, red text indicates proposed actions.

The Walks Park represents the most open stretch of river through a heavily manicured gardens. The river displays artificial wooden banks through the section and is wide and uniform. Banksides are vegetated with planted species for aesthetic purposes. Towards the lower end of the walks there are erosion problems that run past the school, causing sedimentation inputs and un-stable banks. High numbers of ducks are present through the stretch causing erosion of the banks and contributing to decreased water quality. The Walk's Rivulet is also seen within the park, originally constructed to take water to swimming baths, this runs parallel to the river with a similar characteristic.

Bank protection below The Walks is also proposed, using the most sustainable methods possible. It is likely that soft-engineering methods will be insufficient to support these banks, but a solution should include maximum environmental benefits.

Due to the highly urban environment of this stretch and the implied flood risk, current maintenance plans should continue to ensure no increase to flood risk. The channel is highly modified through this reach with little opportunity for improvements.
