Project to increase suitable habitat for BAP priority species, grass-wrack pondweed (*Potamogeton compressus*), within the South Walsham Marshes:

Turion collection, seeding of a widened IDB dyke and species distribution surveys 2012 - 2013

November 2013

Report Number: POTCOMP/ER/001

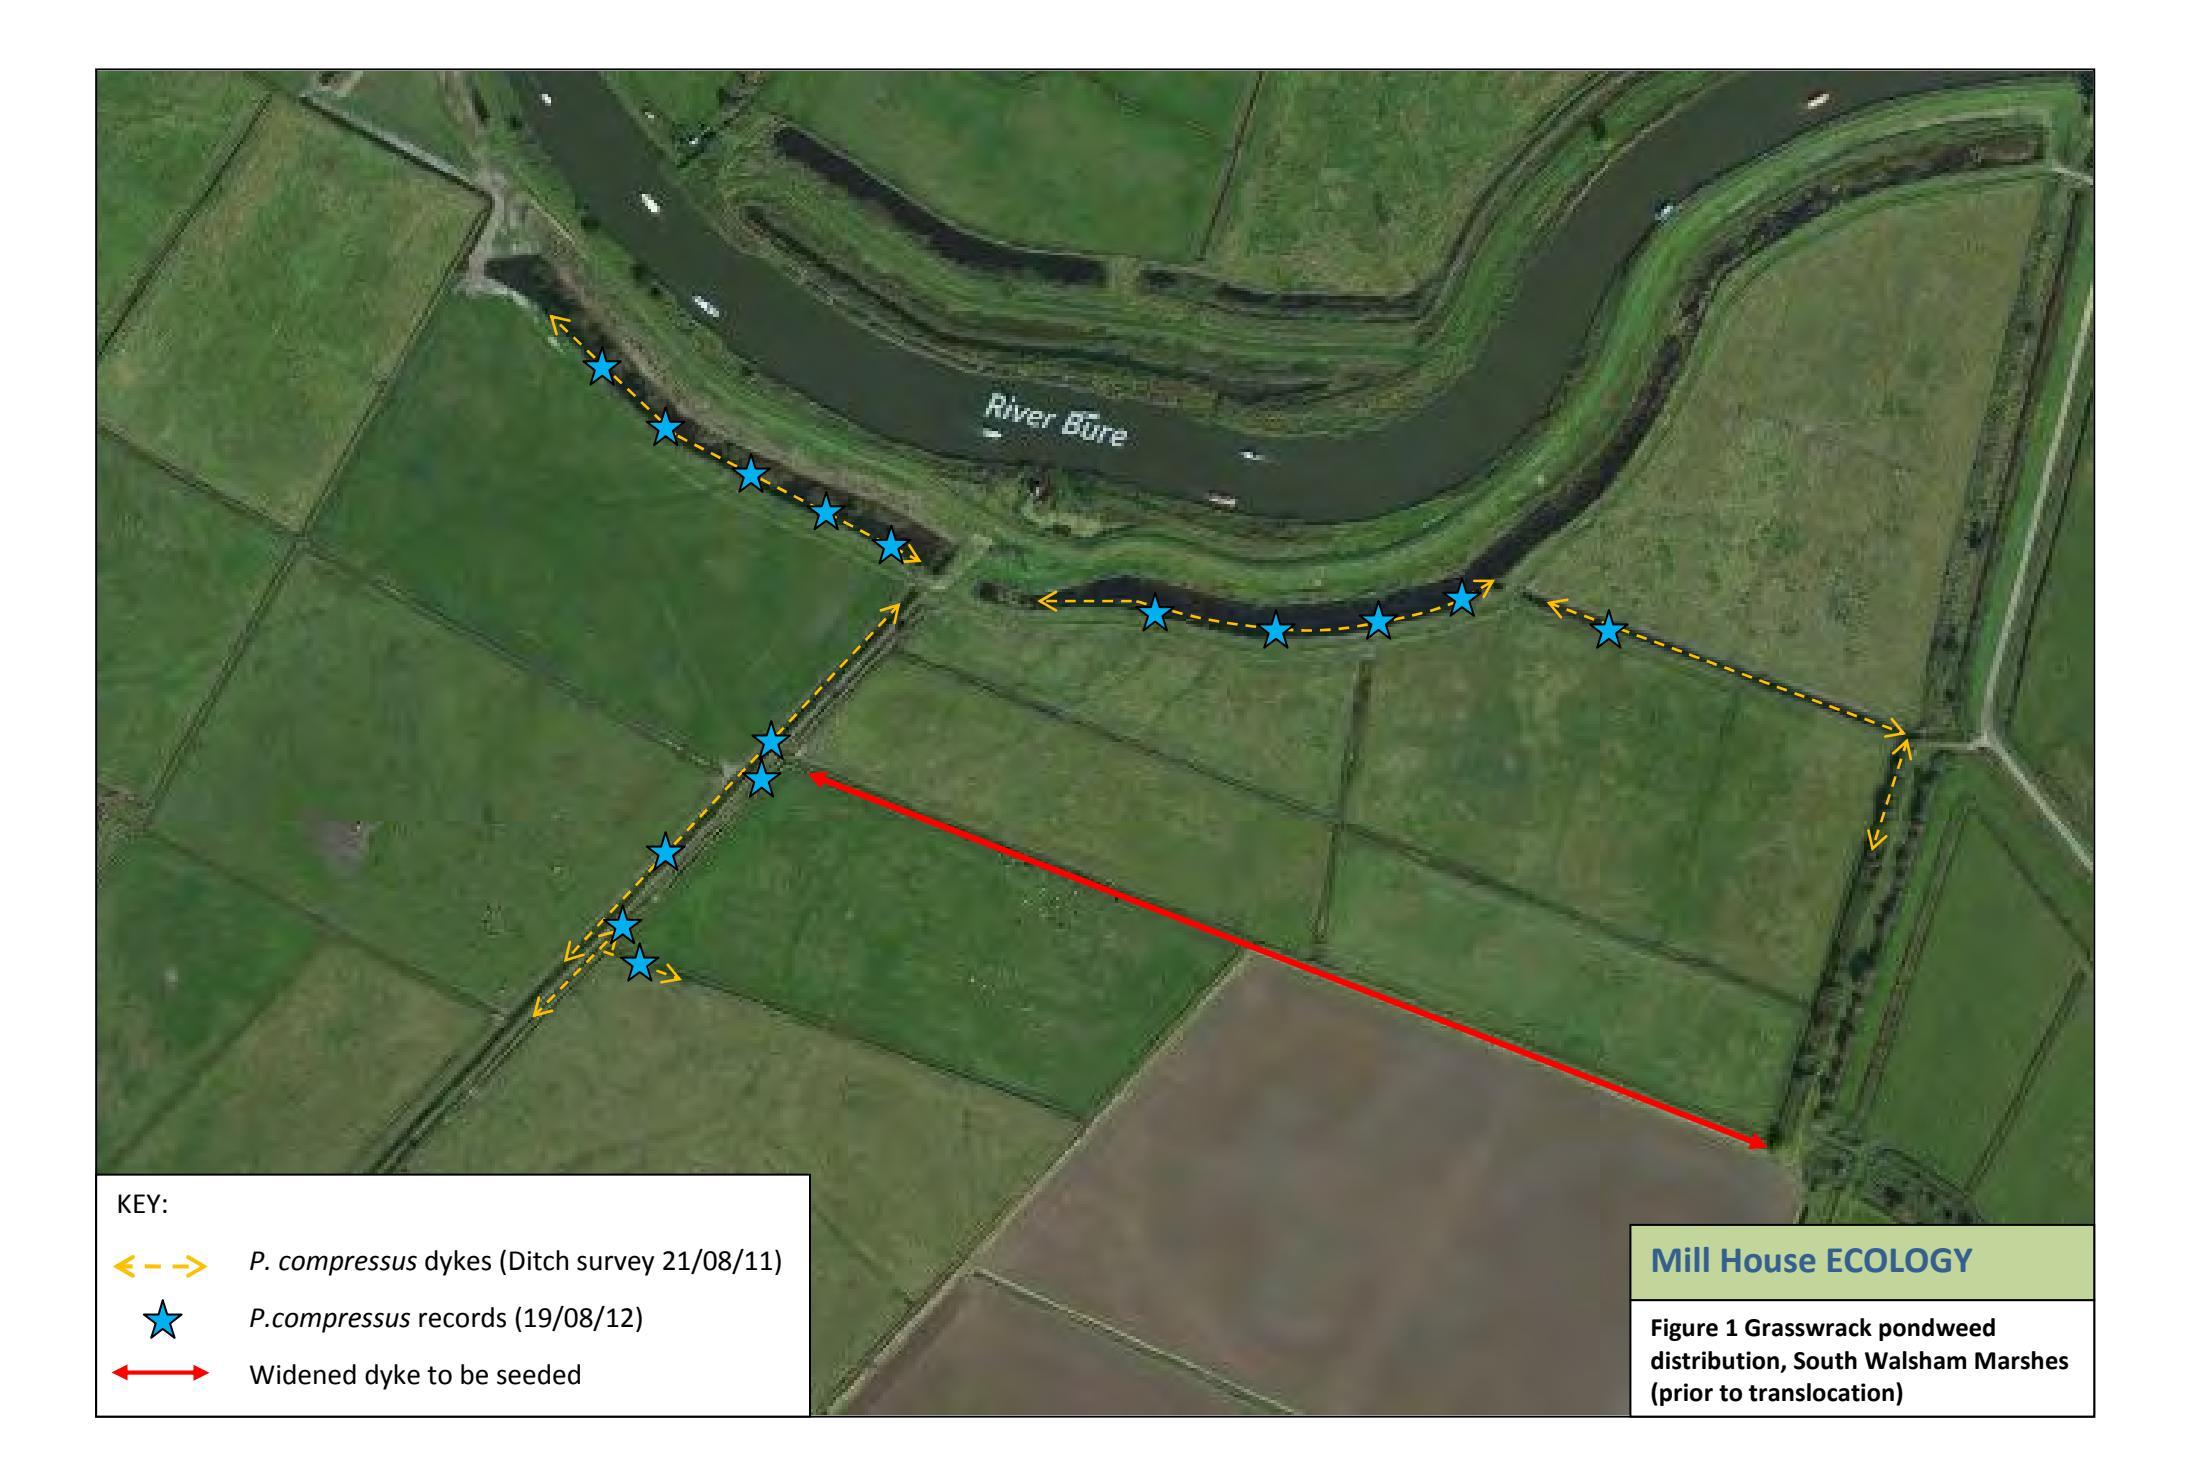
The widened IDB dyke is located to the south of, and roughly parallel with, the soke dyke and adjoining marsh dyke where grass-wrack pondweed is already established (Figure 1). Additional dykes to the west, adjacent to the central track, also support the species.

A survey to map the existing distribution of grass-wrack pondweed locally to the widened dyke was carried out in August 2012 (Figure 1), which generated records in the nearby dykes consistent with observations from 2011.

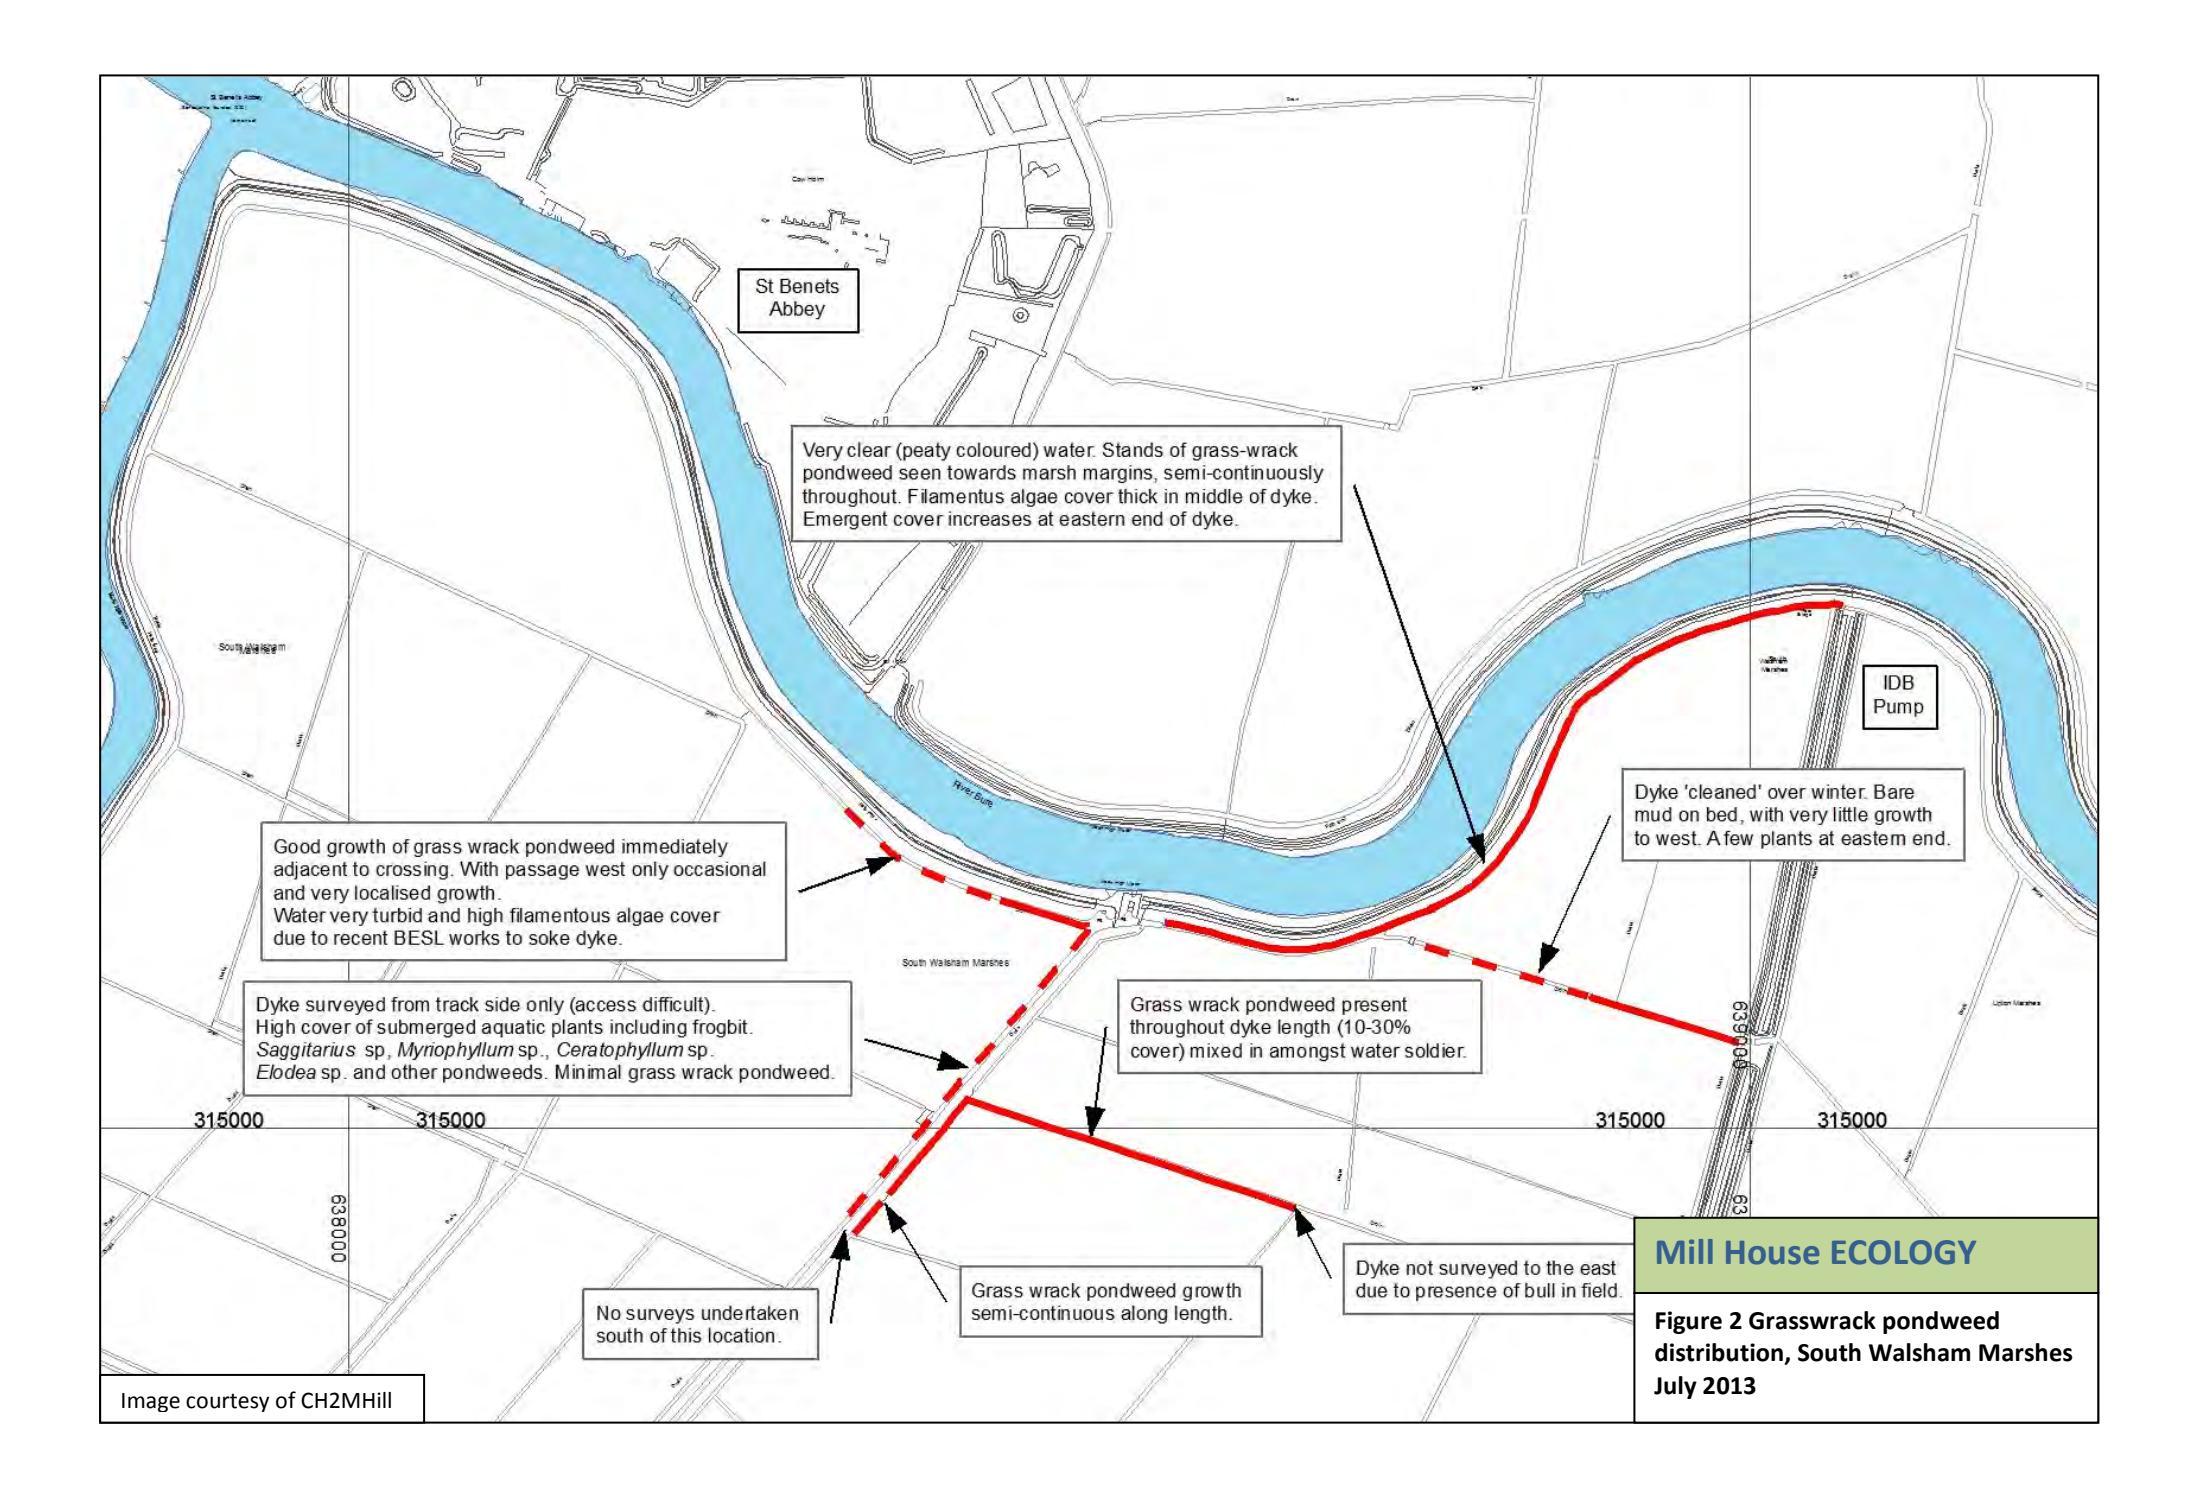
An initial visit was made to the site on the 9th July 2013, when all dykes surveyed in 2011 (Figure 1) were surveyed with exception of the eastern half of the widened IDB dyke where access was restricted due to the presence of a bull in the field (Figure 2).

The plant was generally recorded as per the 2011 survey, although some disturbance to the west end of its known distribution in the soke dyke due to recent BFAP flood defence works had resulted in a localised increase in turbidity and algal growth, with few plants observed in the affected reach (Figure 2).

Along the western length of the widened IDB marsh dyke (Photo 3) grass-wrack pondweed was observed at a cover of between 10 and 30%, in amongst plants of water soldier which although sitting raised in the water column were not yet proud of the water surface in general (Figure 2, Photo 4).

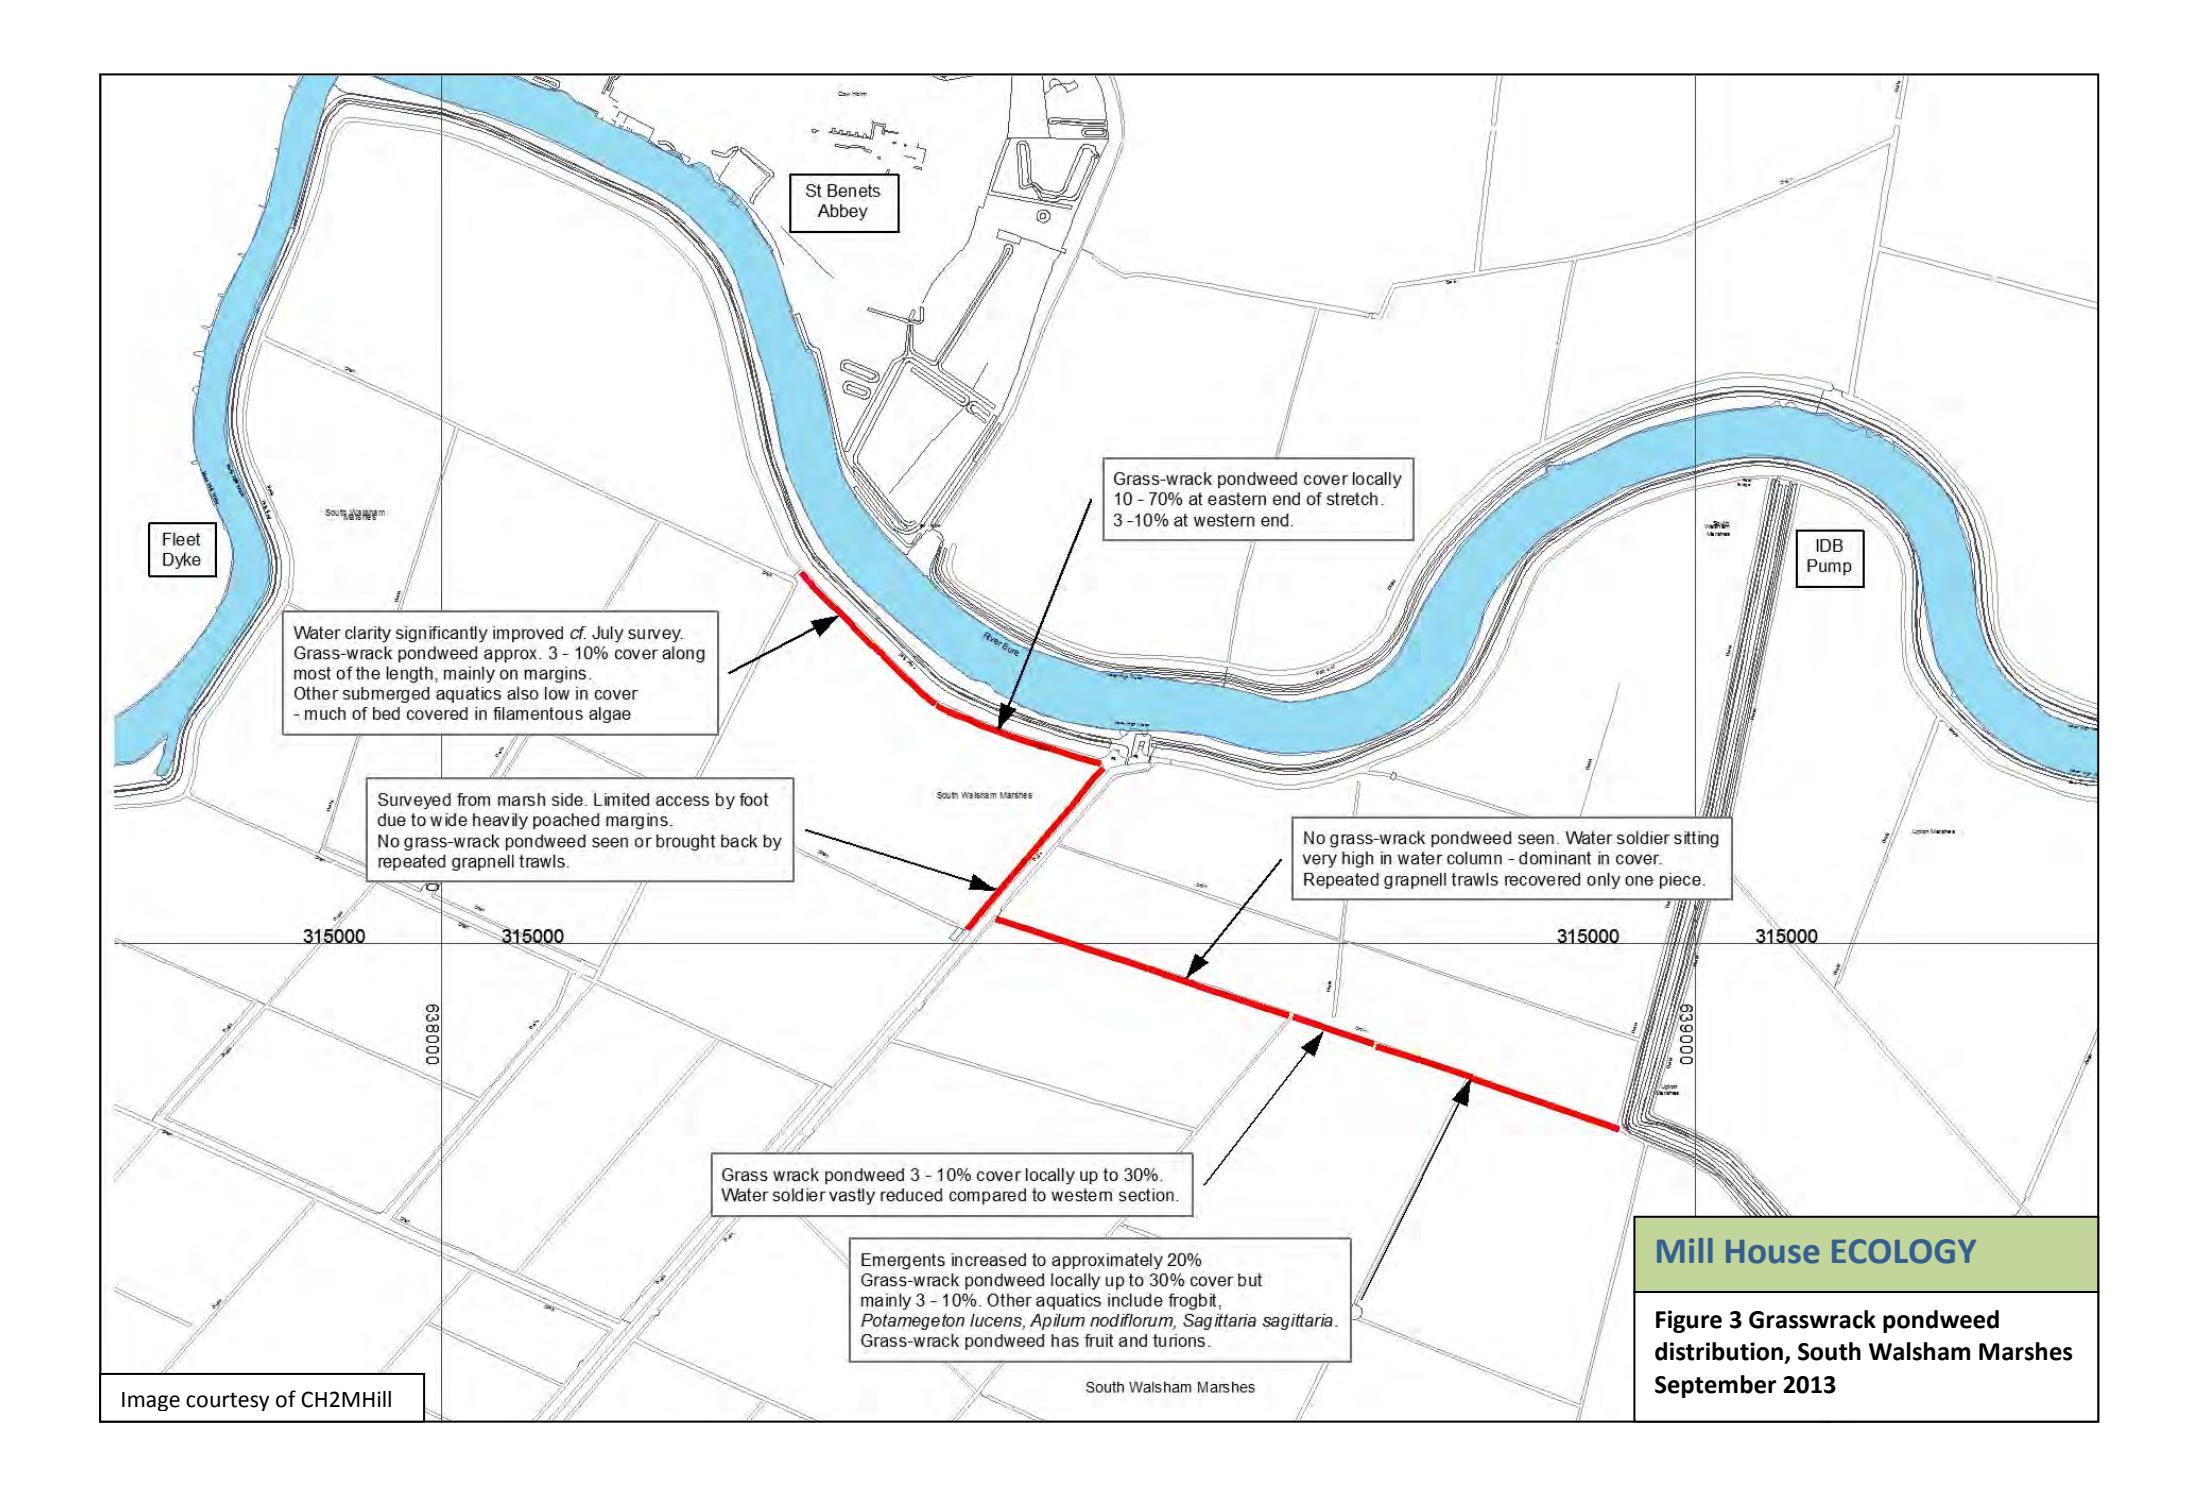
A repeat visit was undertaken on the 4th September 2013 (no bull present) in order to access the eastern half of the widened IDB marsh dyke (Photo 5); the western half of the dyke was also re-surveyed (Figure 3).

Along the margins of the eastern half of the widened IDB marsh dyke, emergent growth accounted for approximately 20% cover, however a fairly diverse stand of submerged aquatic taxa was also present including grass-wrack pondweed at typically 3-10% cover, although locally increasing to up to 30% cover (Figure 3, Photo 6). Some seed heads were seen and turions were abundant.

In contrast to the July survey, no grass-wrack pondweed was seen in the western half of the dyke where it had previously been recorded (Figure 3). Water soldier was now sitting very high in the water, with long stretches of the water surface dominated by the plants' emergent leaves (Photo 7). Repeated grapnel trawls yielded only one piece of grass-wrack pondweed indicating the main vegetative growth had finished. It is hoped that the plants will have had time to adapt to the changing conditions and produced mature turions prior to scenescing.

Immediately following the September survey a telephone call was made to Caroline Laburn of the WMA outlining the issue with water soldier growth, suggesting consideration should be given to removal of a significant proportion of the water soldier present whilst still floating high in the water column (cf. typical dyke clearance operations which are generally winter led when the plant has sunk to the dyke bed). The use of a Bradshaw bucket or similar would allow any turions (and other seeds and macroinvertebrates) present to remain largely undisturbed in the sediments ready for the 2014 growing season. Ongoing monitoring of the relevant stretch is also recommended to determine the effect of water soldier growth upon grass-wrack pondweed.

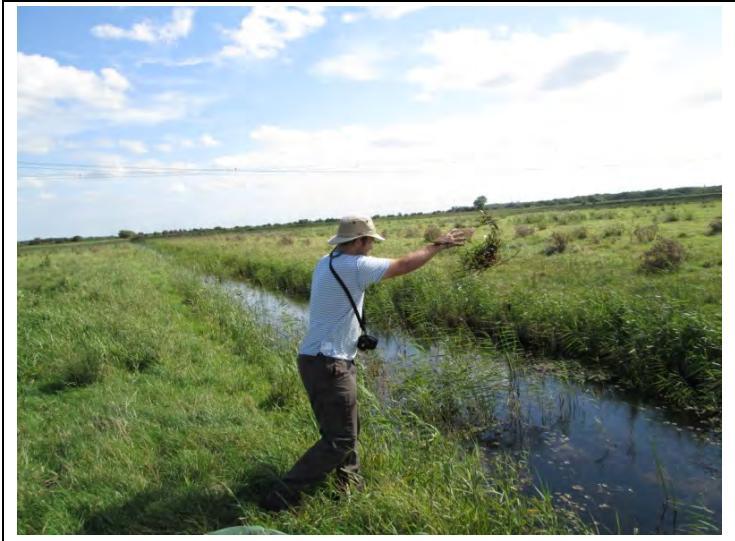
Stored turions were transferred to the widened ditch in early April 2013 following a very cold March. During the seeding it was noted that the western half of the widened IDB dyke appeared to have more open water surface, but with water soldier (*Stratiotes aloides*) visible along the dyke bed, whilst the eastern stretch generally had a higher cover of emergent marginal vegetation, mainly common reed (*Phragmites australis*) on the south bank such that shading of the dyke can occur for parts of the day. Turions were distributed along the full dyke length, but were not placed in areas locally constricted by existing aquatic vegetation.

Photo 1 Seeding the widened dyke with collected plant material

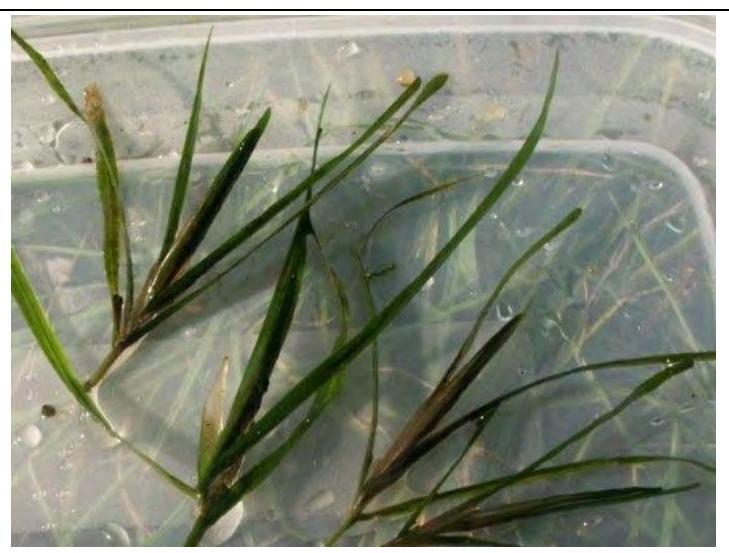
The methods used followed Markwell and Halls (2008). Turions were collected from soke dyke lengths within 150m to the east and west of the old South Walsham pump house in September 2012, as the parent plants were beginning to senesce. Less than 30% of existing plant material was removed from any one location using grapnels. The source locations were chosen as they supported the most abundant growth of grass-wrack pondweed in the area. Three partially filled black bin liners of plant material were transferred by hand directly to the widened dyke (Photo 1), dispersed along the full length. All turions from the remaining one quarter to third of the plant material collected (Photo 2) were removed for storage over winter in sealed, blackened containers containing clean water and placed in a fridge maintained at 4°C. This equated to approximately 100 - 150 turions.

Photo 2 Collected turions

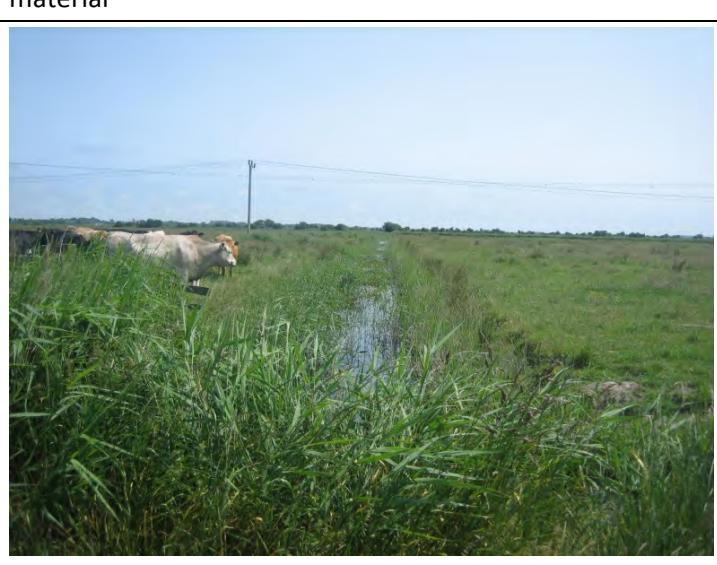
Photo 3 – Widened IDB dyke looking east from central track, July 2013

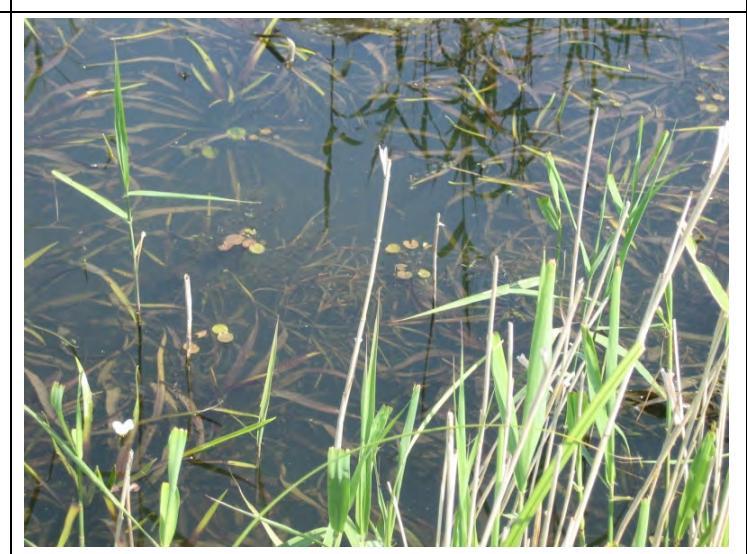
Photo 4 - Grass-wrack pondweed amongst water soldier in the western section of the widened IDB dyke July 2013

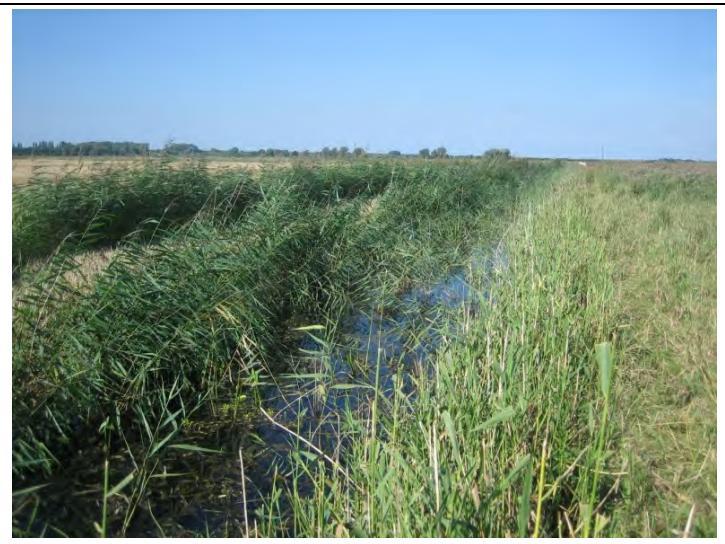
Photo 5 – Eastern stretch of IDB widened dyke, September 2013 (looking west)

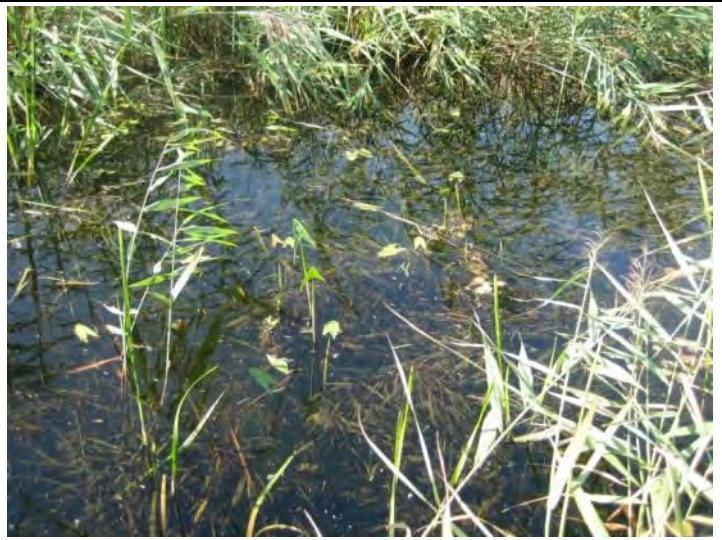
Photo 6 – Grass wrack pondweed in the eastern section of the IDB widened dyke September 2013.

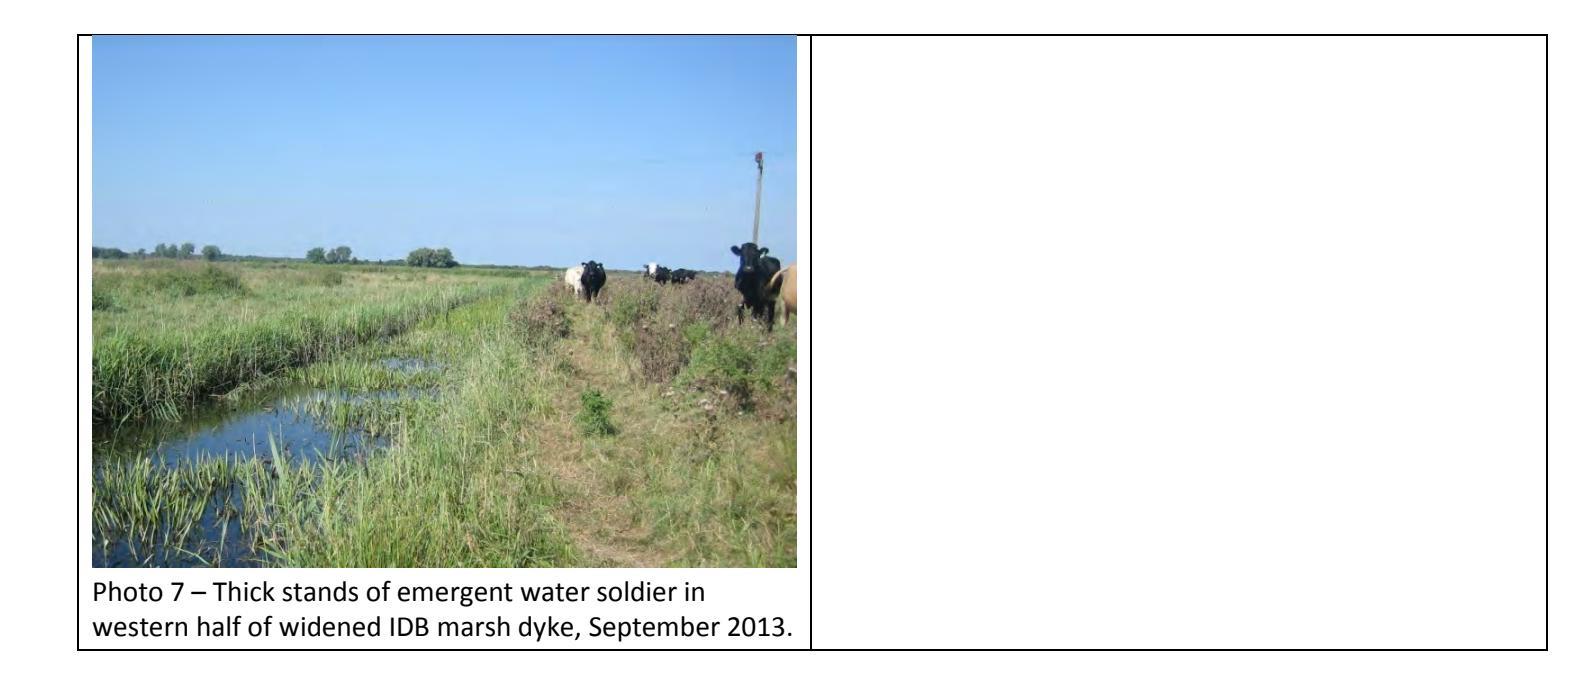
The literature indicates a potential positive association between grass-wrack pondweed and water soldier, however observations at some sites indicate the latter can replace the former (Birkenshaw *et al.*, 2013). It seems reasonable that very thick stands have the potential to cause problems for grass-wrack pondweed propagation both by reducing light levels reaching the sediments in the spring, and by forming a physical barrier above germinating turions.

In light of the water soldier growth observed in 2013, it is recommended that an additional distribution survey is undertaken in 2014, and onwards into 2015 if growth appears reduced in comparison to 2013. If the grass-wrack pondweed population is maintained at its 2013 distribution, future bi-annual or every third year surveys of this and other IDB dykes supporting the species would help to ensure an ongoing balance is achieved between keeping the dyke open and clearance being not too extreme.
