## **Scarrow Beck Restoration Project**

#### Completed October 2021

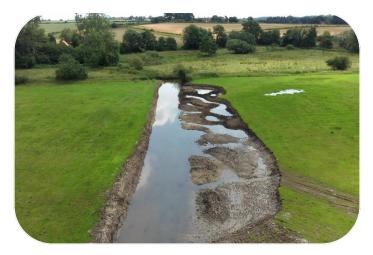
Above: Newly completed channel features
